IMPROVEMENTS IN THE ZERO GRADIENT SYNCHROTRON (ZGS) MAIN MAGNET COIL PROTECTION\*

D. E. Suddeth, W. F. Praeg, and C. W. Potts Argonne National Laboratory Argonne, Illinois

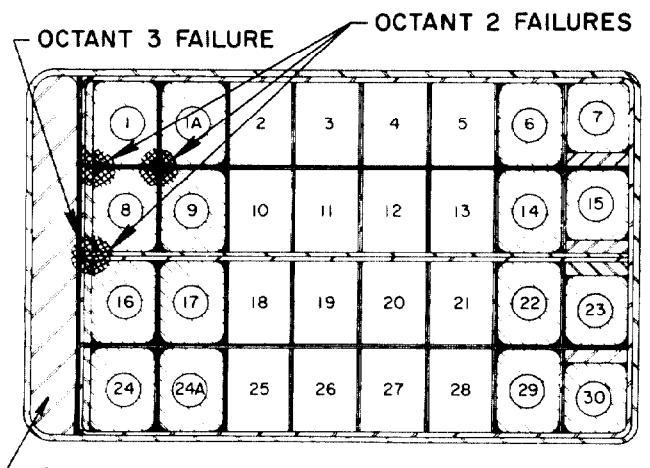
Fig. 1 ZGS Main Coil

After a few button-joint failures early in the life of the ZGS main coils, the coils performed well for many years. On April 21, 1970, after 41 million pulses, the octant 2 coil failed with layer-to-layer and layer-tokicker plate shorts, as shown in Fig. 1. The spare coil was installed in about eight weeks, and the accelerator resumed operation.

On January 9, 1971, after 45 million pulses, octant 3 coil failed in a manner similar to octant 2 coil, except that the damage was less extensive, being concentrated between the outer turns and the kicker plate. This damage was repaired with an ingenious technique and, again, operation resumed successfully.

The other existing protection circuit was detection of ground current flow to the kicker plate. Trimming of individual octant fields is made by current in this plate. Referring to Fig. 1, the reader will note that this stainless steel plate is inside the main coil ground insulation wrap. Spring loaded, electrically insulated anchor bolts attach to the kicker plate to hold the main coil in place when it tends to deflect due to the magnetic forces during pulsing. Since there are 286 anchor bolts on every octant, ground failures are common. The size of this plate creates a capacitance to the grounded magnet iron of  $\sim 60$  nF.

Examination of the damaged coil indicated the possibility of turn-to-kicker plate shorts before turn-toturn shorts occurred. If that was the case, main coil voltage would have forced kicker ground current. Thus, on-line kicker ground protection circuits might have limited the damage. On this thesis, kicker ground detection circuitry was devised that had two levels of protection. The most sensitive level was to alert operating personnel to monitor the ground current flow. These current signals were sent back to the ZGS Main Control Room (MCR) through multiplexing circuitry. The less sensitive level was interlocked to shut down the RMPS when the kicker ground current became large enough to create significant orbit distortions. Dual set point meter relays were put inside a diode bridge to get bipolar dual level protection. These circuits have worked admirably; almost every ground indication has been real and nuisance trips have been few.

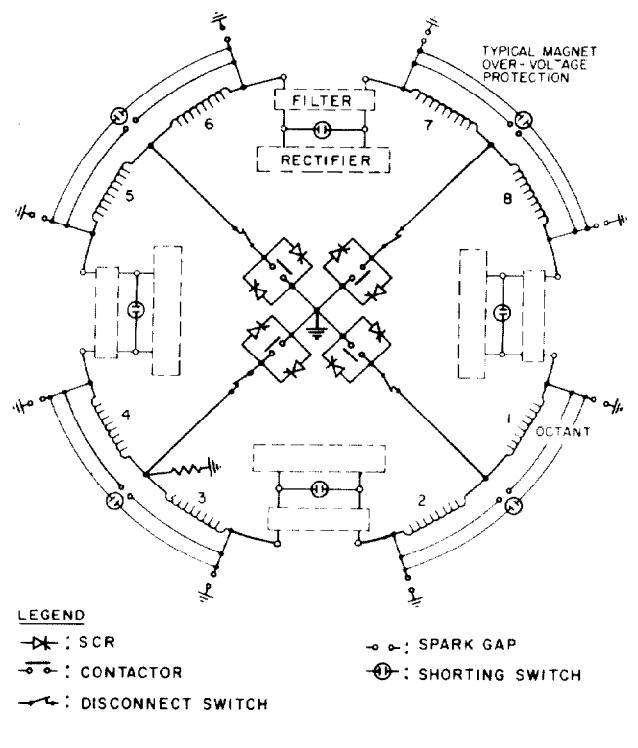
Fig. 2 ZGS Main Coil Circuitry

Figure 2 is a schematic of the ZGS main coil. Power to the ring magnet is added in four locations to achieve a potential distribution as shown in Fig. 3. Note that there are eight points of nominally zero potential to ground. One of these points is tied to earth ground through a resistor, and ground current is monitored here. A most important point to note is that this potential distribution is only symmetrical when:

- 1. Potential is added symmetrically and
- 2. one of the zero points is tied solidly to ground.

Our modification of this circuit had to be a compromise between our desire for a solidly grounded reference point for protection purposes and the fact that, like all weak-focusing accelerators, unbalanced leakage currents cause large warps in the proton beam orbits. The action taken was to ground the ring through a  $l+\Omega$ resistor (an order of magnitude smaller than any single leakage path) and make sensitive (33 V at 33 mA) but slow (0.6 s with 33 V applied) protection circuits. With this sensitivity, all but one of the turns in an octant was protected and yet the slowness of the response has kept spurious transients such as excitron arcthroughs from falsely tripping the ground protection.

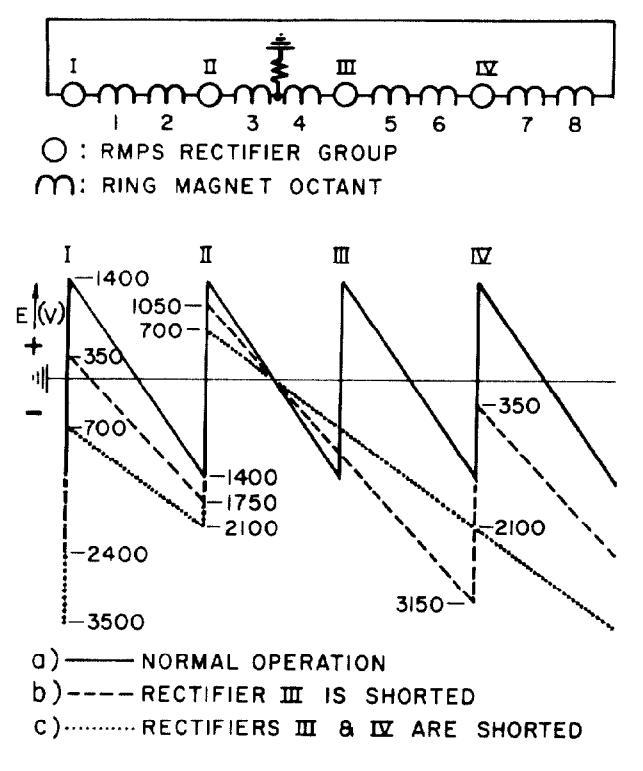
Fig. 3 ZGS Main Coil Potential Distribution

Certain types of RMPS faults initiate the closing of the vacuum shorting switches shown in Fig. 2. The shutdown timing sequence of these switches leads to the potential distributions as illustrated by Fig. 3. Relative changes in the timing of one switch to another of 2 ms could produce not only high voltages to ground as shown, but high turn-to-turn voltages. Arc faults in the rectifier power supplies and operation of protective spark gaps produce similarly distorted potential distributions. To eliminate this problem, a system was needed which could maintain the nominal zero potential points (phantom grounds) in the presence of applied voltage dissymmetries.

Inverse parallel SCR's capable of carrying 10,000 A for 1 s were installed at each of the three ring magnet phantom ground points and in parallel with the 1-k $\Omega$  ground resistor. Contactors rated 5000 A are connected in parallel with the SCR's. When the protective circuits of the RMPS detect a fault likely to cause a potential dissymmetry, the SCR's are gated on before the voltage transient occurs. The contactors close some 80 ms later to transfer most of the current from the SCR's.
