# OPTIMIZING THE RELIABILITY OF THE FIRE ALARM SYSTEM IN THE TAIWAN PHOTON SOURCE

W. S. Chan<sup>†</sup>, F. D. Chang, C. S. Chen, Y. F. Chiu, J. C. Liu, Z. D. Tsai, National Synchrotron Radiation Research Center (NSRRC), Hsinchu 30076, Taiwan

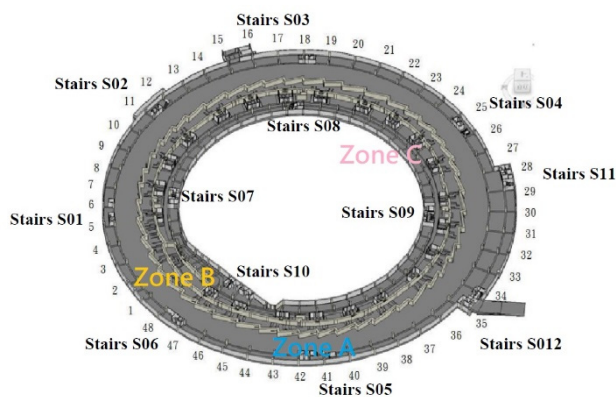
The TPS building is divided into three zones: (1) experimental hall including beamline hutches, laboratories and utility area (zone A); (2) shielded tunnels containing linac, booster and storage ring (zone B); (3) the core area including control instrumentation areas (CIA), radio frequency (RF) modules, laboratories and utility area (zone C), as illustrated in Fig. 2.

Figure 2: Perspective drawing for the first floor of the TPS [2].

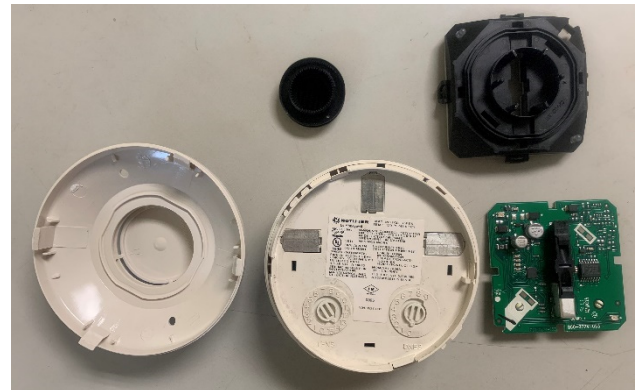
**Visual inspection** The broken smoke detectors were dismantled into parts and inspected visually. Dust/mist accumulation and trace of surge striking on printed circuit board were not discovered, as demonstrated in Fig. 3.

Figure 3: Visual inspection of failed smoke detectors.

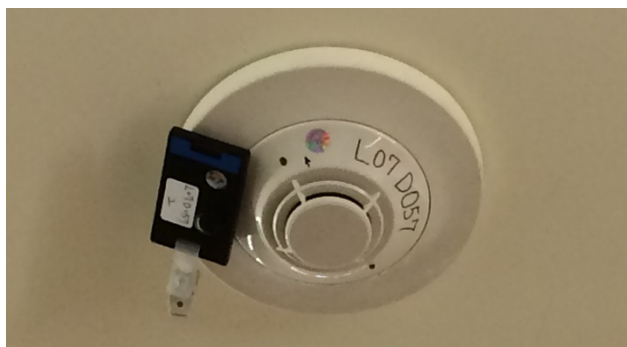
**Radiation evaluation** Six thermo-luminescent dosimeters (TLDs) were utilized to record the radiation dose to smoke detectors installed in the TPS tunnel, as shown in Fig. 5. The TLDs were attached to the smoke detectors for a week and then analysed by a Harshaw TLD Model 6600 Plus Automated Reader Instrument. The total deep dose in these six TLDs were 2.41 to 4.33 Gy. A CERN report [3] has determined an upper dose limit to electronic components of 100 to 1000 Gy. This guideline implies that the exposure of the smoke detectors installed in the TPS tunnel would reach the upper dose limit in 20 to 45 weeks.

Figure 5: Detector installed in the TPS tunnel with a TLD.

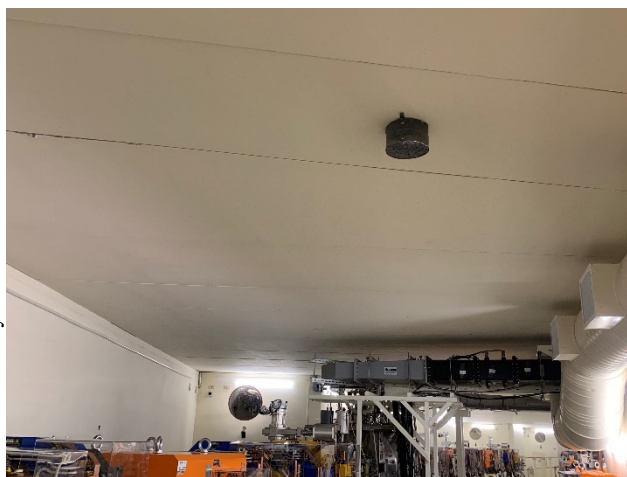
Figure 6: Smoke detector with lead shielding.

A two mm thick lead shield around the smoke detectors and a porous plate at the bottom was installed to prevent noise induced by radiation or EMI, as shown in Fig. 6. A smoke detector tester was used to verify a sensing time of less than 30 seconds. Furthermore, the alarm verification time was adjusted from 0 to 5 seconds for the smoke detectors installed in the TPS tunnel and the probability for a false alert by the TPS fire alarm system was reduced to less than 0.5 times per year, even for a beam current of 500 mA.

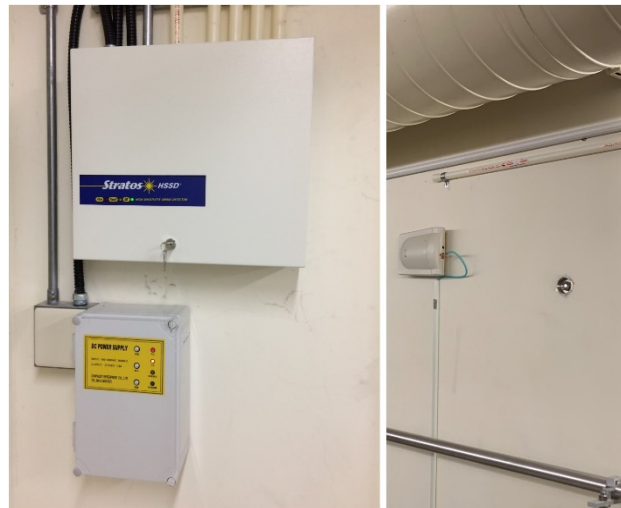
Figure 7: Aspirating smoke detector installed in the CIA room outside of the tunnel (left) and sampling pipes in the tunnel (right).

Aspirating smoke detector with high sensitivity with laser-based detection chamber was employed at the outside of the TPS tunnel, as shown in Fig. 7. Air from the tunnel was drawn into the detection chamber through a network of air sampling pipes by an aspirator. The benefit to electronic components of this detector is no exposure to radiation and/or an EMI environment. The alarm sensitivity range of this laser-based detector was wide (i.e., 0.0091%–7.62% obs/ft) and can be used as an add-on to the fire alarm system in the TPS tunnel.
