X-RAY DETECTOR ARRAY FOR SPATIAL AND TEMPORAL DIAGNOSTIC AT THE LANSCE LINAC*

M. Sanchez Barrueta[†], G.O. Bolme, J.T.M. Lyles, J.E. Zane, AOT-Division,
Los Alamos National Laboratory, Los Alamos, NM, USA
R.Z. Pinsky, University of Michigan, Ann Arbor, MI, USA

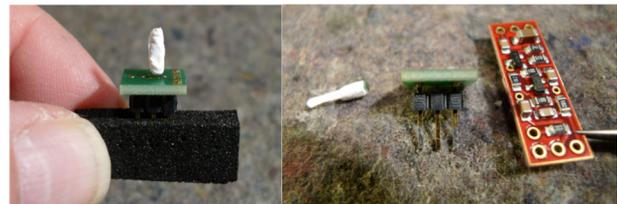
Figure 1: Scintillator mounted on SiPM detector (left), LYSO scintillator, SiPM detector and preamplifier.

The chosen detector was a Ketek PM1125-WB, containing 1600 microcells and with a recovery time of 30 ns. The detector alone can be used to detect high energy X-rays, but for the purposes of our application, it was used as a readout for a Cerium doped Lutetium-based crystal ($\text{Lu}_{1.8}\text{Y}_{0.2}\text{SiO}_5:\text{Ce}$) LYSO scintillator that has a decay time of 40 ns. The detector output is a current, the amplitude of which relates to the number of photons received in the cell, which in turn relates to the energy of the incident X-rays. This current output was converted into a voltage and amplified via an Advatech AMP-0611 preamplifier (Fig. 1) into a signal that could be displayed and compared with an oscilloscope. The whole ensemble was placed into a small light-sealed box (Fig. 2) with connectors that can supply the 28 VDC for the SiPM reverse biasing and the 9 VDC necessary for the preamplifier power supply.

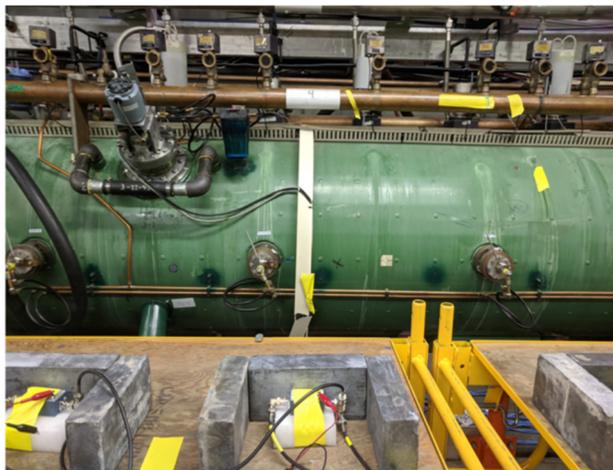
Figure 3: Detector placement for first test. The brick on the front has a 1 cm hole to act as a collimator and limit the detector's field to only one gap of the cavity. This three-brick housing proved ineffective in shielding the detectors from X-rays being produced in adjacent gaps.

Initially, the detectors were placed on 2 different supporting tables and each device was shielded by only 3 lead bricks (Fig. 3). Our first results revealed that the X-rays emanating from the breakdown were visible on all the detectors independently of their position, which meant that better shielding was needed to prevent cross detection. A complete housing made of 14 solid lead bricks (Fig. 4) and a single perforated brick at the front to act as a collimator was built for each device to look at a single gap of the DTL. Crosstalk between individual sensors was greatly reduced because of this improvement.

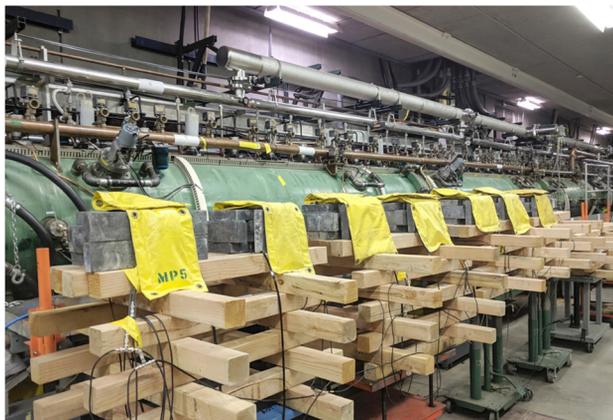
Figure 4: Lead blanket added to shield the detectors from backscattered X-rays emanating from adjacent cavities and final configuration of the detectors.

During the next batch of tests, it became apparent that backscattered X-rays from another cavity would be recorded by the sensors and contaminate the results. The maximum gap voltages on the other cavities of the 201 MHz part of the linac are: 340 kVp (Cavity 1), 1.03 MVp (Cavity 2), 1.31 MVp (Cavity 3), 1.46 MVp (Cavity 4). All of these gap voltages are high enough to produce X-rays when RF is fed into the cavities [3]. A lead blanket was added on the back of the housing (needed opening for the cables that feed the 9 and 28 VDC to the detectors) and the X-rays emanating from other cavities nearly disappeared on the waveforms of the sensors.

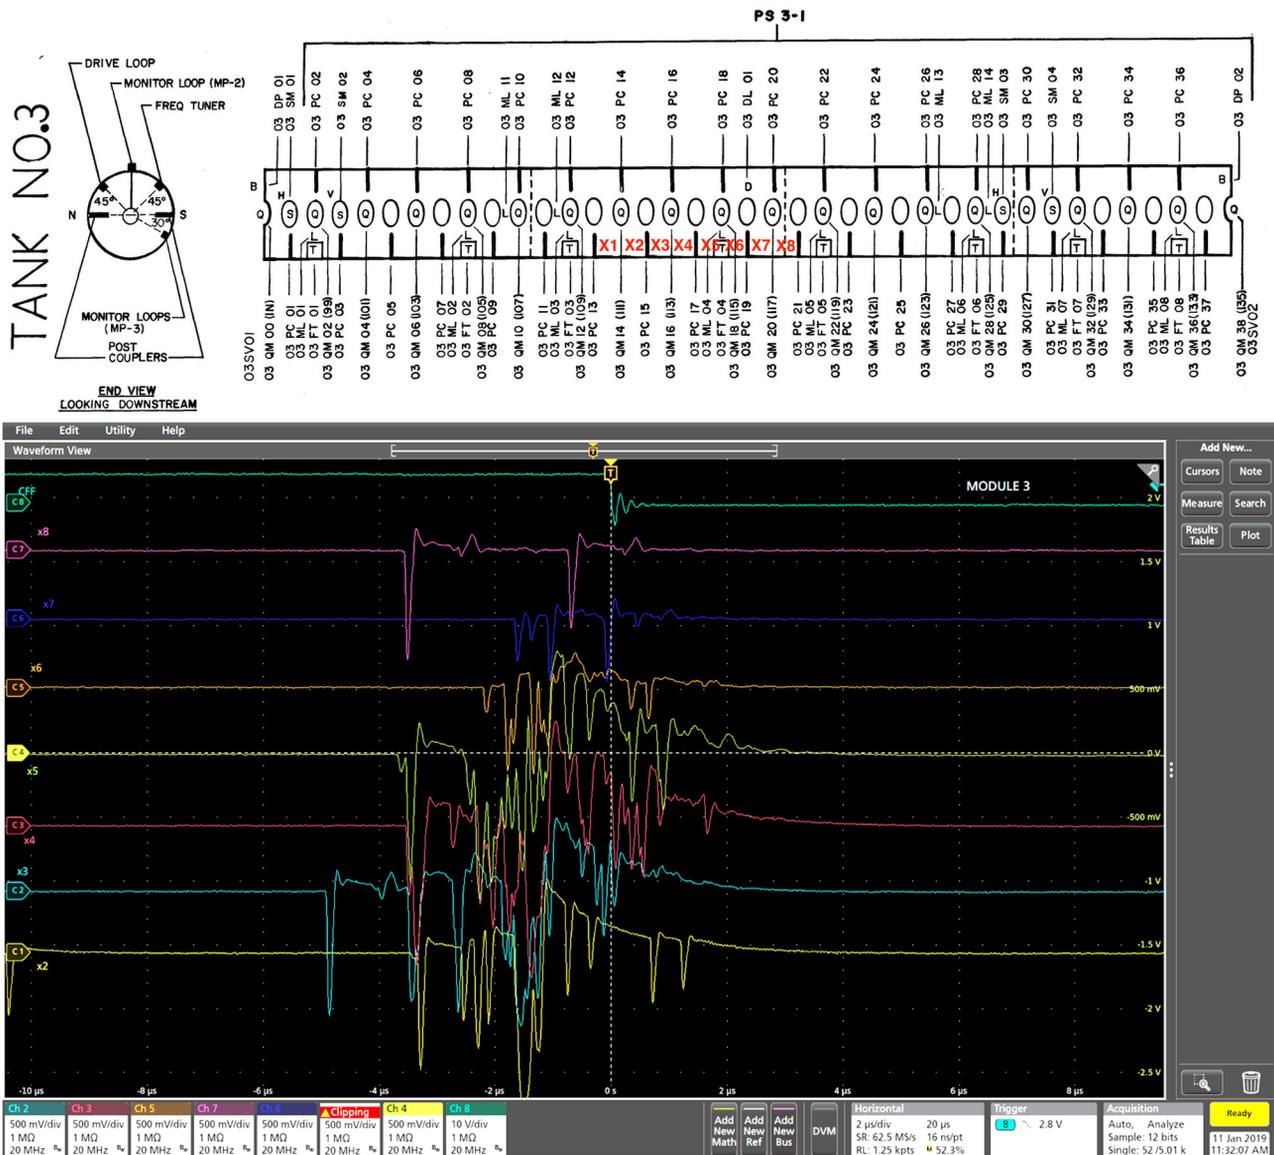
Figure 5: The most energetic X-rays are registered on the second quarter of the tank. The detectors have a negative output and due to the AC coupling of the amplifier, after every X-ray emission received there is a positive offset displayed.

The detectors were subsequently placed in front of different sections of the cavity, to locate the highest energy emissions and possible source of the high voltage breakdowns. The highest amplitude detected during most of the breakdowns was on the gaps on the second quarter of the tank (Fig. 5). The highest peaks were found mostly at the center, but throughout the many faults, the maximum amplitude voltages could be traced to different gaps in the same section. The results pointed to the cause of the breakdowns being in this particular portion of the cavity.

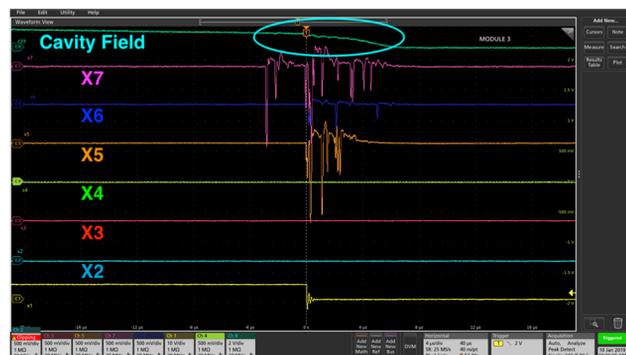
Figure 6: The RF field presents a slower drop that is accompanied by X-ray emissions from the start.
