THE SPECIAL LHC INTERCONNECTIONS: TECHNOLOGIES, ORGANIZATION AND QUALITY CONTROL

J.Ph. Tock, F. Bertinelli, D. Bozzini, P. Cruikshank, O. Desebe, M. Felip, C. Garion, A. Jacquemod, N. Kos, F. Laurent, A. Poncet, S. Russenschuck, I. Slits, L. Williams, CERN, Geneva, Switzerland, L. Hajduk, HNINP, Polish Academy of Sciences, Krakow, Poland, L. Vaudaux, IEG, St-Genis Pouilly, France

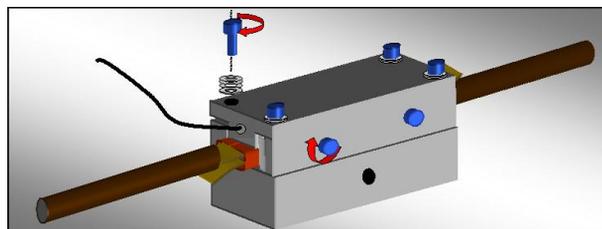
Figure 1: Design of an oven for resistive soldering

In the standard IC, the production has relied on induction soldering for the main busbars (13 kA) [2]. As the cable geometry in the special zone is different, major modifications and re-qualification tests would have been necessary; it was judged more profitable to develop resistive soldering ovens (Fig. 1) that could be optimized more economically for each of the situations met in the special IC. This technique depends more on the ability and expertise of the operators; that is the reason why only some very experienced and skilled technicians were qualified to perform these connections.

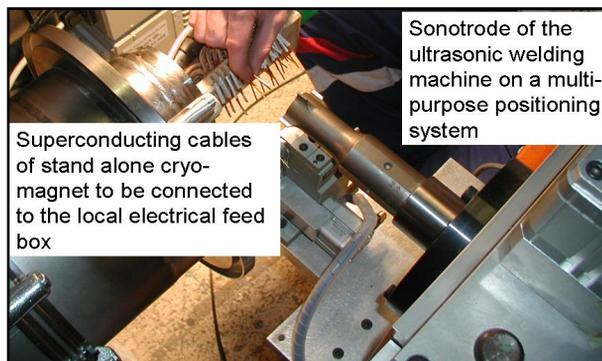
Figure 2: Ultrasonic welding in the special IC

The ultrasonic welding technique used to connect the auxiliary and spool pieces busbars presents many advantages as already reported [3]. As only minor adaptations to the anvil and the mechanical structure were necessary to apply the tooling in the special IC, it was preferred to use it after adaptation at a reasonable cost (Fig. 2).

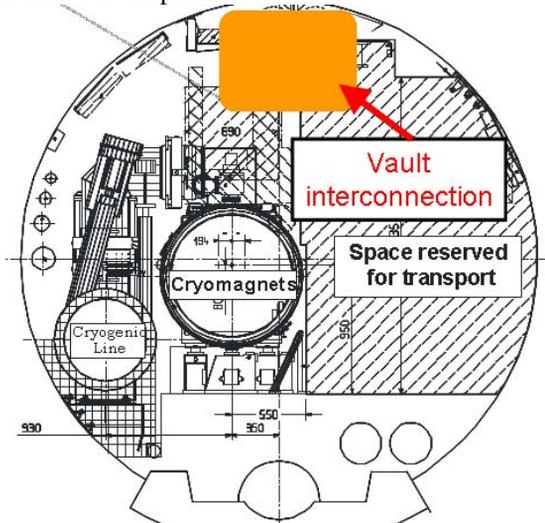
Figure 3: Location of link IC at point 3

In the standard regions, even if the access was not easy, investment in tooling and accessories was done to alleviate this. This was not the case for the special IC. As an example, for one of the superconducting links, there was only one IC of a certain type located near the tunnel ceiling (Fig. 3) and so no expensive accessory was procured. Ad-hoc, inexpensive, but more time consuming solutions were implemented.

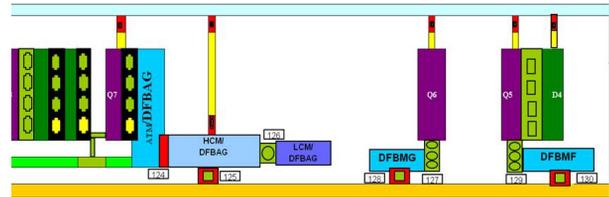
Figure 4: Extract of the graphical follow-up file

resources were shared and an overall optimisation was necessary. A graphical view (Fig. 4) of the work progress has been defined, dividing the work in four main subtasks

- connection of the beam lines,
- electrical connections,
- connection of the cryogenics lines,
- thermal shielding and closure of insulation vacuum.

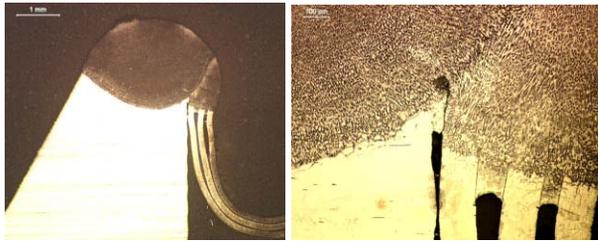
Figure 5: Analysis of leaking bellows

As an example, a 3-ply bellow with venting holes in the two outer plies was found leaky. A copper ring and copper sleeves were welded around the convolutions as a squirm protection. Surface stereomicroscopic observations of the central undulation of the inner ply, supposed to be leak tight, revealed oxidation and dimples of ductile rupture indicating that fusion had occurred and melted plies together at the location where the copper sleeve was welded onto the copper ring. An additional leak in the inner ply was found in the weld connecting the undulations to the end piece.(Fig. 5) Repair was delicate since the electrical connection between superconducting cables had to be unsoldered and flange interfaces modified to install the new bellows.
