Developing Facilities For SNS Cryomodule Performance Improvements

J. Mammosser

Outline:

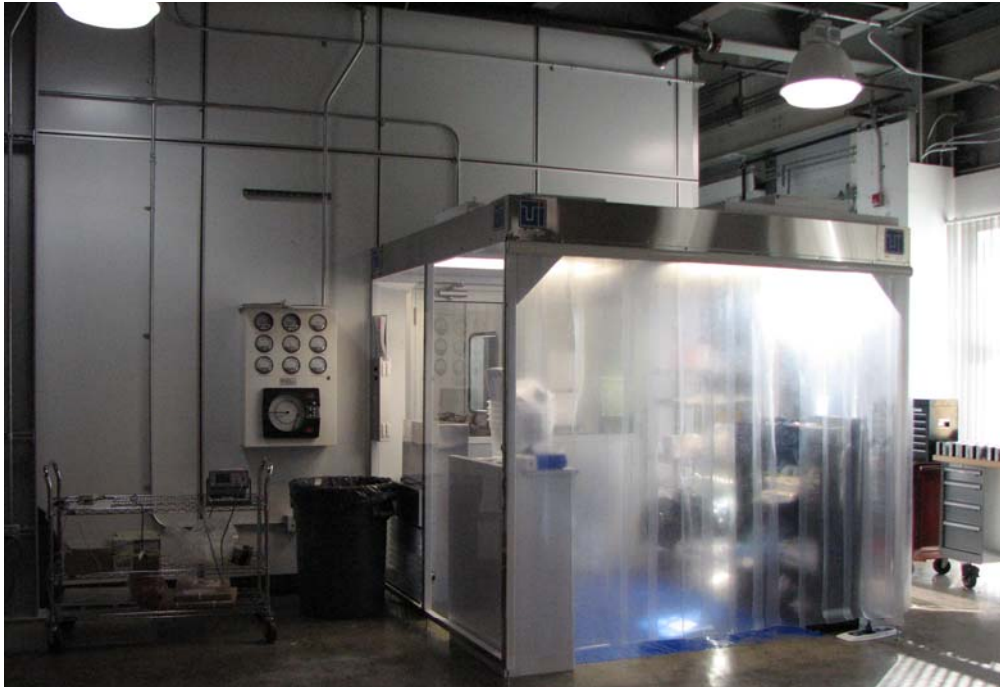
- **Cleanroom entry**
- **Class 10,000 area**
- **Small part cleaning**
- **Ultrasonic cleaning**

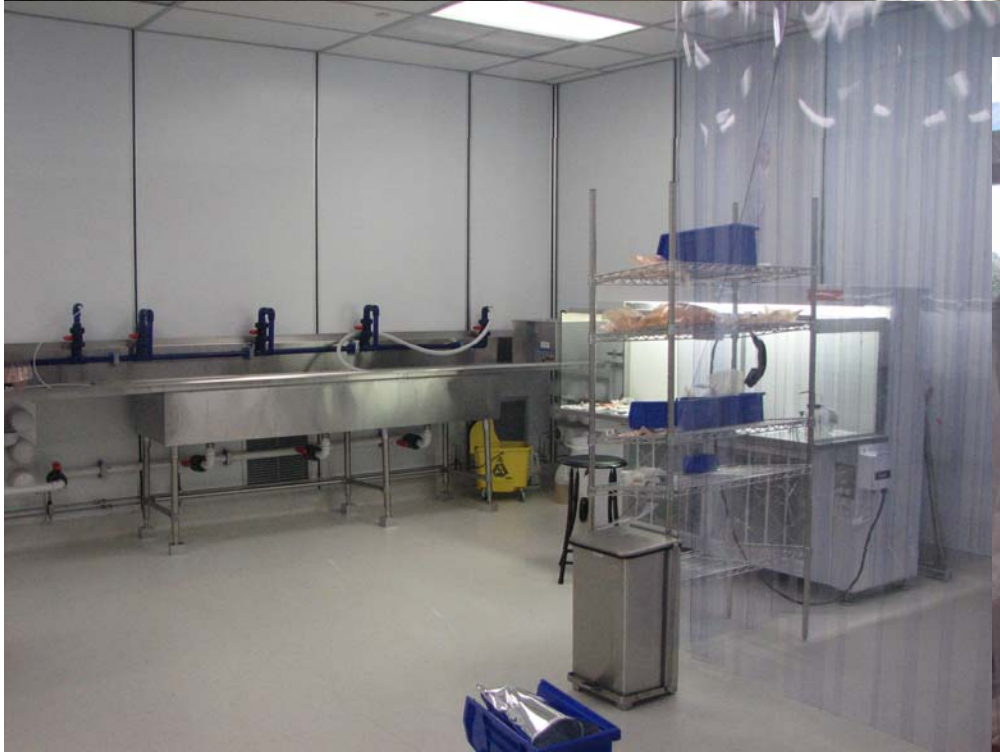
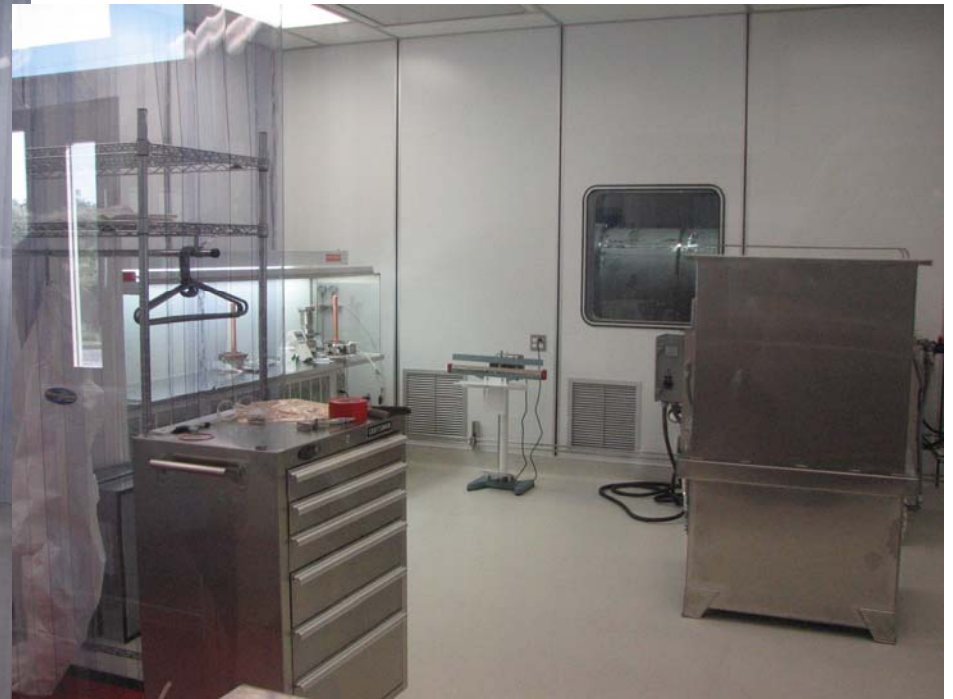
**Class 100 area used for
Cryomodule repairs**

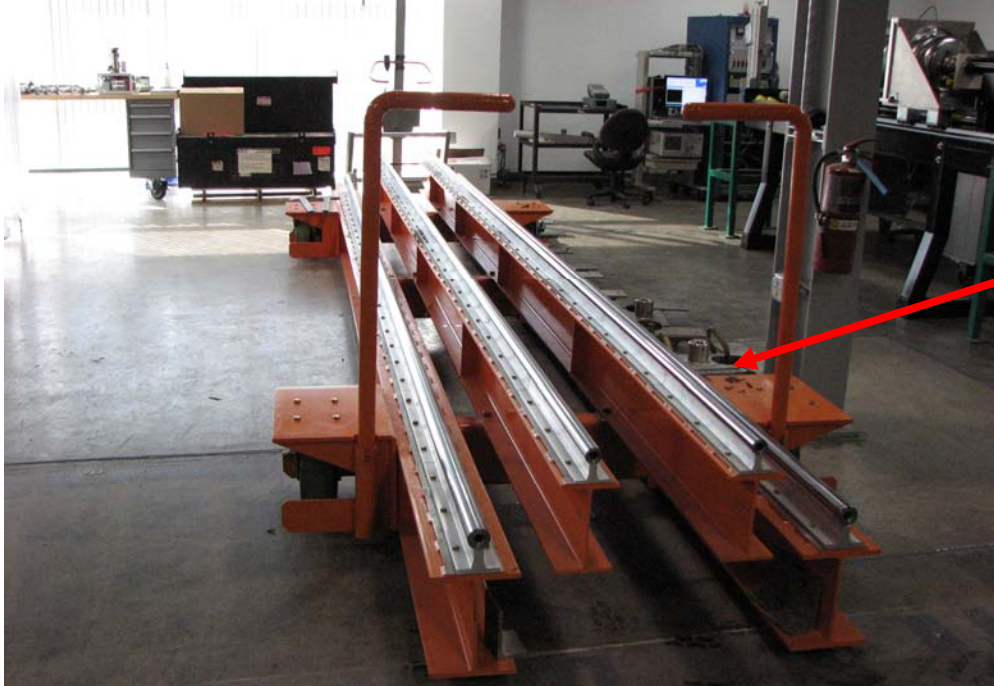
- Tooling for building spare Cryomodules

Fixed Rail

Transfer Cart

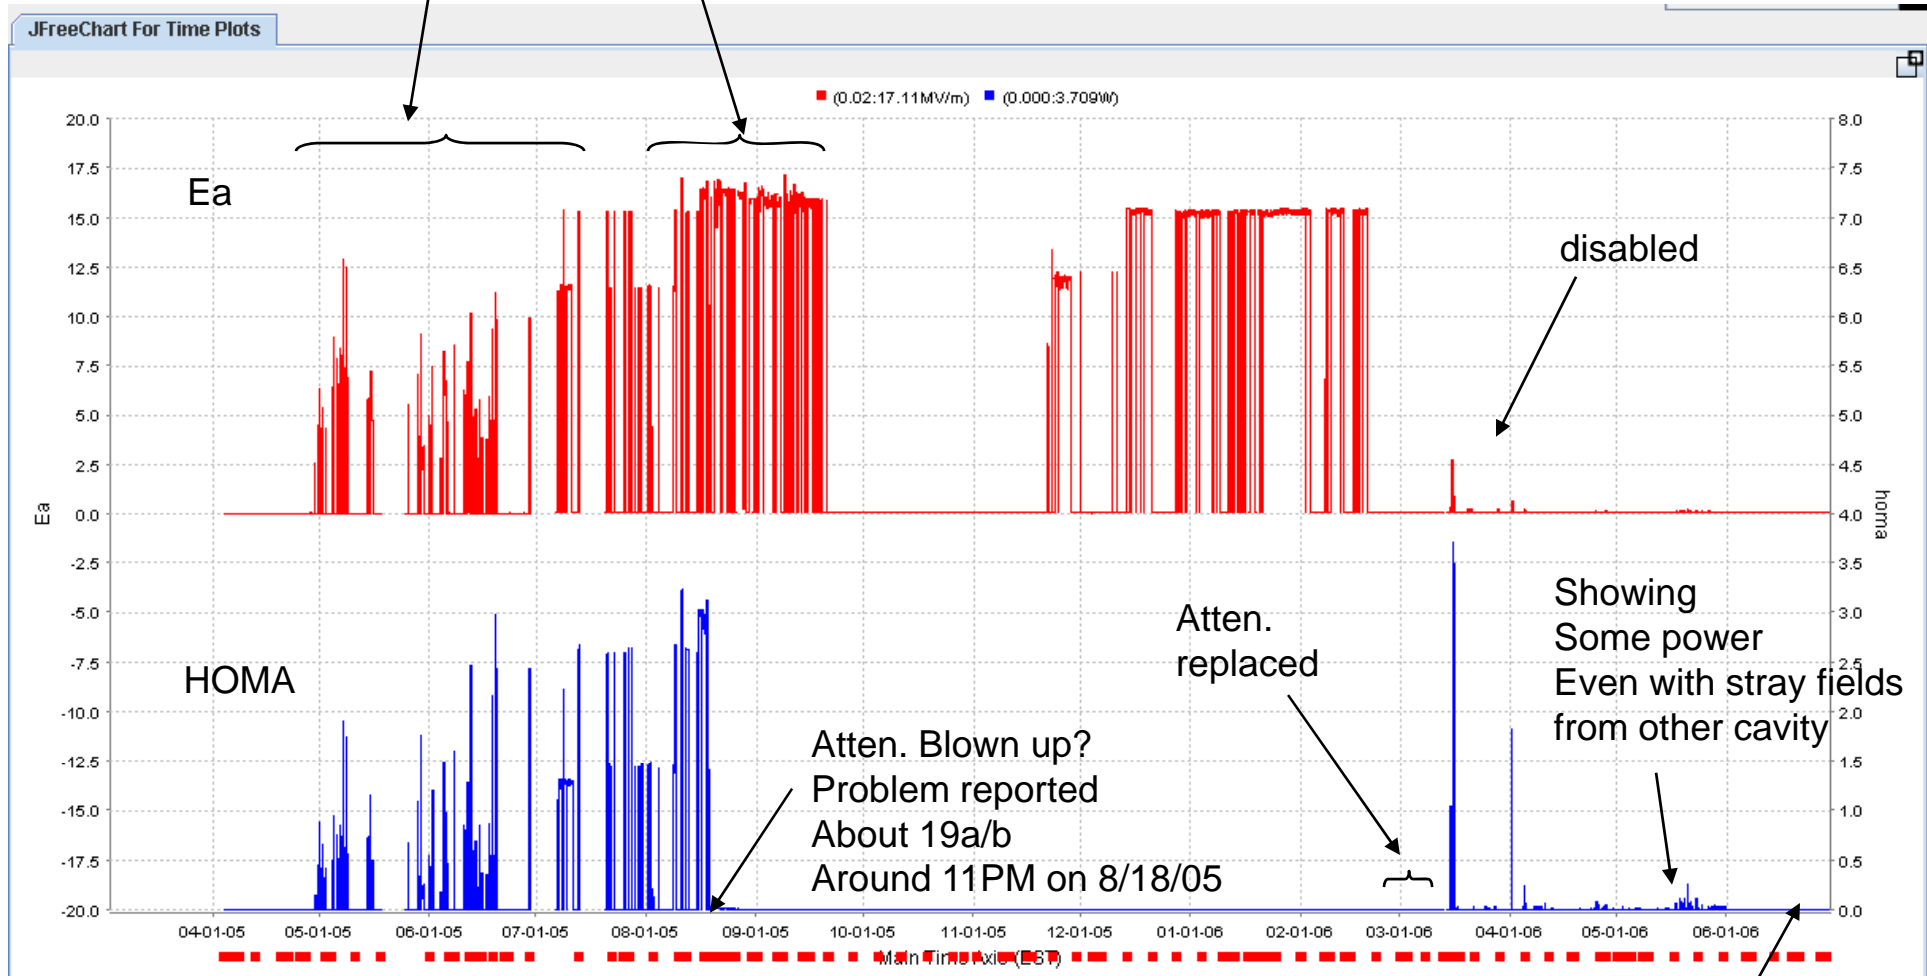
Cryomodule Commissioning
 19b Ea, limit~18 MV/m
 ; Qhoma (high power)~1.5e11
 Qhoma (low power)~ 1.4e11

Low power measurement
 At 4K in the tunnel
 Qhoma~3.8e8 (+25 dB)

- **CM19 cavity b suffered from erratic/high power transmission from the HOM b probe**
 - Cavity was operated several months with a blown attenuator on this port
- **Repair of CM19**
 - Cryomodule was moved to cleanroom and beamline vacuum was letup
 - Both HOM probes were removed and blanked off
 - Careful repair procedures were developed and implemented
 - Full monitoring of particulates recorded
- **Repair of CM10**
 - Field probe signal noise

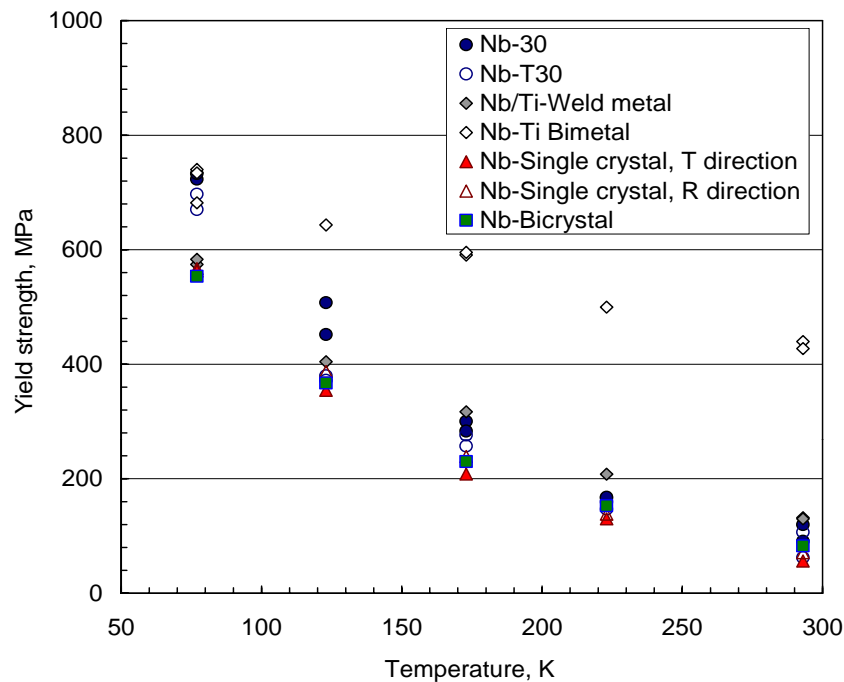
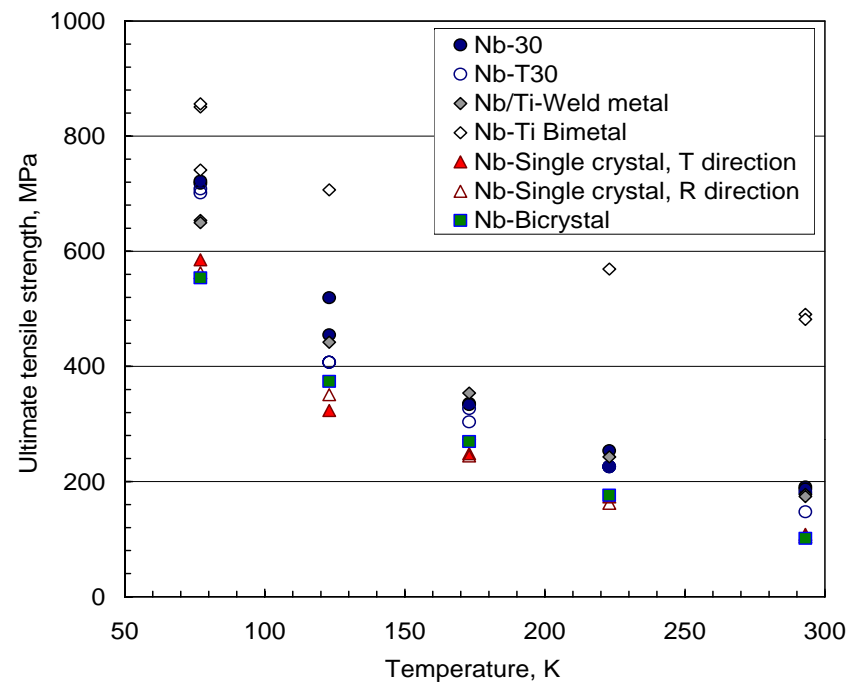
Strength of cryogenic vessel materials

- The strengths of Nb metals (Nb-30, Nb-T30, weld metal, single crystals, bicrystals) display strong temperature dependence, while they are similar at a given temperature.
- The Nb-Ti bimetal (explosion welded) shows the highest strength among the metals tested. This indicates that, assuming there is no influential defect formed by the welding process, the weld will not fail prior to a failure at adjacent softer material part.

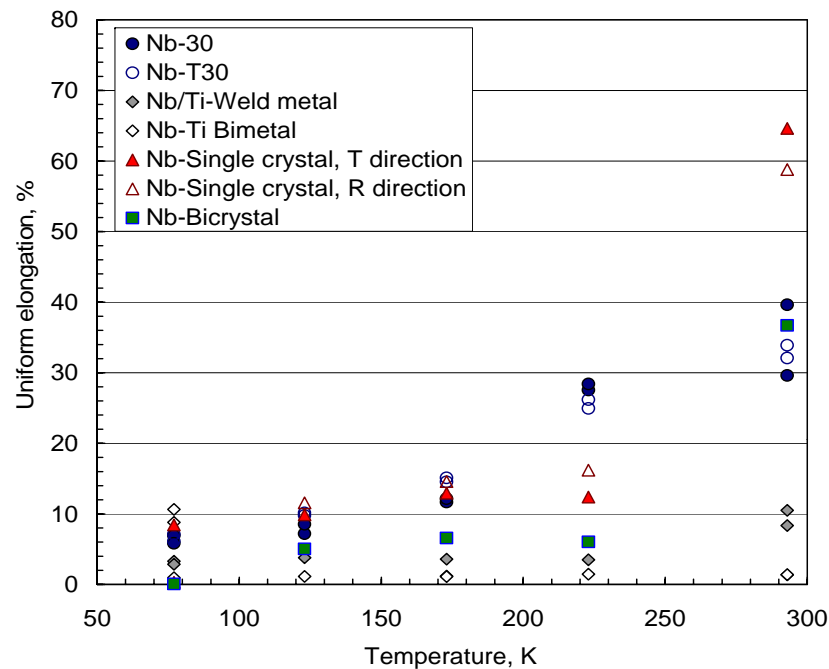
Ductility of cryogenic vessel materials

- The ductility of Nb metals increases with test temperature. It displays larger variation at higher temperatures.
- Both base metals, Nb-30 & 30T, retain at least 5% uniform elongation and 11% total elongation at the lowest temperature.
- The single crystal specimens show higher elongations than the Nb-Ti bicrystal specimens, indicating that the grain boundaries are weakened by a mechanism. (Loading direction was perpendicular to the grain boundary.)
- The Nb-Ti bimetal and Nb/Ti weld metal retain relatively low elongations over the test temperature range. The bimetal broke always at the weld joint.

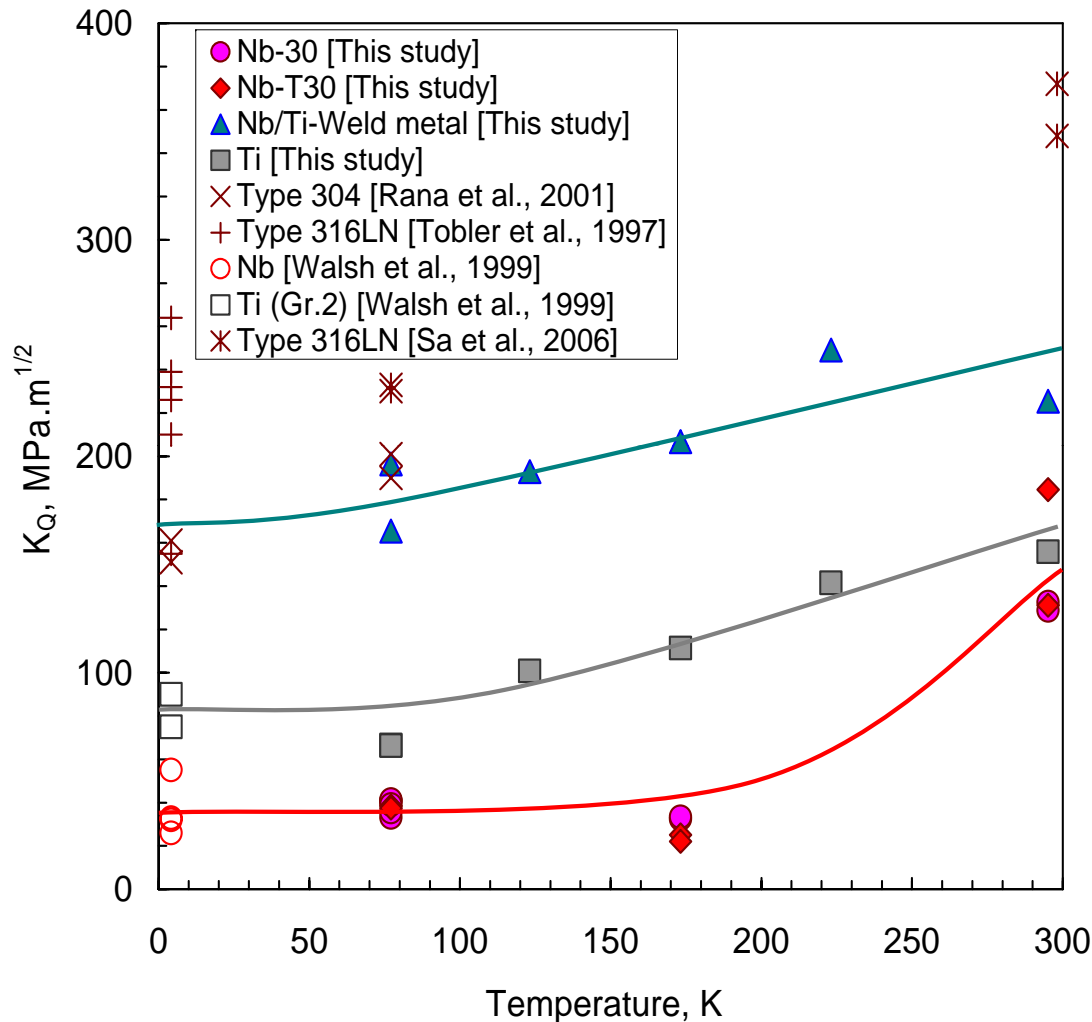
Fracture toughness of helium vessel materials

- The fracture toughness of Nb (30 & T30) decreases with decreasing test temperature and reaches the lower shelf values ($30 - 40 \text{ MPa}\cdot\text{m}^{1/2}$).
- The Nb/Ti weld metal shows much higher fracture toughness than the base metal (Nb). The fracture toughness of Ti is also higher than that of Nb.
- Among the metals compared the stainless steels (304 & 316LN) show the highest fracture toughness values over the temperature range.
- For Nb and Ti, the fracture toughness data from this study are consistent with those from earlier studies (when extrapolated to 4 K).
- Fracture toughness tests at 4 K is expected to confirm these findings.
