OPERATION EXPERIENCES OF THE DTL/SDTL FOR THE J-PARC

T. Ito[#], Japan Atomic Energy Agency, Tokai, Japan
K. Nanmo, C. Kubota, F. Naito, KEK, Tsukuba, Japan

An operation of a DTL and a Separated type DTL (SDTL) of J-PARC started in November 2006. The DTL and SDTL are currently running stable and accelerating the beam. To maintain the stable operation of the DTL and SDTL, we have done the maintenance of various equipment for the tank and solved many troubles. In this paper, we will present the operation experiences of the DTL and the SDTL.

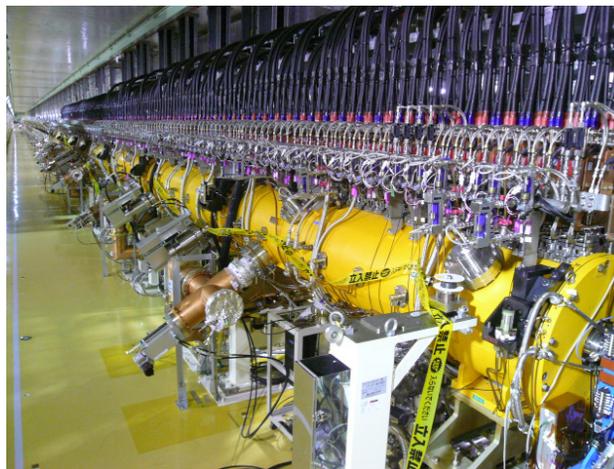
Figure 1: Photograph of the DTL. The right side is the upstream and the left side is downstream.

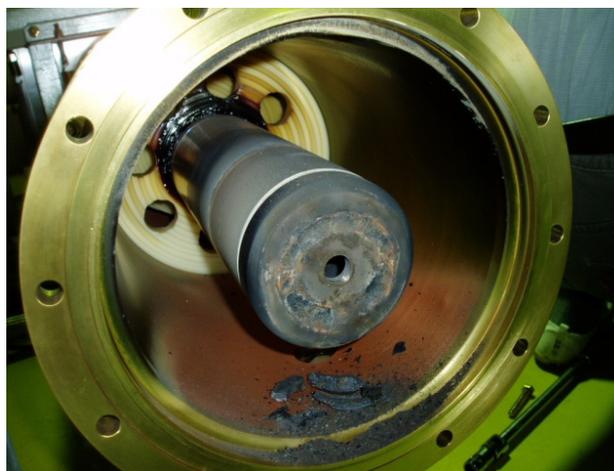
In the accelerator tunnel, the rf power for the DTL and the SDTL is fed through a coaxial tube. The damage event of the coaxial tube was occurred at the connection between the tubes. Figure 3 is the photograph of the damaged coaxial tube. As the contactors of the inner conductor was not jointed each other correctly, the electric connection was loose. As a result, the contactor was heated abnormally, the surface of the contactor was crumbly texture and the polyethylene inner tube support was heavily charred. The cause of this problem is faulty workmanship of installation of the coaxial tube.

This trouble has ever occurred twice. The first was on February 2009, we happened to find this problem at SDTL-7A. The operation of the SDTL-7A was very stable and the trip rarely happened at SDTL-7. When we entered the accelerator tunnel in order to do the maintenance work after the beam acceleration, we felt the burned smell slightly and could identify the location of the problem point. The outer conductor was too hot to touch for a long time. When measuring the coaxial tube, The temperature was about 40 degrees at the outer conductor surface and 54 degrees at the contactor surface about 2 hours after the beam was stopped.

Figure 3: Photograph of damaged coaxial tube.

To check that the same thing occur to other connections of the coaxial tube, we put thermo labels on almost all connections of outer conductor.

In an effort to improve the situation, we will put the labels on no-label connections of outer conductor in this summer maintenance period.
