RECOVERY OF THE J-PARC LINAC FROM THE EARTHQUAKE

Abstract

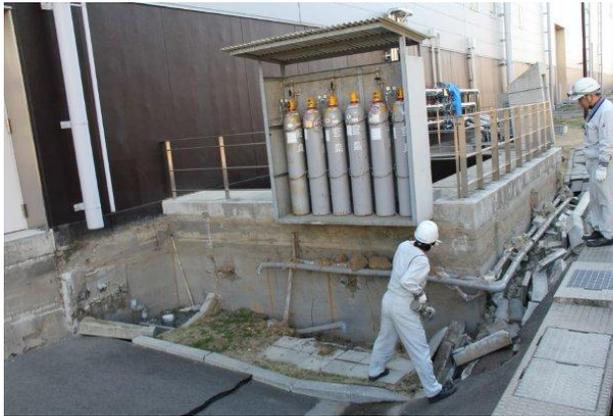
The linac building had the most seriously damages among all other buildings. A wide area at the entrance of the linac building subsided about 1.5 m, and almost all water supply and drainage pipes were broken as shown in Fig. 2. We could not get into the building until March 17 due to many strong aftershocks. It was found that there were fortunately no severe damages on the accelerator components themselves, but found that water was accumulated by 1 cm in depth on the linac tunnel floor. When we entered the tunnel again a week later on the 24th, the water level increased to approximately 10 cm. The leakage speed in this week was much faster than that of the first week from the earthquake. Therefore, we

Figure 2: Subsidence near the entrance of the linac building. Water supply and drainage pipes were broken.

decided to pump it out immediately. Because the electricity for the building had yet not been restored for the building, we used a diesel engine generator. In addition, because the leaked water that went through the

concrete wall was highly alkaline, we had to neutralize it by acids before draining it. It took two days to drain approximately 150 m³ of water. When the floor exposed, numerous lateral cracks were recognized on the floor and the walls.

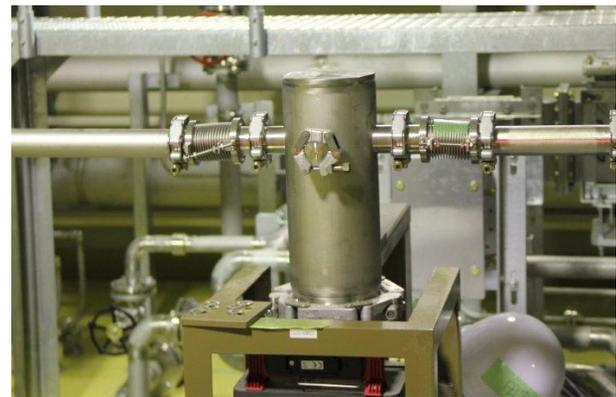
There was a recognizable beam loss after the beam restoration, in particular after the SDTL straight beam transport section. Through a beam study, we found that beam loss was affected by beam trajectory, and to reduce beam losses, we had to adjust the beam trajectories at +5 mm and -5 mm as shown in Fig. 5. We found that high radiation dose points existed at vacuum pump boxes in the transport line, and there was a larger displacement than expected[8] as shown in Fig. 6.

Figure 6: Displacement of the box. Deformed bellows with a red laser level marker line are shown.

After realignment of the boxes and ducts, the amount of beam loss declined to that before the earthquake. Through this problem, we learnt that we should have considered not only precise alignment of magnets and cavities, but also that of the other components, such as the ducts and vacuum boxes.
