Recovery of the J-PARC Linac from the Earthquake

Kazuo Hasegawa

J-PARC Center/Japan Atomic Energy Agency

LINAC12

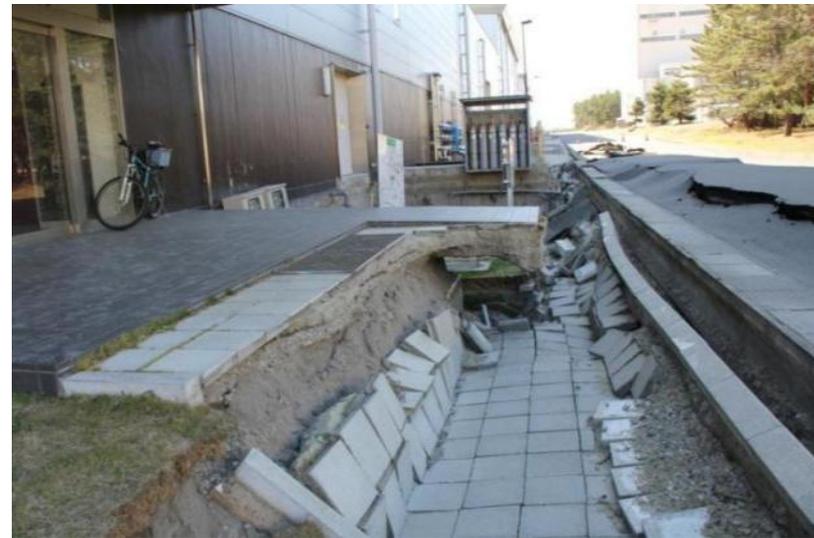
Entrance of the Linac

About 1.5 m drop over a wide area.
All electric wires and water pipes were damaged.

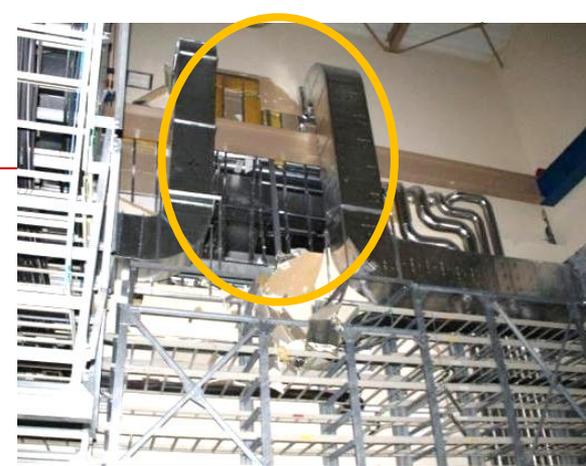
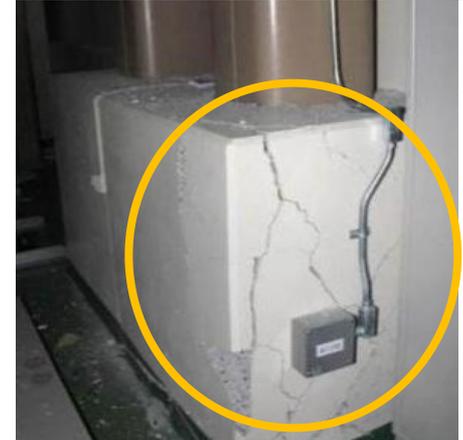
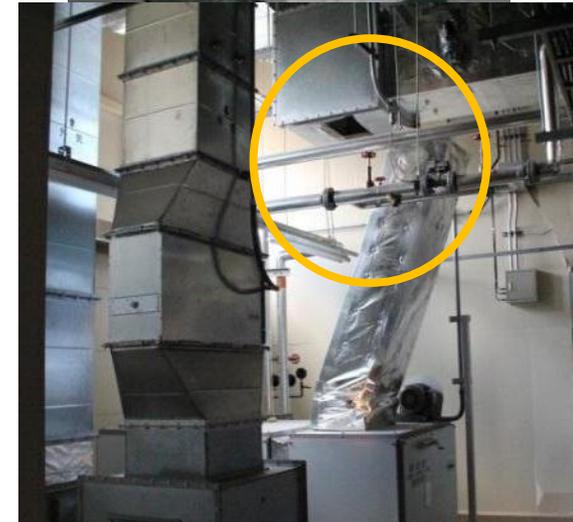
- **Flooding in the accelerator tunnel:** Broken and corroded
- **Deformation of the building:**
 - Displacement: accelerator components
 - Damaged or broken: many partition walls, pillars and floors
 - Unavailable cranes : deformed rails
Restored in the klystron gallery just two weeks ago!
- **Strong shaking:**
 - Broken: beam monitors, bellows, air ducts and water plumbing
 - Wavy road: **Not restored yet!**
- **Damage on air-conditioning system:** Accelerator components left for several months in poor condition (**high temperature and humidity**)

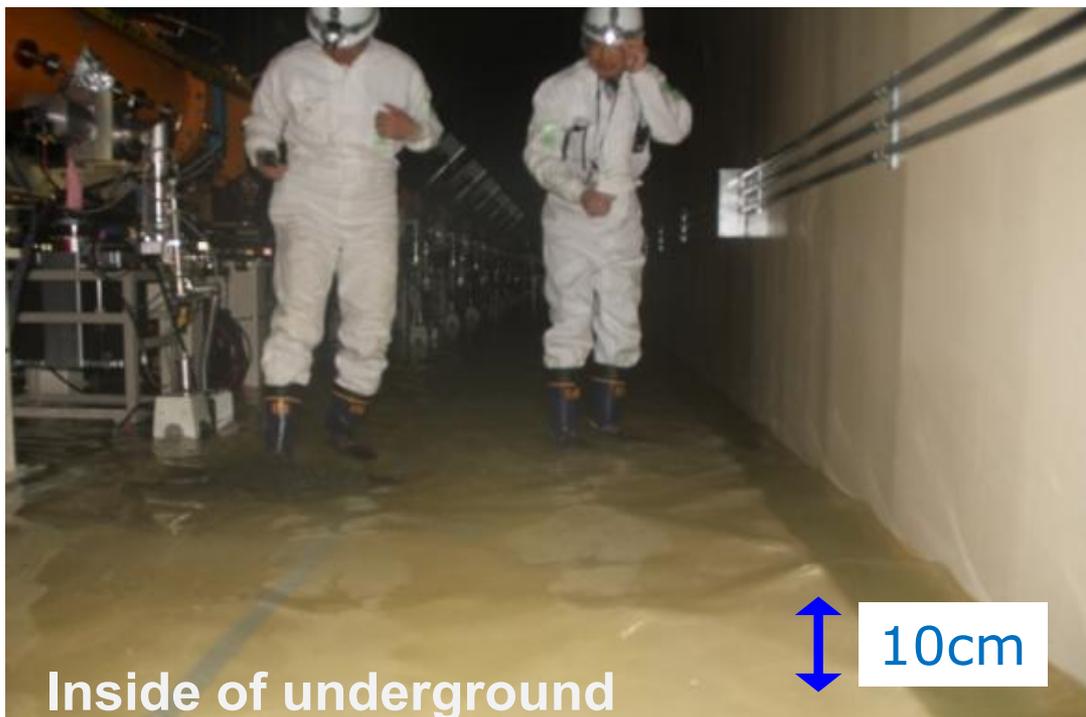
Inside of underground tunnel

Groundwater leaked into the tunnel: depth of 10 cm (150 tons) within two weeks

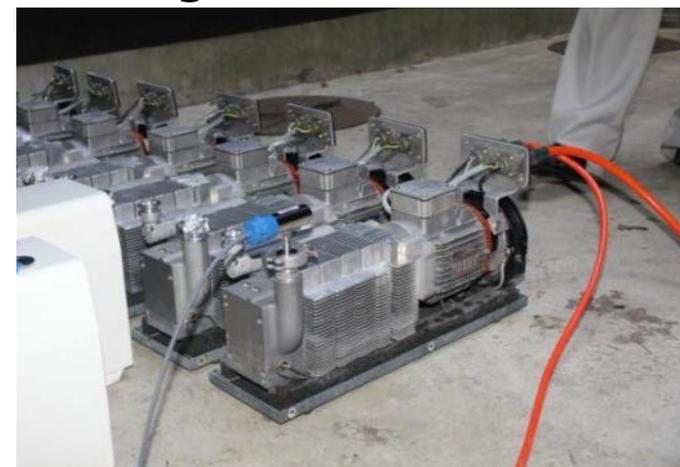
Some flooded pumps were broken.

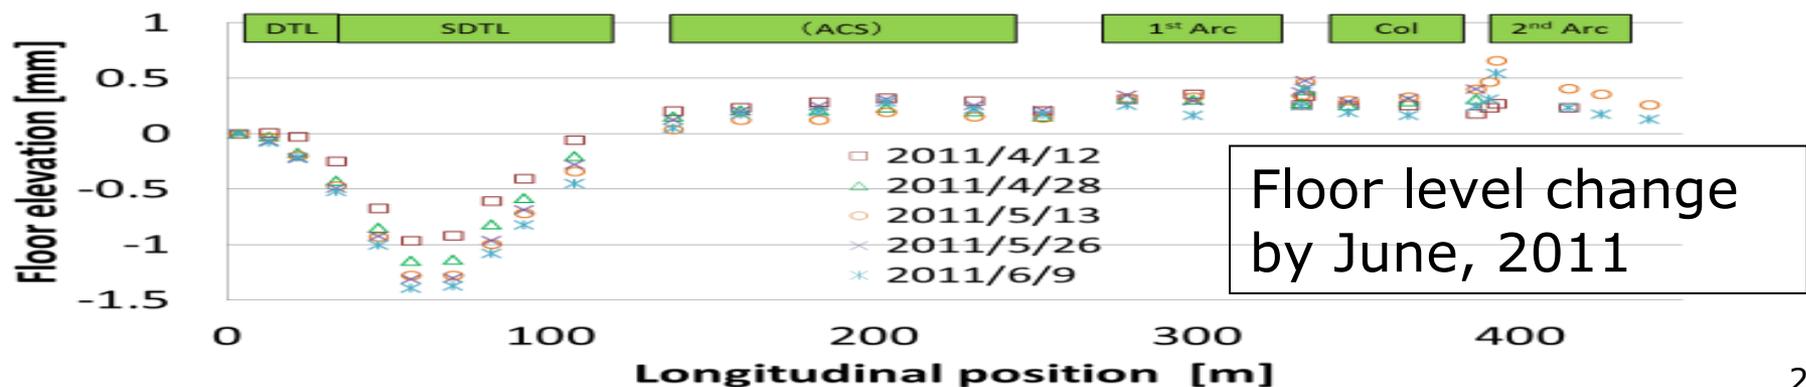
- Subsidence: 40 mm (DTL and SDTL section) and 20 mm (now BT, future ACS section)
- Continued floor elevation change by June: precise alignment carried out after that.

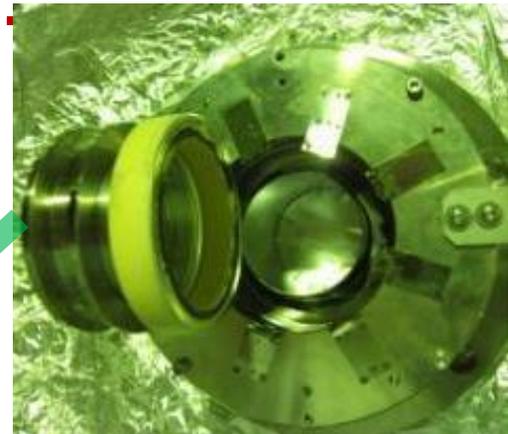
Broken current transformer: separated brazed ceramic parts and stainless parts

- The mechanical flexibility helped against DT displacement.
- But bellows and monitors could not stand for these flexibilities and broken.
- In this case, time of “DT realignment >> monitor rebuild”, Contributed shorter restoration, but.....
- Lessons Learnt: We should consider side effects in advance to mitigate the total damage.

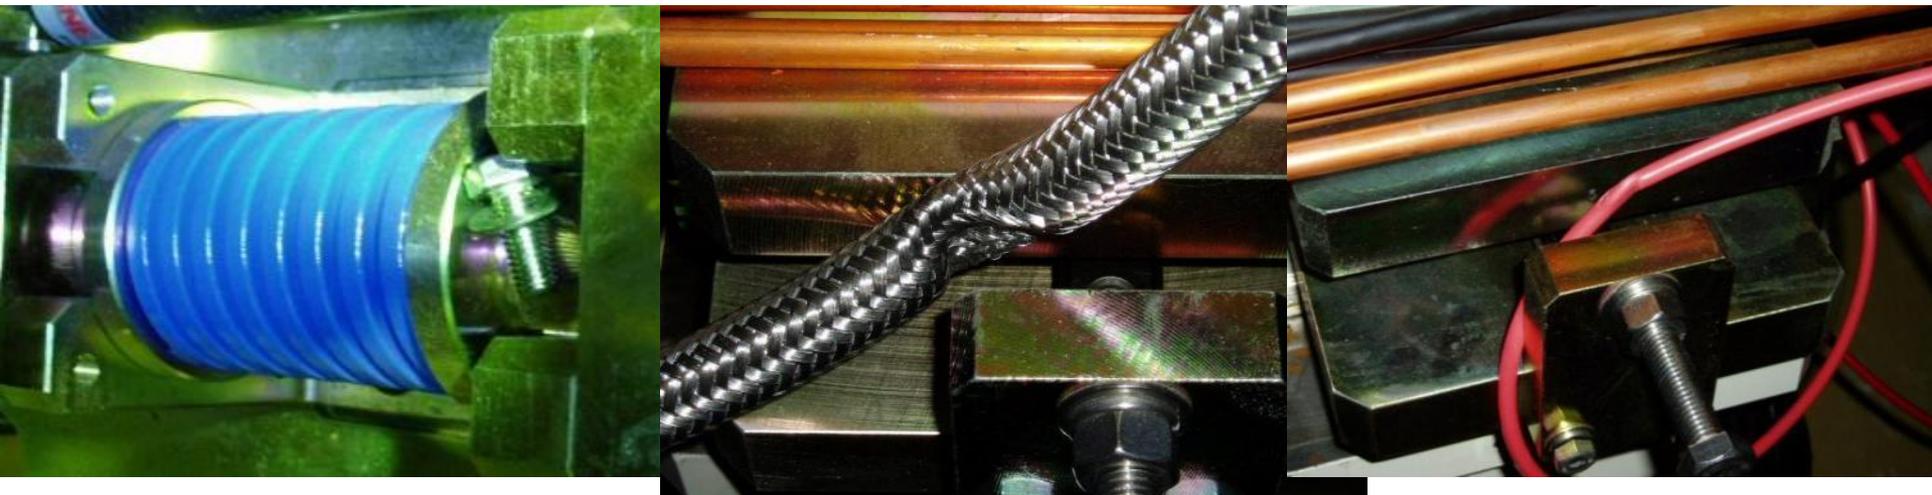
- We had to clear in the movable area to secure the earthquake proof system. But we can see **some materials after the earthquake**.
- We ignored to check this area, because **we didn't expect big earthquakes**: today, tomorrow, after tomorrow ---.
- **Lessons Learnt: We have to recall the famous Japanese saying "A natural disaster will happen when we least expect it."** by Dr. Torahiko Terada, physicist 1878-1935

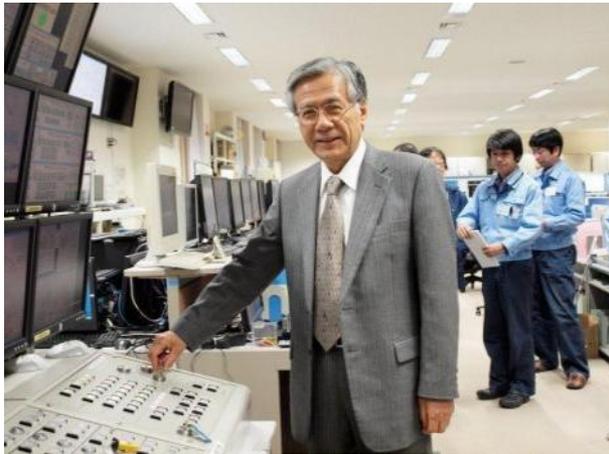
14:00 Beam went throughout the Linac at 3 MeV with RFQ acceleration.

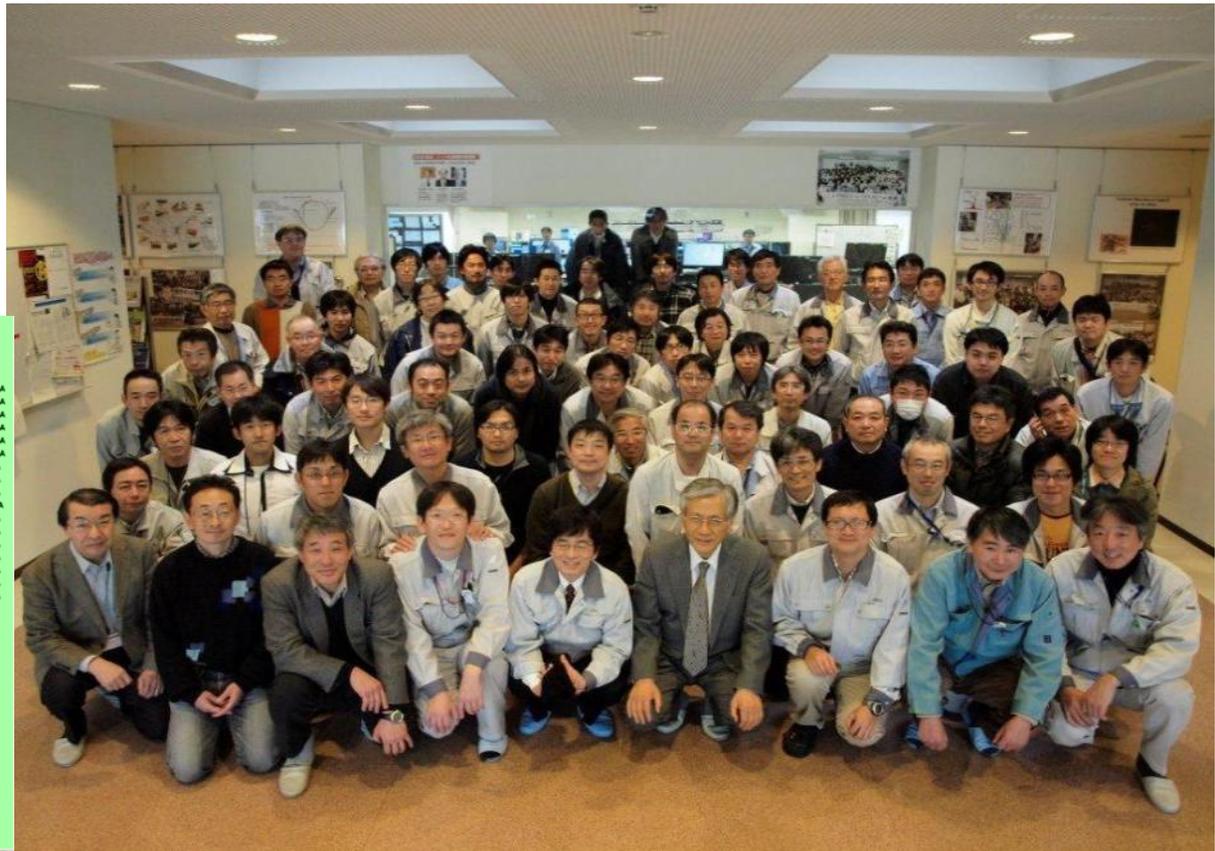
09:30 Key was on.

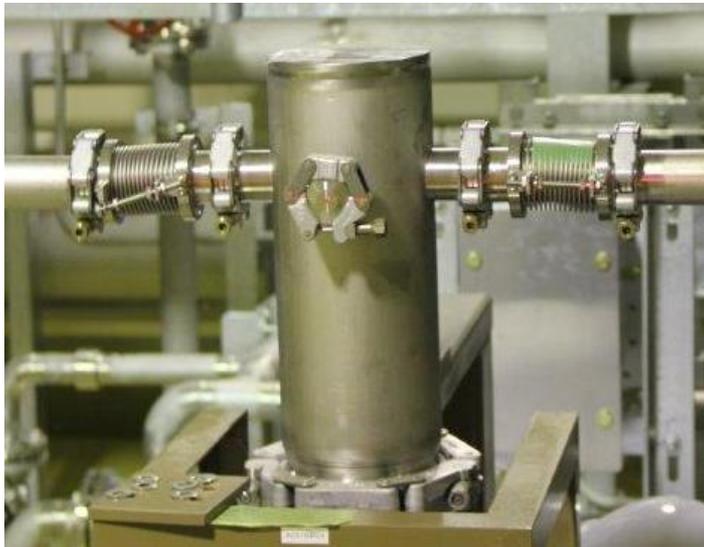
Displacement of the box.
Deformed bellows are shown.

- High radiation dose points at the vacuum pump boxes
→ We found larger displacement than expected.
- After re-alignment of the boxes and ducts, beam loss was reduced as before the earthquake.
- We took little concern of the ducts rather than magnets.
- Lessons Learnt: We should consider peripheral devices as well as the main components.

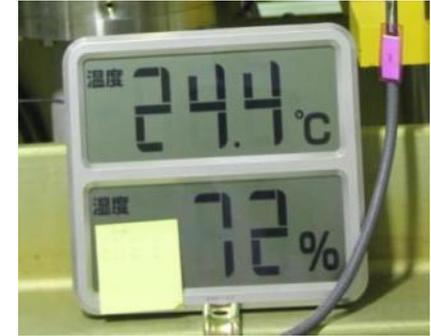
- Used dehumidifiers in the restoration stages.
- But high humidity ($> 70\%$) caused many troubles after the beam operation: discharge at the ion pump connectors, bad electricity connection, poor insulation.
- **Lessons Learnt: We should keep off high humidity.** (We know, but in realistic, it is not easy to achieve.)

Temperature and humidity at the SDTL cavity

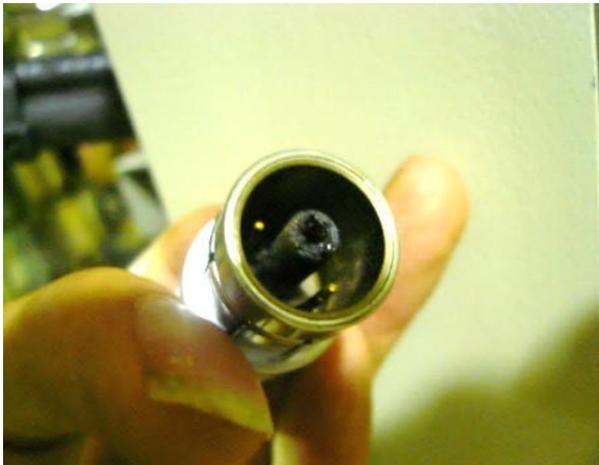
Discharge at the Ion Pump connector at the SDTL9B

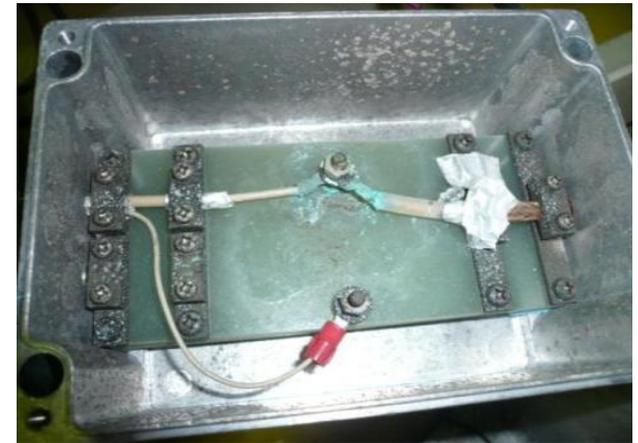
Bad electricity connection at the connector box.
