SRF Workshop 03

Status of The SNS SC Cavity and Cryomodule Production

J. Mammosser

SNS Production At JLab

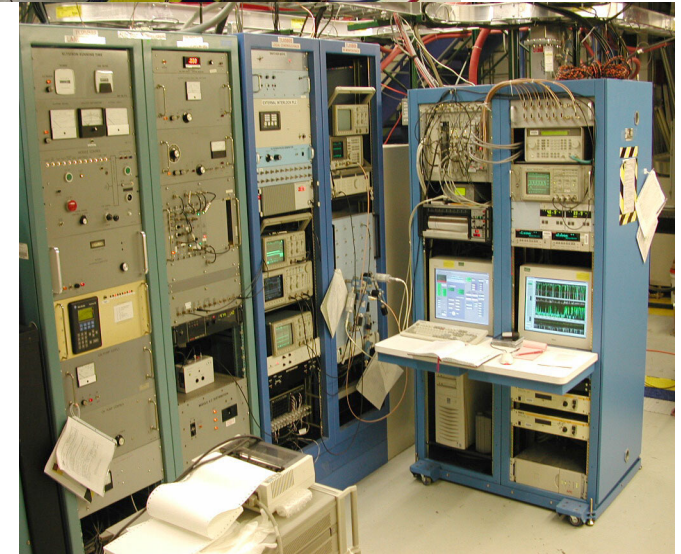
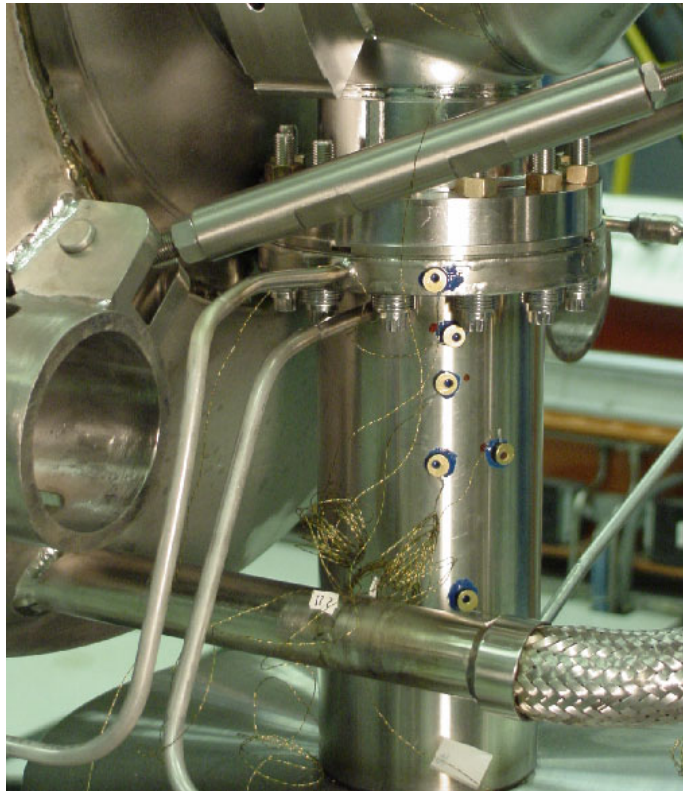
Fundamental Power Coupler Performance

- Pre-conditioning (baking 24 hours @ 200C 5 E-10 mbar)
- RF Conditioning and testing is done with 1MW TW, 2.4 MW SW pulsed
- 43 of 44 FPC assemblies processed (4 assemblies took longer)
- Processing to 1 MW, typically 6-15 hours

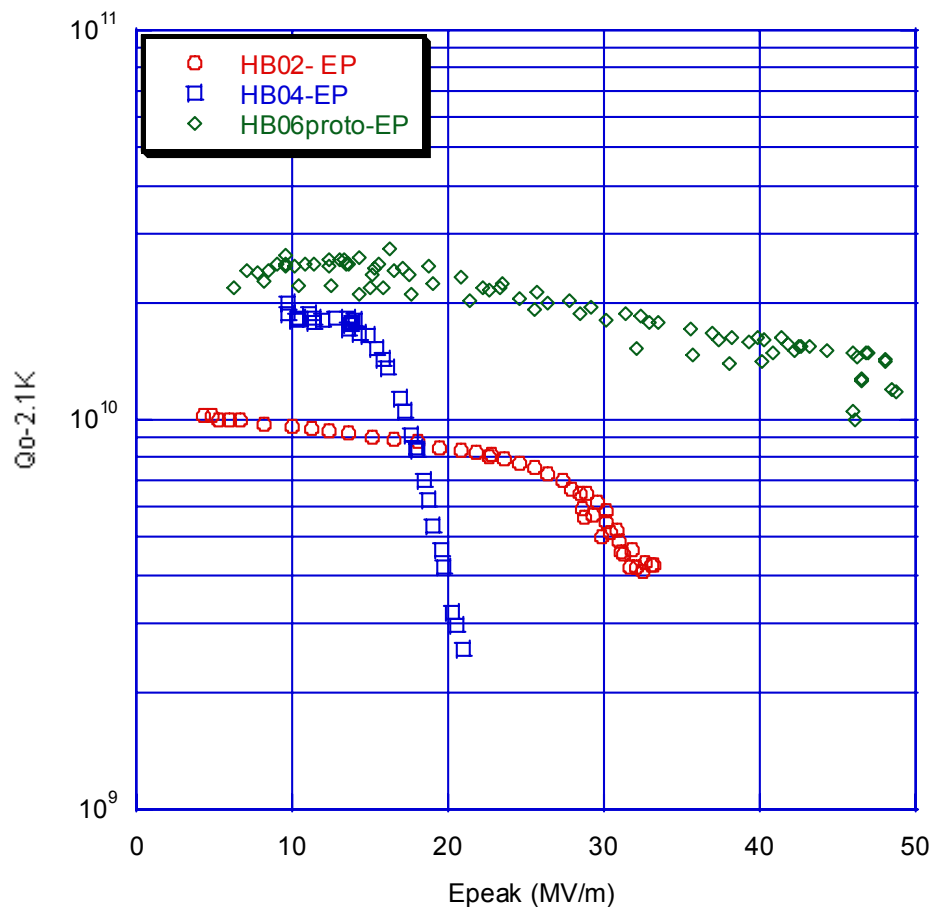
EP Results

Test Results:
