# Quench studies for ILC cavities

G. Ereemeev, J.Dai, R. L. Geng, and A. D. Palczewski, TJNAF, Newport News, U.S.A.

**ABSTRACT:** Quench limits accelerating gradient in SRF cavities to a gradient lower than theoretically expected for superconducting niobium. Identification of the quenching site with thermometry and OST, optical inspection, and replica of the culprit is an ongoing effort at Jefferson Lab aimed at better understanding of this limiting phenomenon. In this poster we summarize experiments that have been and are being developed at JLab for quench studies and highlight some of our findings with several SRF cavities that were limited by quench.

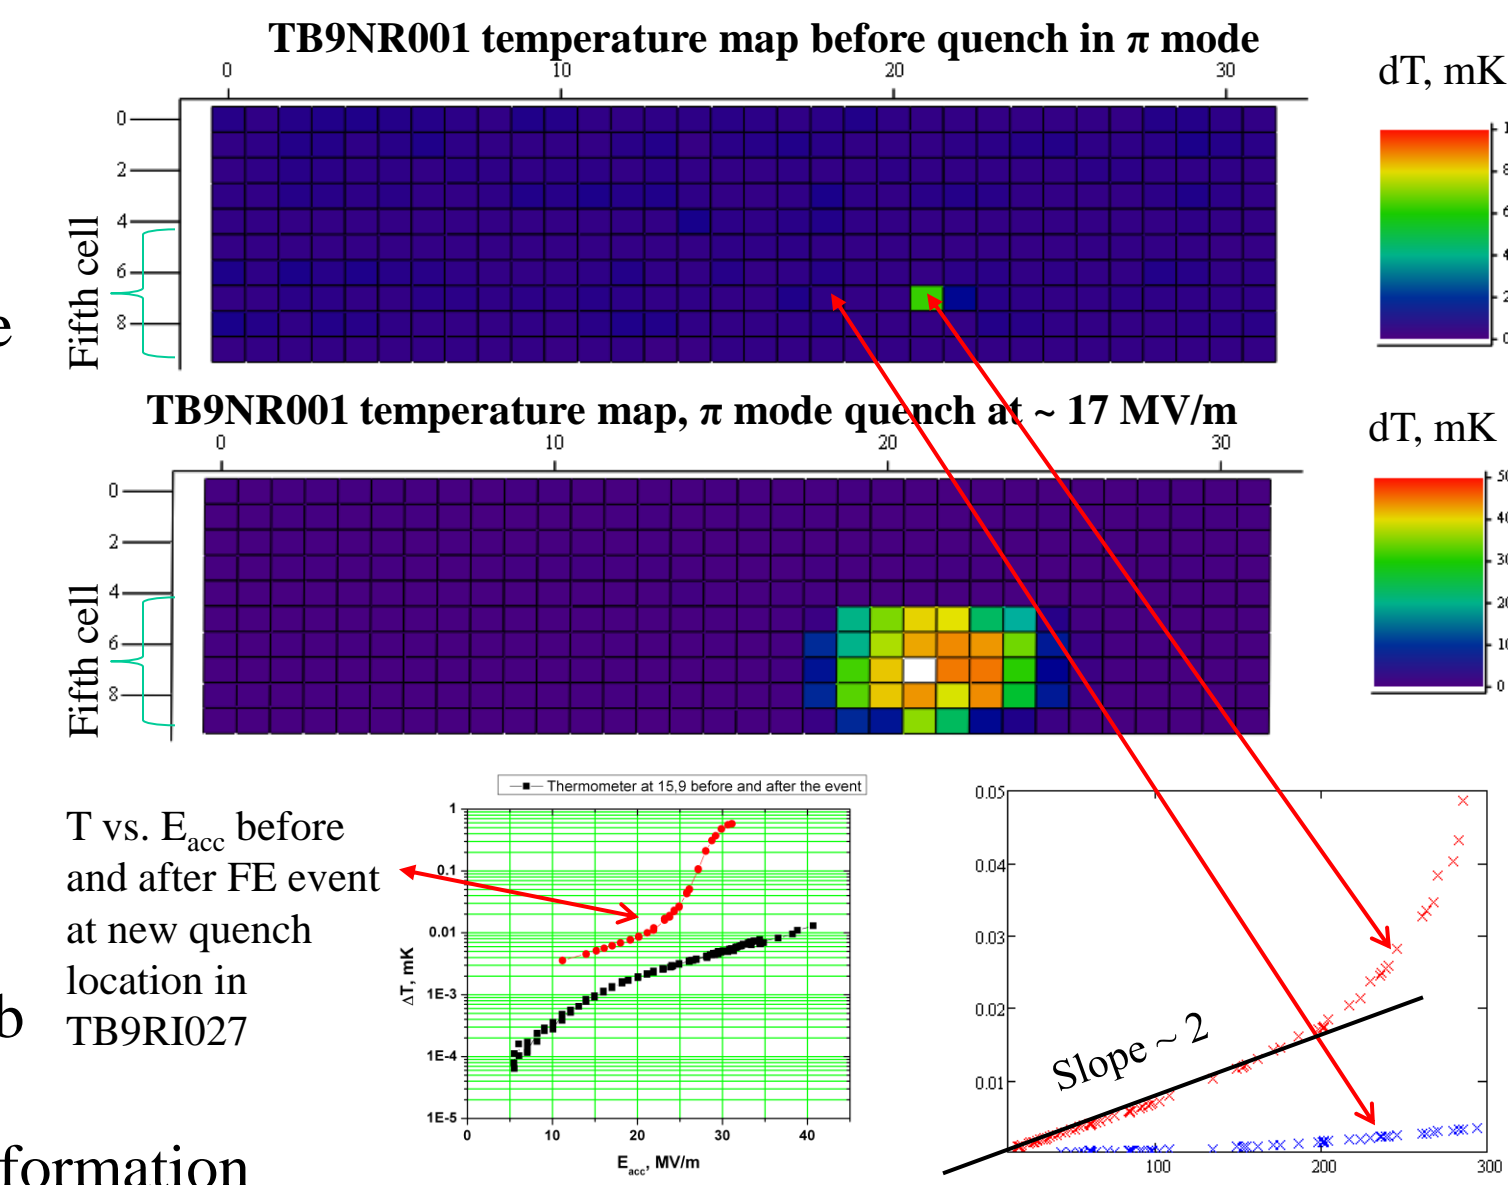
We routinely use 2-cell thermometry for quench localization and pre-heating characterization:

- Quench location was identified in TB9RI027 and quench location move to a different location after field emission event was recorded. The change in temperature rise vs. field was also measured before and after the event, which led us to believe that niobium surface modification may be involved into the field emission event.
- Twin defect was identified in TB9NR001 on the equator weld, and the preheating data shows deviation from quadratic behavior starting from about 14 MV/m with quench at about 17 MV/m
- Quench location were identified in TB9RI019 and JLab LG-1

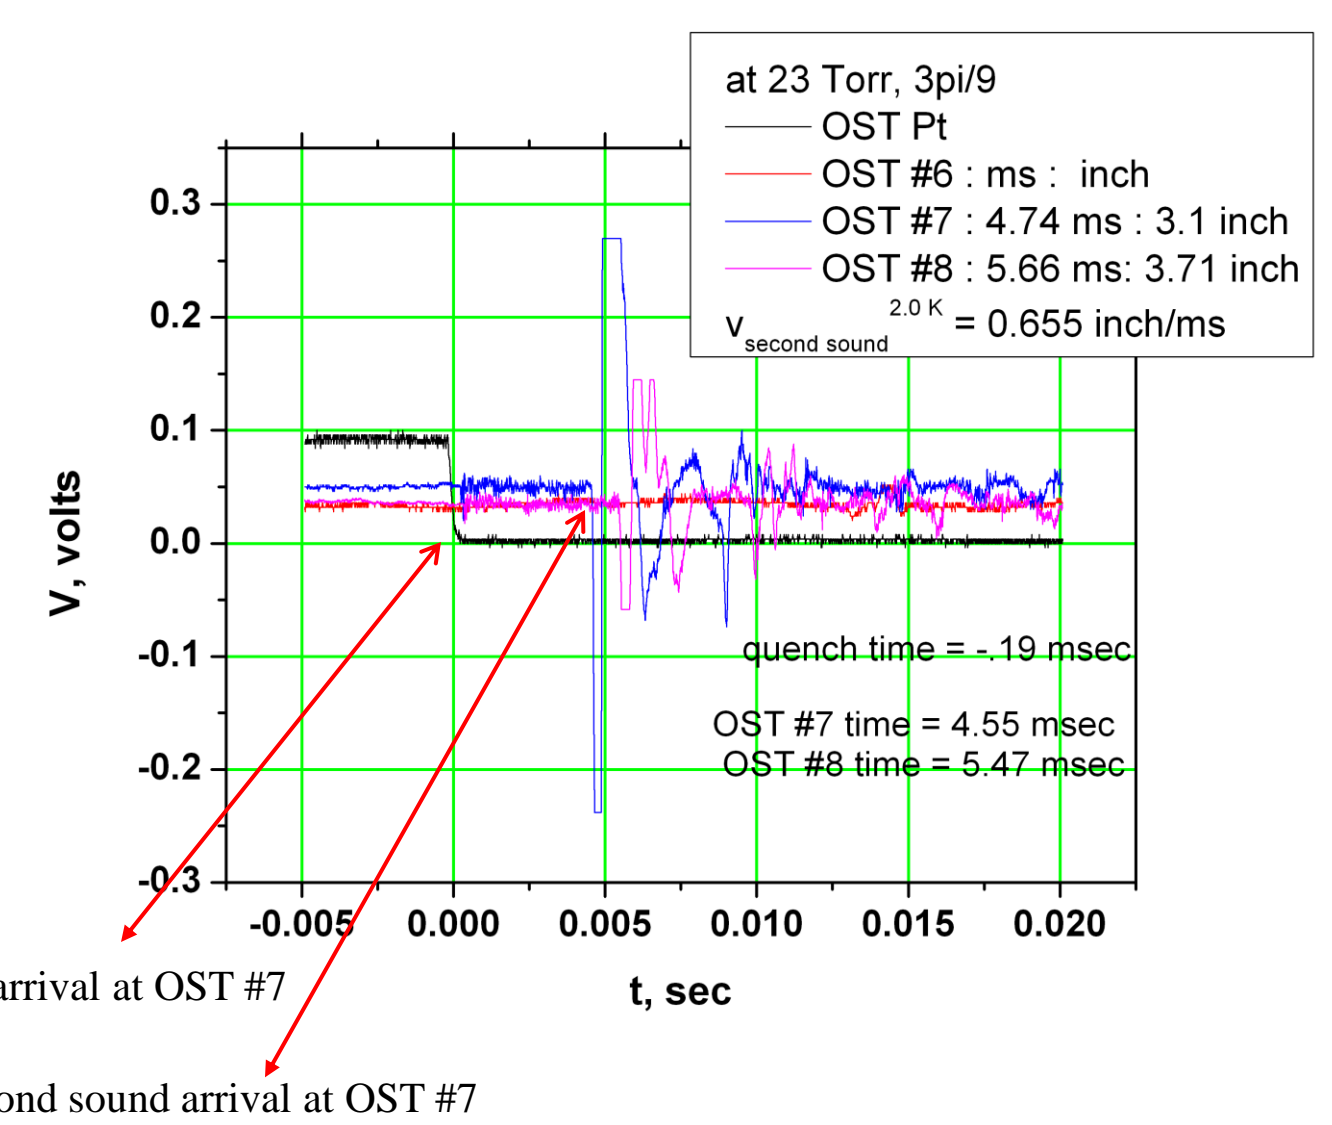
## OST

Second sound quench detection in superfluid helium with superleak oscillating transducers (OSTs) was recently introduced by the SRF group at Cornell University. OSTs offer unique advantage compared to the conventional thermometry that they are not limited to a particular cavity shape and can be used for virtually any cavity testing in superfluid helium.

- OSTs were used to locate quenches in TB9RI019, TB9RI027, TB9NR001, Jlab LG-1, PKU2, Seamless DESY 9-cell as well as in ICHIRO-07 and MHI-08 where our 2-cell thermometry cannot be attached. We also attempted to locate quenches in 3.5 cell cavity and crab cavity.
- When detectors were close to quench location we also observed first sound arrival.

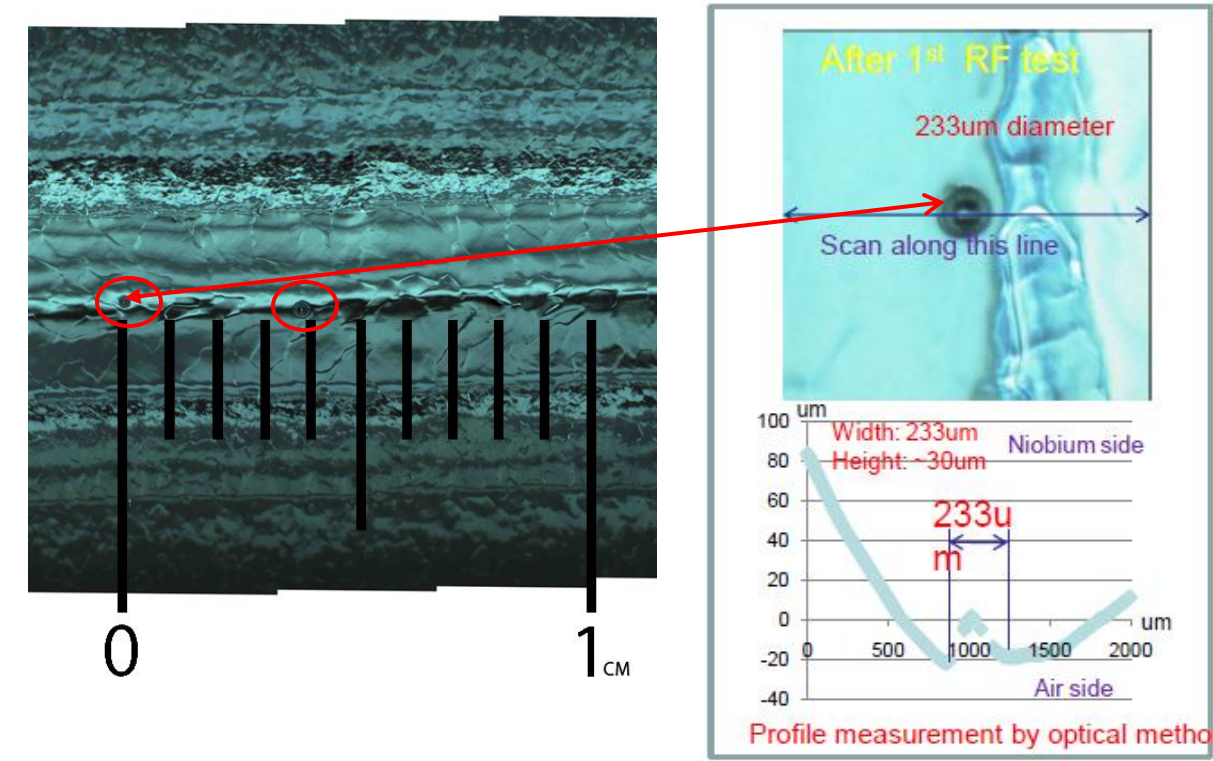
Part of the defect identification and characterization is optical inspection. Many defects that cause quench are visible geometrical features on the inner surface that can be resolved with optical inspection systems. These systems provide information on the location of the features and their dimensions.

Twin cat-eye feature in TB9NR001 was found with the optical inspection system at the predicted quench location

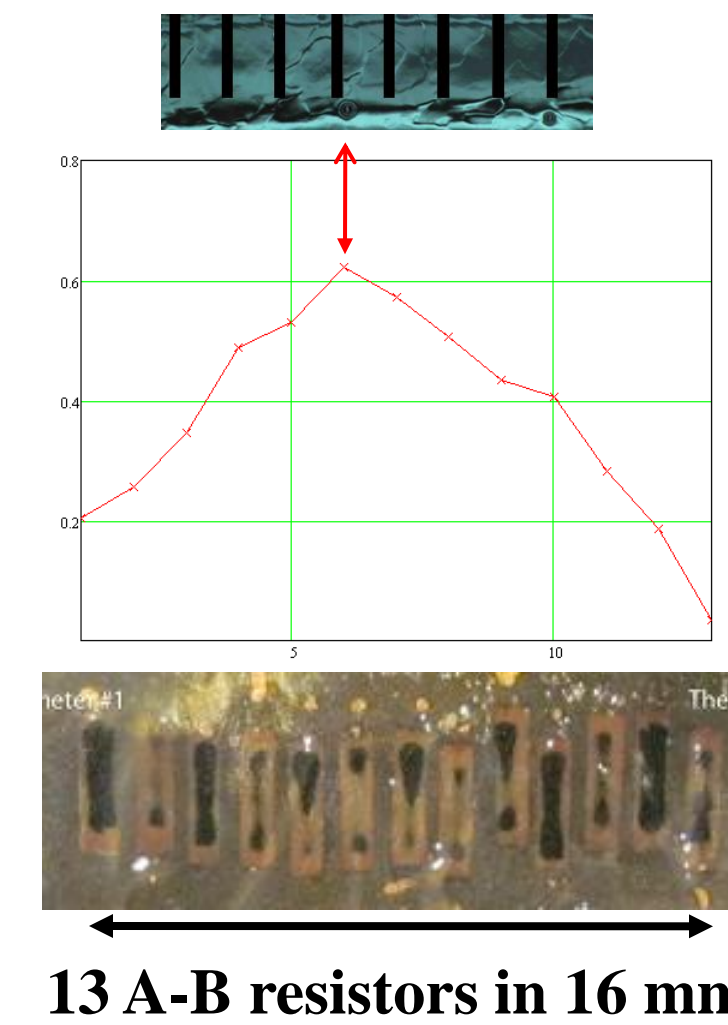
2-cell ILC shape conventional thermometry as well as newly-built high resolution thermometry has been used to characterize quenches and quench preheating:

- Preheating before and after high field FE event in TB9RI027 has been recorded with the 2-cell thermometry;
- Heating distribution and field dependence at the artificial geometrical defect in C1-3 cavity was measured with high resolution thermometry;
- Larger pit of twin cat-eye feature in TB9NR001 was identified as the culprit causing quench at 17 MV/m in  $\pi$  mode and pre-heating field dependence for both pits was measured

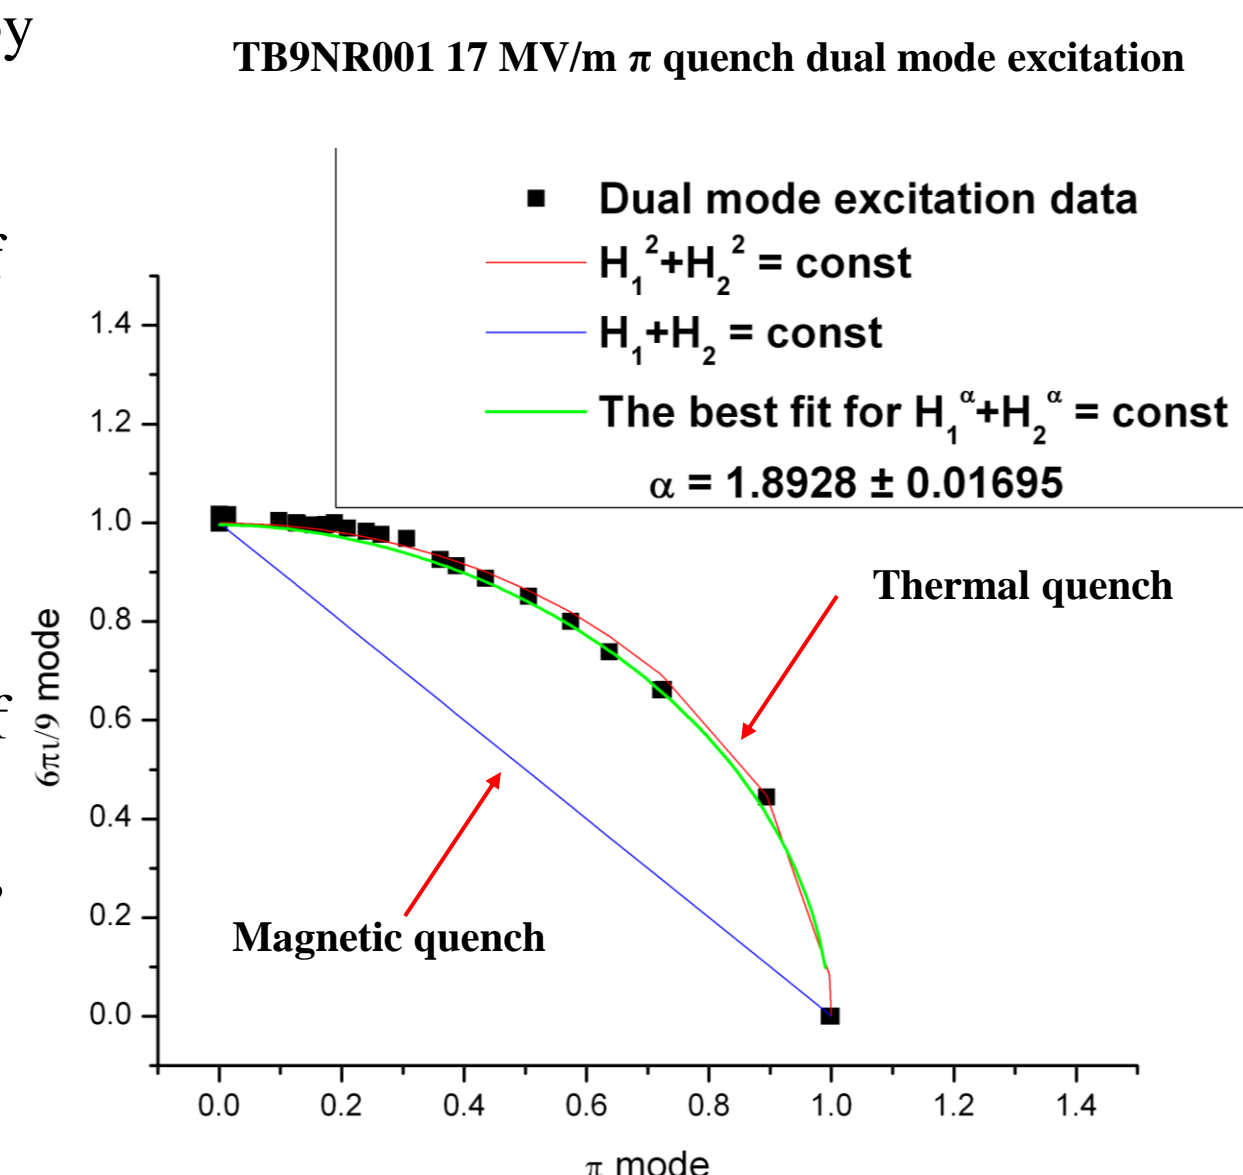
The idea is to excite two modes in the 9-cell cavity limited by the same quench. Depending on the nature of the quench we expect two scenarios:

- If it is a thermal quench, then the limitation during excitation of two modes will be  $H_1^2 + H_2^2$ , where  $H_1$  and  $H_2$  are fields in each mode;
  - If it is a magnetic quench, then the scaling will be  $H_1 + H_2$ .
- Total 7 defects were measured with this technique in PKU2, Jlab LG-1, and TB9NR001;
  - Quench in Jlab LG-1 in 8pi/9 mode at 40.5 MV/m has exponent of  $1.50 \pm 0.04$ , indicating that it is not a magnetic quench;
  - $\pi$  mode limiting defect in TB9NR001 has exponent of  $1.91 \pm 0.03$ , which is the closest to thermal quench exponent we've measured so far.

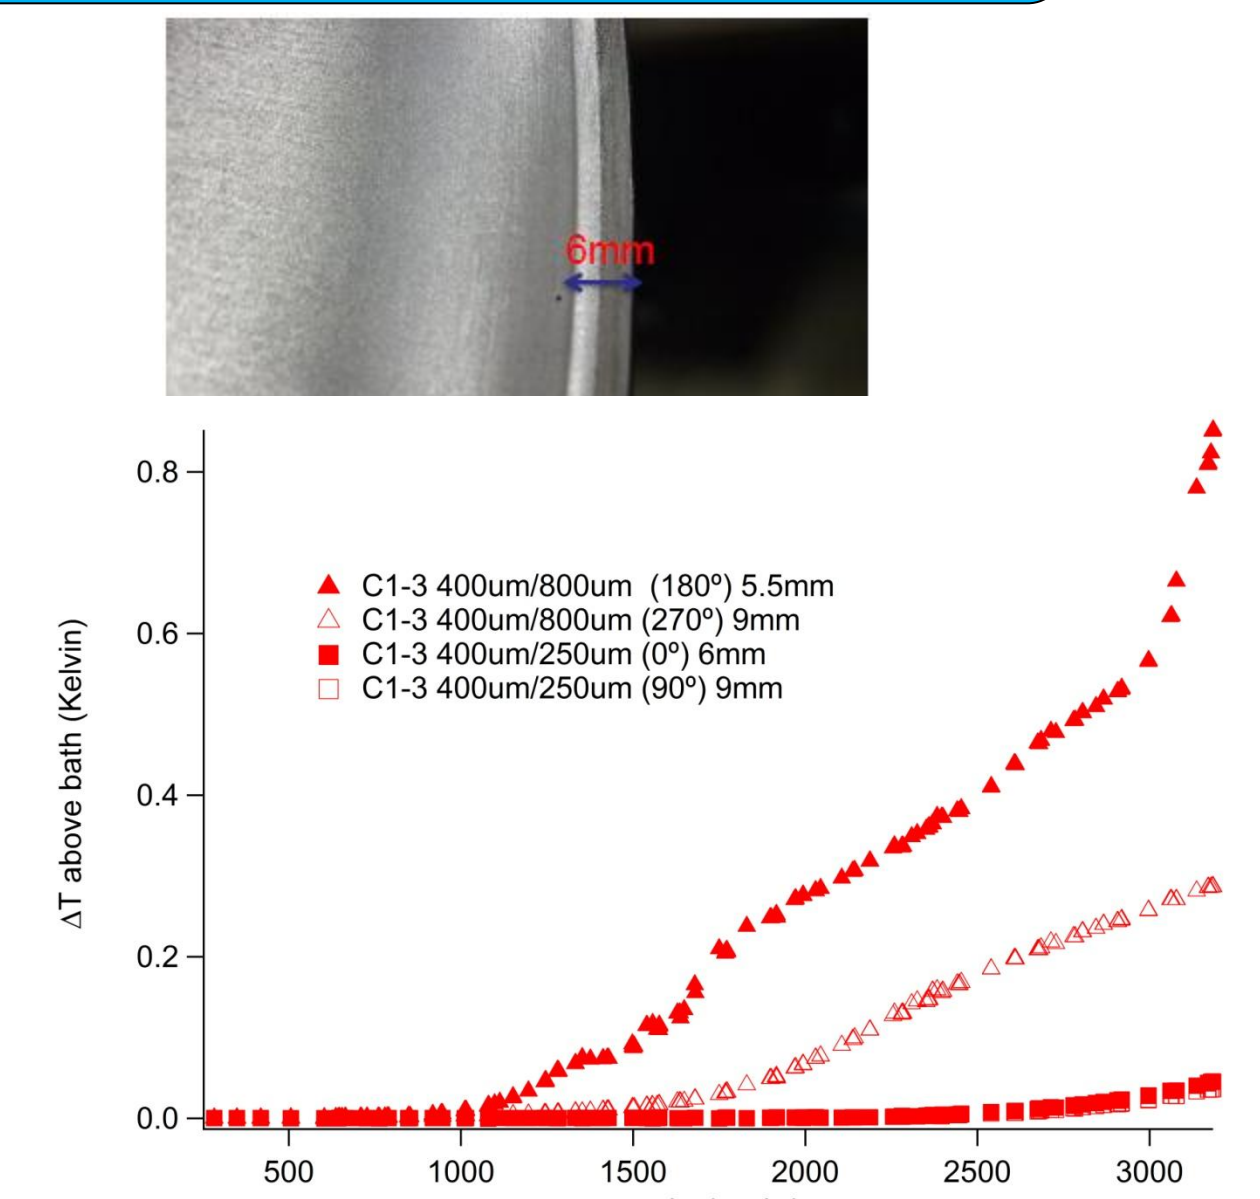
Contamination, surface features, local field enhancement, etc., can lead to suppressed superconductivity that will limit the achievable gradient. In order to gain insight into contribution to quench from topological features four pits with well-defined geometry were created on the inner surface of a 1.5 GHz CEBAF-shaped cavity.

- The cavity was limited at 13 MV/m by a deeper pit in the high magnetic field region;
- Field dependence of quality factor, local heating with conventional thermometry as well as local heating around limiting defect with high resolution thermometry were measured and compared to calculations.

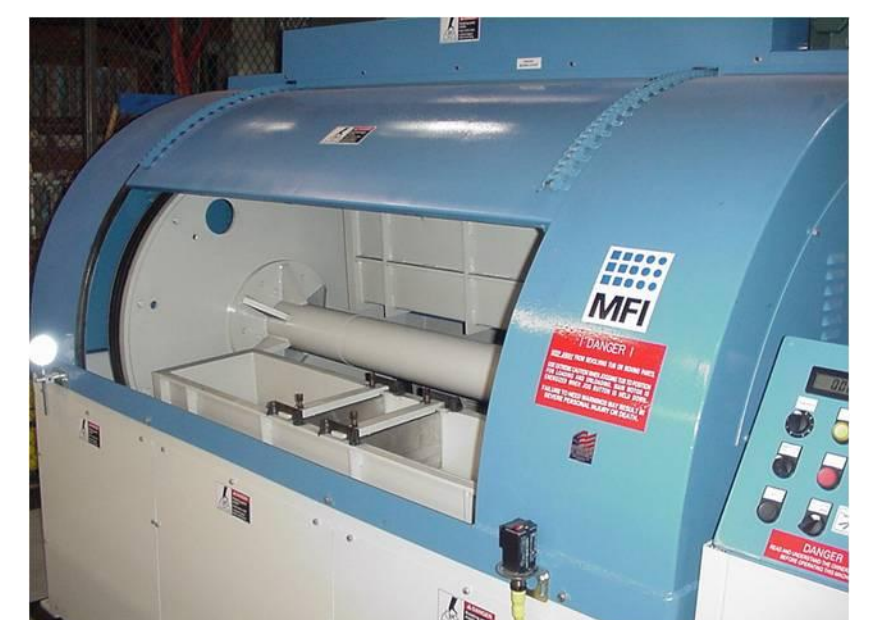
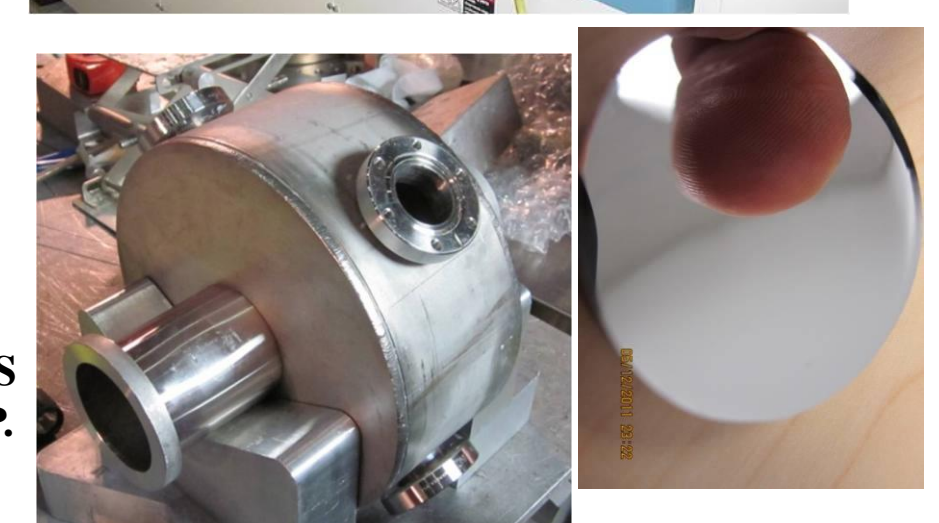
MFI CBP machine at JLab

Often the number of features revealed by the visual inspection on the surface is too many for a local mechanical grinding. In such cases centrifugal barrel polishing can produced mirror-like surface over the whole surface area, as was recently demonstrated at Fermilab. We are working towards turning existing JLab centrifugal barrel polishing machine into a convenient tool for resetting surface of problematic cavities.

- Preliminary studies have been done on samples to measure the residual contamination and roughness of the surface following Fermilab's recipe;
- 6 new 1-cell cavities are being made for CBP optimization as a part of ICP development at JLab.
