# SUPERCONDUCTING RF CAVITY DEVELOPMENT WITH UK INDUSTRY

The aim of the PIPSS project is to develop the capability of UK industry in the manufacturing of superconducting RF cavities.

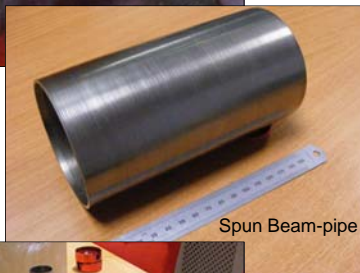
Copper Half Cell Trial

- Successful trials performed with copper
- First niobium half cell was distorted
  - Dragged due to sheet thickness
- Second attempt with niobium was successful
- Beam-pipes were spun
  - Reduction in wall thickness minimal (~0.75 mm)
- Three sets of cavity parts produced
