RELIABILITY OF THE LCLS II SRF CAVITY TUNER

Y. Pischalnikov[#], B. Hartman, J. Holzbauer, W. Schappert, S. Smith, J.C. Yun
 FNAL, Batavia, IL 60510, USA

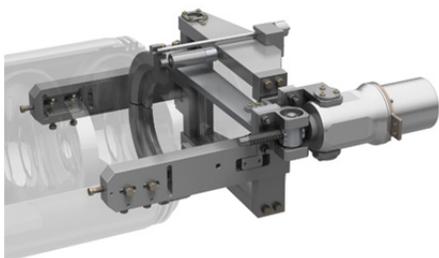
Figure 1: 3-D model of the LCLS II Tuner.

Description of the design and measured parameters of the SRF cavity tuner for LCLS II project were presented at the IPAC2015 conference [1] (Figure 1).

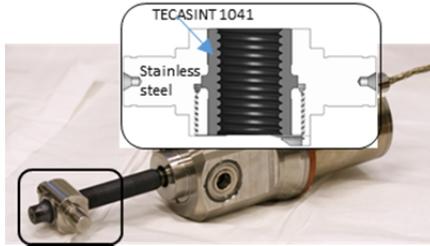
Figure 3: Traveling nut on the Ti spindle. Schematic design of the nut made from the stainless steel with TECASIN-1041 insert.

The tuner will be equipped with two limit switches to limit the range of motion (Figure 2). The role of the limit switches is to avoid having the tuner arm hit a “hard stop”. Limit switches will be wired to the stepper motor driver. If the tuner arm is allowed to reach the end of the motion, the forces on the traveling nut can reach 2-4kN. This is above the force limit of the actuator (+/-1.3kN). Excessive forces will damage TECASIN-1041 insert of the traveling nut (Figure 3).

Traveling nut from stainless steel has a TECASIN 1041 insert which mates to the M12X1 thread (Figure 3). TECASINT 1041 is a high temperature polyimide with 30% MoS₂. This material has excellent radiation resistance properties ($1-10 \times 10^8$ Rad). Large radiation dose will cause material to “swell” [13]. This can lead to increased friction for Ti-spindle/traveling nut system. We conducted after-irradiation visual inspection and measurements of mechanical dimensions of the insert. No damages or size changes have been found.

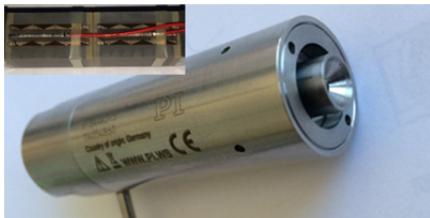
Figure 4: Encapsulated piezo actuators P-885.51.

Encapsulated piezo-stack (Encapsulated piezo unit P-844K075) was designed by PI (Physik Instrumente, Inc) per FNAL specifications. Each capsule is made from two butted PICMA™ low-voltage piezo stacks (P-885.51) (Fig. 4) [5]. P-844K075 unit designed with several design features to extend lifetime of the piezo-tuner:

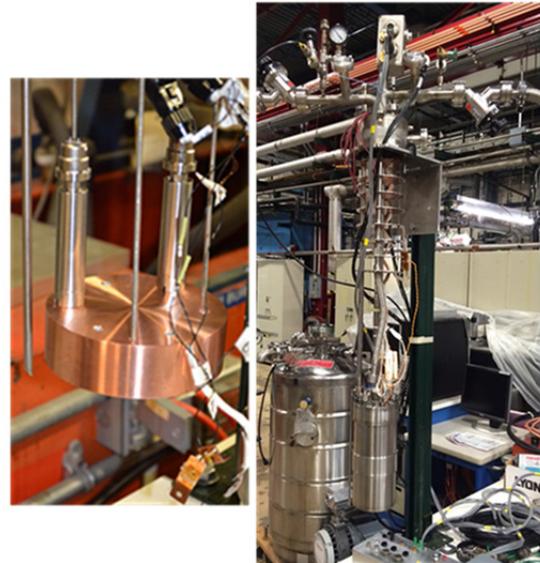
Figure 5: Facility for piezo-stacks ALT. Right: Helium Dewar and vacuum insert. Left: Two encapsulated piezo (with geophones) mounted on the heavy copper plate.

Designated facility was developed at FNAL to conduct ALT of the piezo at cold/insulated vacuum environment (Figure 5). Piezo-stacks were mounted on the massive copper disk. Several temperature sensors were glued to the piezo-ceramic elements and to the copper disk. Geophones were attached on the top of the each encapsulated piezos to monitor response of the piezo during long (several months) automated test. The disk with piezos and instrumentation installed inside a vacuum enclosure. The enclosure was inserted into a LHe dewar. Data was collected through LabView based data acquisition system.

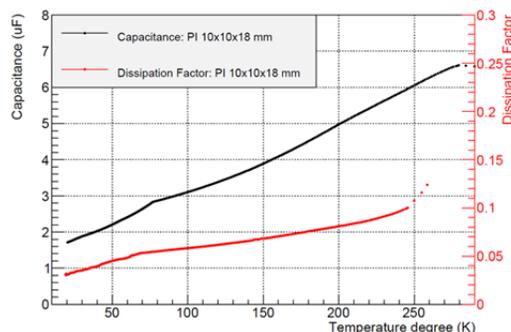
Figure 6: Dependency of the capacitance and dissipation factor of the PICMA™ piezo-stack versus temperature

Measurements of the PI piezo capacitance and dissipation factor during cool-down cycle are presented on the Figure 6.

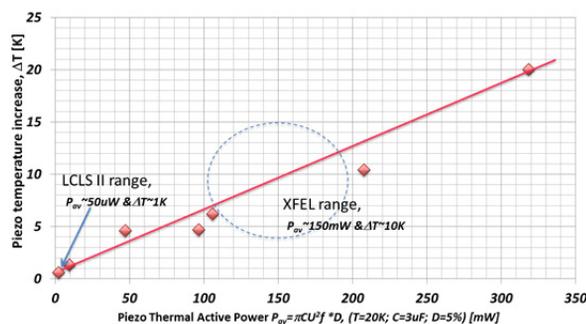
Figure 7: Increase of Piezo temperature (ΔT) versus power dissipated into piezo-ceramics.

After main LCLS II ALT we conducted an additional study with much higher power dissipation inside piezo (Figure 7). Test objectives were to explore impact of heat dissipation on the piezo operation in much more demanding operational conditions (like XFEL). We ran piezo up to $P_{av} \sim 300mW$ or ~2 times higher than that of XFEL operational condition ($V_{pp}=26V$ and $f=1kHz$). Temperature of the piezo-stacks typically stabilized in 1-2 hours after piezo operation started (Figure 8.) Piezos were operated within XFEL parameters ($P_{av} \sim 100mW$) for several days. We did not observed any degradations of piezo parameters or piezo overheating conditions.

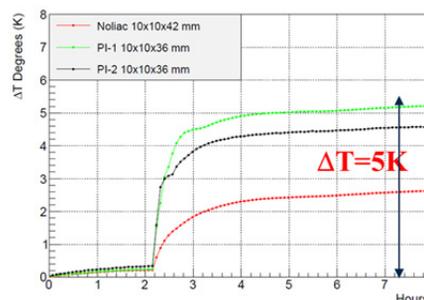
Figure 8: Piezo-ceramics temperature increase after stimulus pulse $V_{pp}=10V$ and $f=1kHz$ turned ON.

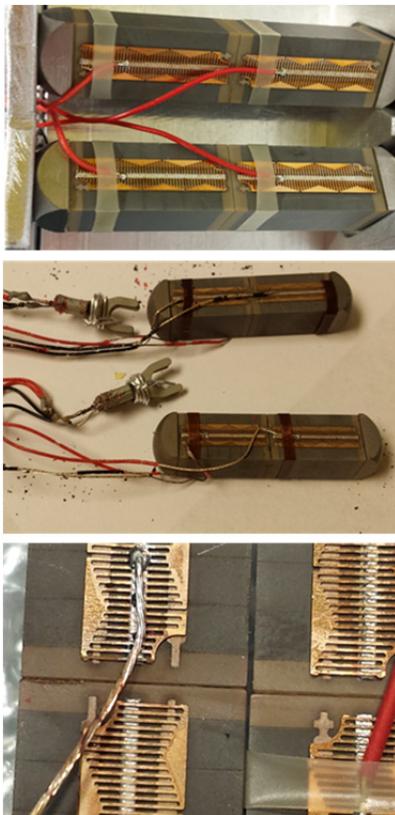
Figure 9: Top: sample A & B before irradiation test. Middle: sample A & B after 5*10⁸ Rad dose. Bottom: Central part of the two piezo-stacks (epoxy layer between two 10*10*18mm piezo): left- sample B (after 5*10⁸Rad) and right - sample C.

Before and after irradiation samples went through visual inspections (Figure 9). For all of the samples, including reference samples (C&E2), main parameters (capacitance, heat dissipation factor, and stroke) were measured before and after each irradiation session (Figure 10, Table 5). Strokes of the piezo-stacks were measured with Keyence LC-200 Laser Displacement Meter (Figure 10).

Visual inspection after irradiation tests do not reveal any serious damages to the piezo ceramics, except for Teflon insulation on the leads wires on the samples A&B. At the same time piezo-stack E1 (designed for LCLS II tuner) that has leads wire with Kapton insulation has no visible damage.

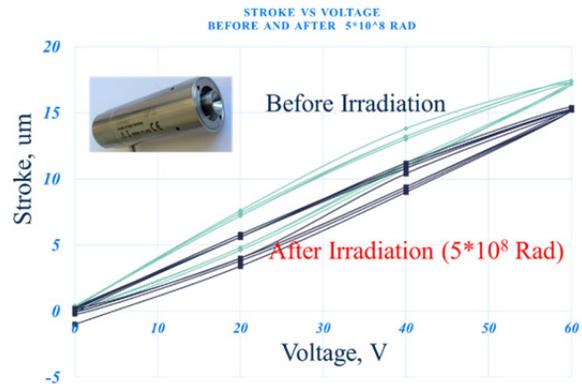
Figure 10: Piezo hysteresis curve for E1 sample before and after irradiation up to 5*10⁸ Rad.

Most important parameter – stroke of the piezo-actuator has decreased only on 10% and that is acceptable to LCLS II requirements [1].

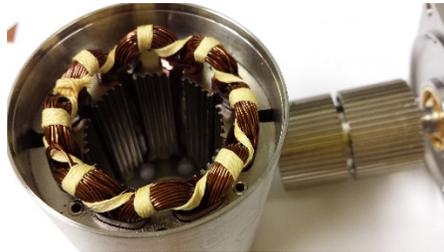
Figure 11: Phytron stepper motor internal windings after irradiation with dose 5×10^8 Rad.

Stepper motor was disassembled to visually inspect inside windings before and after irradiation. Our interest was wire insulation on the stepper windings. Visual inspection and “short-circuit test at 40V” do not revealed any damage from the irradiation.
