STATUS OF THE K500 SUPERCONDUCTING CYCLOTRON PROJECT AT KOLKATA

Rakesh Kumar Bhandari and Bikash Sinha (for VECC Staff), VECC/DAE, Kolkata, India.

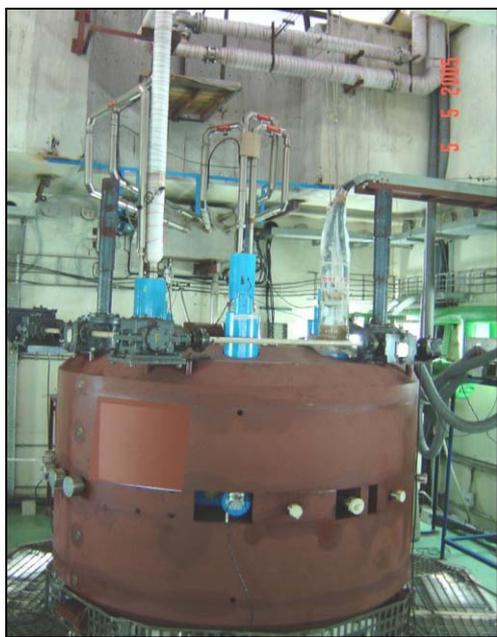
Figure 1: Main magnet assembly.

The cyclotron magnet cool-down was started at the beginning of 2005 and it was operated satisfactorily for almost one year till 2006 [1]. During this period magnetic field measurements and correction of the imperfections were carried out in detail. In middle of 2006, the coil was warmed up to assemble other systems of the machine, like RF resonators, cryo-panels, injection and extraction beam line, etc. Figure 1 shows the main magnet assembly.

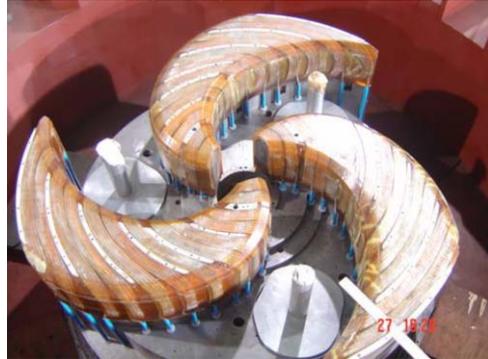
There are 13 epoxy potted trim coils wound on each pole tip as shown in figure 6. There are 78 trim-coil feed-thrus and several vacuum fittings on the back of the pole caps, that were thoroughly leak tested, after installing RF liners on the pole tip sectors wound with trim coils. Figure 7 shows the median plane liner and dees installed in position over the pole tips and trim-coils.

Figure 6: Trim coils placed on the pole tip.

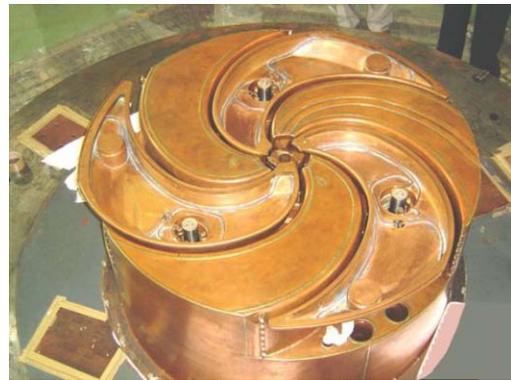
Figure 7: Liner and dees installed on lower pole tip.

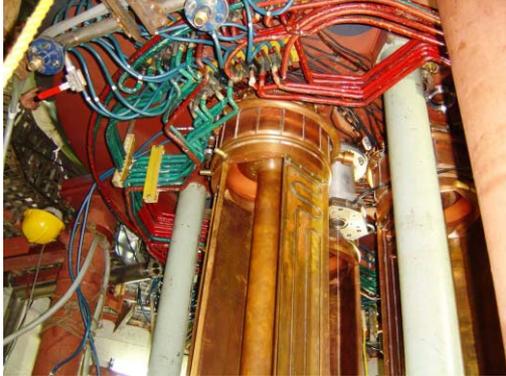
assemblies. The joints were hydro-tested at 16 kg/cm^2 pressure and helium leak rate found was below 5×10^{-9} std cc/sec. At one end of this 5.5 m long structure, dees are mounted and machining was done to maintain parallelism between the faces of the inner conductor spinning base flange and dee joint flange within $\pm 0.13 \text{ mm}$. Figure 8 shows various components below the magnet frame.

Figure 8: One of three lower outer conductor spinning assemblies below pole base of the cyclotron magnet.

The inner conductors were installed with the cryogenic transfer lines for cryo-panels located inside the three lower dees. Work on installation of the sliding short drive systems is in progress and installation of the upper resonator cavities will start soon.

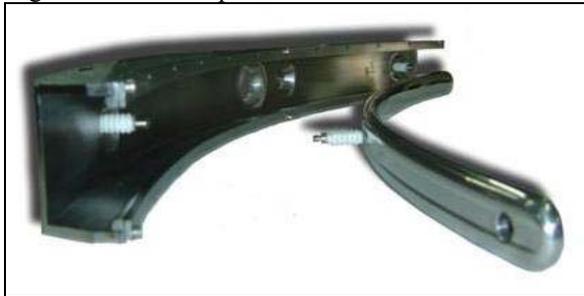
Figure 9: Electrostatic deflector.

A deflector test stand had already been setup. The deflector system (figure 9) has been tested there satisfactorily with more than 50 kV over 6 mm gap and less than 100 nA dark current, over several weeks.
