CARBON FIBER DAMAGE IN ACCELERATOR BEAM

M. Sapinski, B. Dehning, A. Guerrero, J. Koopman, E. Metral, CERN, Geneva, Switzerland

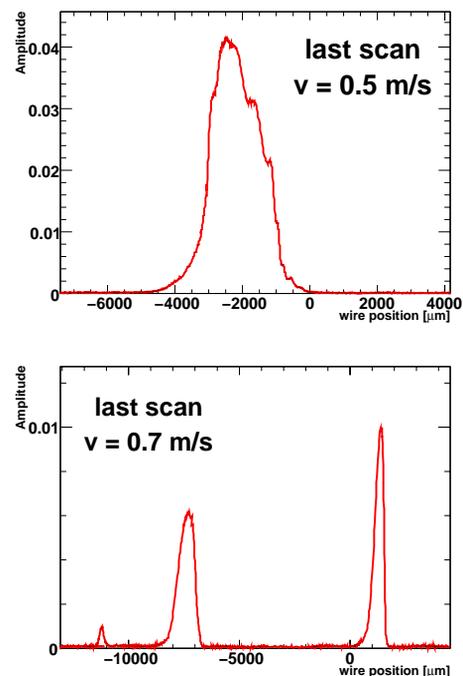
Figure 1: The last profiles after which the wire has been found broken. Upper plot shows breakage of vertical wire: deviations from Gaussian profile are visible. The bottom plot shows breakage of the horizontal wire: multiple peaks suggest that the wire has already fragmented.

In Fig. 1 the beam profiles registered during the last scans are shown. The deviations from Gaussian shape and

multiple peaks are symptoms of the wire deterioration and breakage. The measurement of the wire resistivity after these scans showed that the wire has been broken.

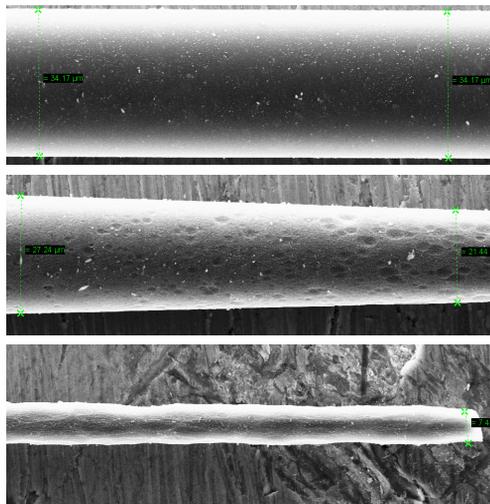
After the experiment the Wire Scanner has been opened and both wires have been recovered. They have been photographed with scanning electron microscope. The images obtained with 1000 times magnification, taken in three positions: at the center of the beam impact, 0.5 mm away and 1 mm away are presented in Fig. 2. They clearly show that the main process deteriorating the wire is sublimation due to the high temperature. In the center of the beam-impact location the remaining wire diameter is only about $7.5 \mu\text{m}$, what is equal to the sublimation of 95% of the material. At 0.5 mm from the beam-impact center the beam traces are visible and sublimation removed about a half of the material. At 1 mm from the beam center the fiber is intact.

Figure 2: Fiber fracture at three distances from the beam impact location: 1 mm (upper plot), 0.5 mm (middle plot) and at beam center location (bottom plot).

In conclusion the wire breakage mechanism during these scans can be explained as a sublimation of the wire material until the moment when the mechanical properties of the wire does not allow to withstand forces which appear during the scan.

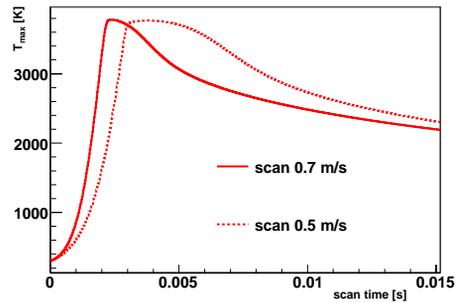
The simulated evolution of the maximum temperature of the wire in the point where wire crosses the beam maximum is shown in Fig. 3 for scans with 0.5 and 0.7 m/s. At

the speed of 0.5 m/s a plateau of about 2 ms in temperature evolution due to the equilibrium between beam heating and cooling by thermionic emission is observed.

Figure 3: Simulated evolution of the maximum temperature of the wires during final scans.

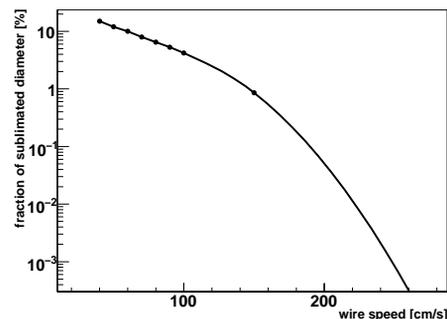
The estimation of the sublimation rate is based on parametrization from [3]. In Fig. 4 the percentage of the wire diameter expected to sublimate during scan as a function of the velocity is shown. Scans with speeds of 0.5-0.7 m/s lead to sublimation of 8-12% of the wire diameter. The whole scan sequence used in the damage test should leave about $12 - 14 \mu\text{m}$ of the wire. This expectation is almost two times higher than the wire diameter measured on post-mortem samples.

Figure 4: Simulated sublimation of the wire material in the wire center during scans with decreasing velocity.

From Figure 4 it is concluded that the sublimation process removes significant amount of material for all wire speeds slower than 2 m/s . This allows to determine the safety factor of 4, with respect to breakage conditions, as assuring a safe scanner operation. This factor can be obtained by decreasing the beam intensity or by increasing the wire velocity.
