THE RHIC BEAM ABORT SYSTEM – OPERATION DURING THE RHIC 2001 GOLD RUN*

L. Ahrens[§], J.-L. Mi, W. Zhang, BNL, Upton, New York

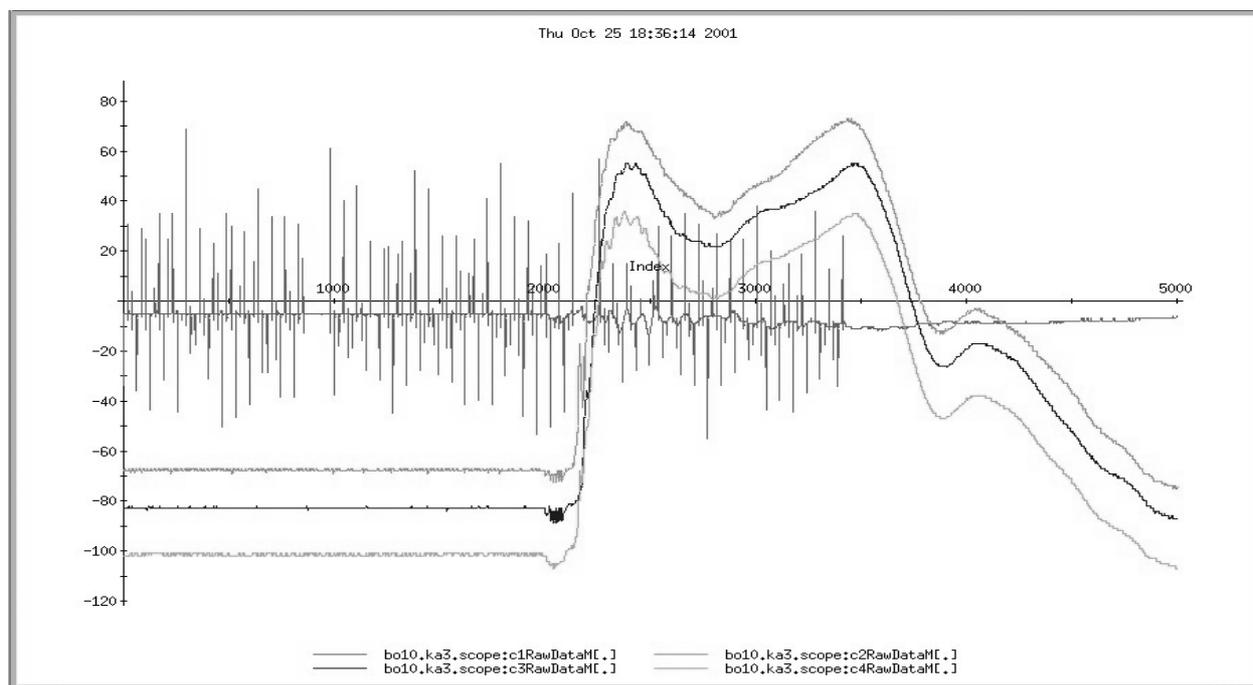
Figure 1 Three PFN Current Transformer Waveforms and the 55 Bunches in the Blue Ring
 Note the abort gaps on the (differentiated) beam signal and the sweeping of the kicker currents

A few-bunch shift in the relative blue abort gap timing was discovered and corrected during a September study period. The shift would cause some beam to fall on the rising kicker edge. Diagnostics were developed to allow checking this timing without a dedicated study. A local BPM signal was added to the oscilloscope display of the current pulse signals from the Abort system PFNs. The resulting scope trace (Figure 1 again) gives the relative timing unambiguously. In fact no further timing problems occurred. The scope traces are available as a “comfort display” in the Main Control Room.

In order to reconstruct what happened when the Abort system faults, usually hours after the fact, we rely on "logged" data. The fast current traces shown above are saved, as are 1 Hz samples of the voltages on the ten PFNs. To save the critical data – right time and time scale – is the challenge. To some extent we were lucky to have clear indications of what had happened from prefire events. These necessarily come without a precursor trigger so the oscilloscope must trigger "internally". A second similar trigger will come shortly erasing the first since the prefire will cause a permit pull. Indeed in this situation the beam permit will be pulled by the Abort system itself once that system realizes that the voltage on one PFNs is not correct. An upgrade in the sophistication of the logging machinery, introducing the ability to very quickly trigger logging on an external event, and more scope storage capacity are planned.
