CONCEPTUAL DESIGN OF AUTOMATED SYSTEMS FOR SRF CAVITY OPTICAL INSPECTION AND ASSEMBLY*

Abstract

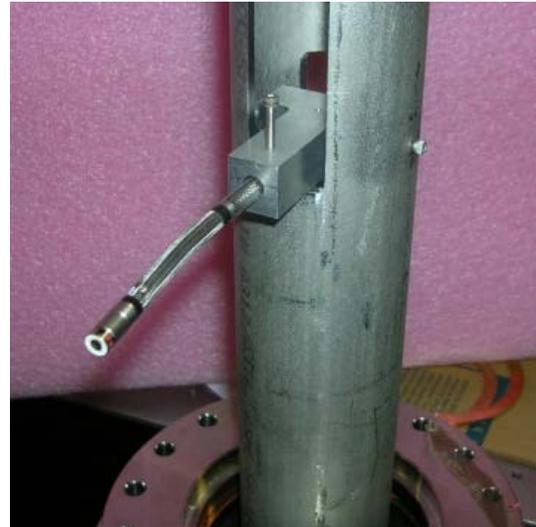
Figure 5: A 6 mm diameter videoscope set in the fixture.

The T-shaped fixture was fabricated and attached to a stainless steel pipe. Then, a 6 mm diameter videoscope was inserted into the fixture as shown in Fig. 5. This pipe was inserted into an 805 MHz, $\beta=0.8$, single-cell cavity shown in Fig. 6. In Fig. 6, also shown is an indirect light source needed to look at the interior clearly without a glare from a point light source.

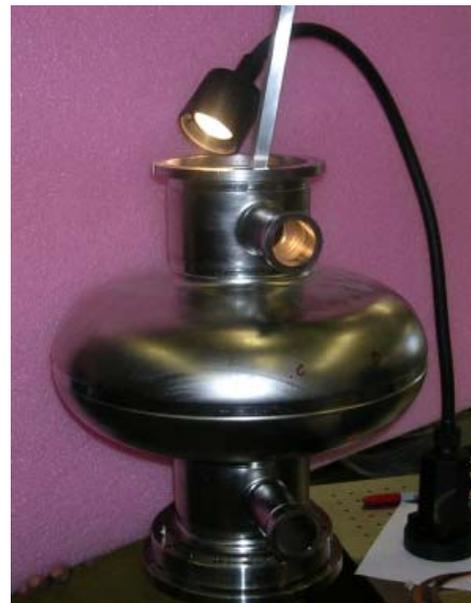
Figure 6: A 805 MHz single-cell cavity inspected.

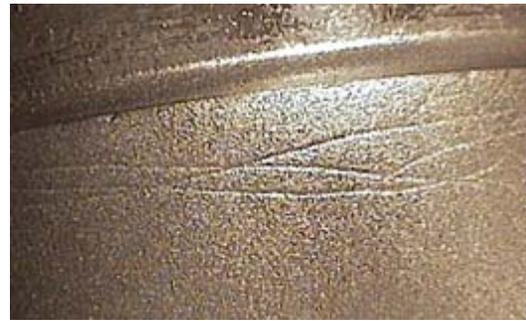
Figure 10: Scratches near the equator.

An inspection of the equator region and its vicinity was performed using the remote articulation function of the videoscope. Several imperfections and defects were found, as shown in Figs. 8 through 10. The largest and most outstanding defect was the one shown in Fig. 9, which is located about 25 mm away from the equator. This defect could be the cause of the quench.
