## STATUS OF THE TRISTAN SUPERCONDUCTING RF SYSTEM

Kiyoshi KUBO, Kazunori AKAI, Eiji KAKO,  
 Shuichi NOGUCHI, Toshio SHISHIDO and Toshiji SUZUKI\*  
 KEK, National Laboratory for High Energy Physics,  
 1-1 Oho, Tsukuba, Ibaraki, 305 Japan

**Abstract:** 32 5-cell superconducting cavities have been operated at TRISTAN, a high energy electron positron colliding accelerator. 16 cavities were installed in the summer of 1988 and the other 16 in the summer of 1989. Efforts have been made mainly for the stable operation with the higher beam current.

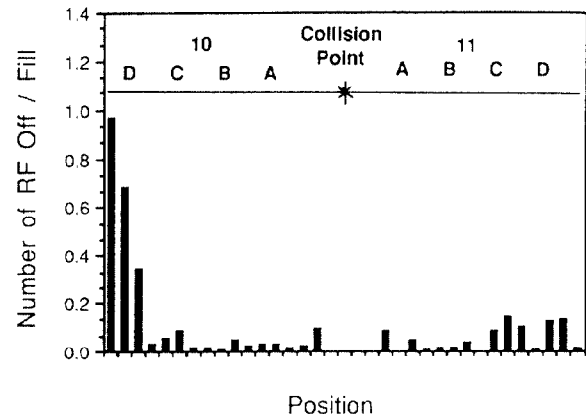
Fig. 5. Average number of interlock actions of each cavity in a beam filling as function of the location.

Fig.5 shows average number of interlock actions (shut off RF power) in a beam filling for each cavity as a function of the location in the ring. The interlock actions have occurred for some specific cavities frequently. There seems to be two types of the frequent interlock actions.

First, some cavities, whose  $E_{acc,max}$  are enough high without beam, sometimes trip with beam ( $>10mA$ ). The voltages of these cavities have been set enough low for stable operation. For example, a cavity, whose  $E_{acc,max}$  is about 7 MV/m, has tripped several times in a beam filling at 3 MV/m with beam.

At the time of these interlock actions, the field level of the cavities fall down very fast (about 10  $\mu$ sec, much shorter than the filling time of the cavities; or the stored energy in the cavities are spent quickly in the cavities). The vacuum levels become worse at these times. These observations suggest that discharges in the cavities occur.

The second type of frequent interlock actions occurs during beam acceleration (or increasing the accelerating field) as the vacuum level's jump up, one or two times in a beam filling.

These actions occur at specific cavities near the bending sections and the trip rate seems to depend on the beam orbit. Probably, the synchrotron light from the arc (bending) section is the trigger of these trips.
