# Recent achievements in the production of metallic ion beams with the CAPRICE ECRIS at GSI

Aleksandr Andreev

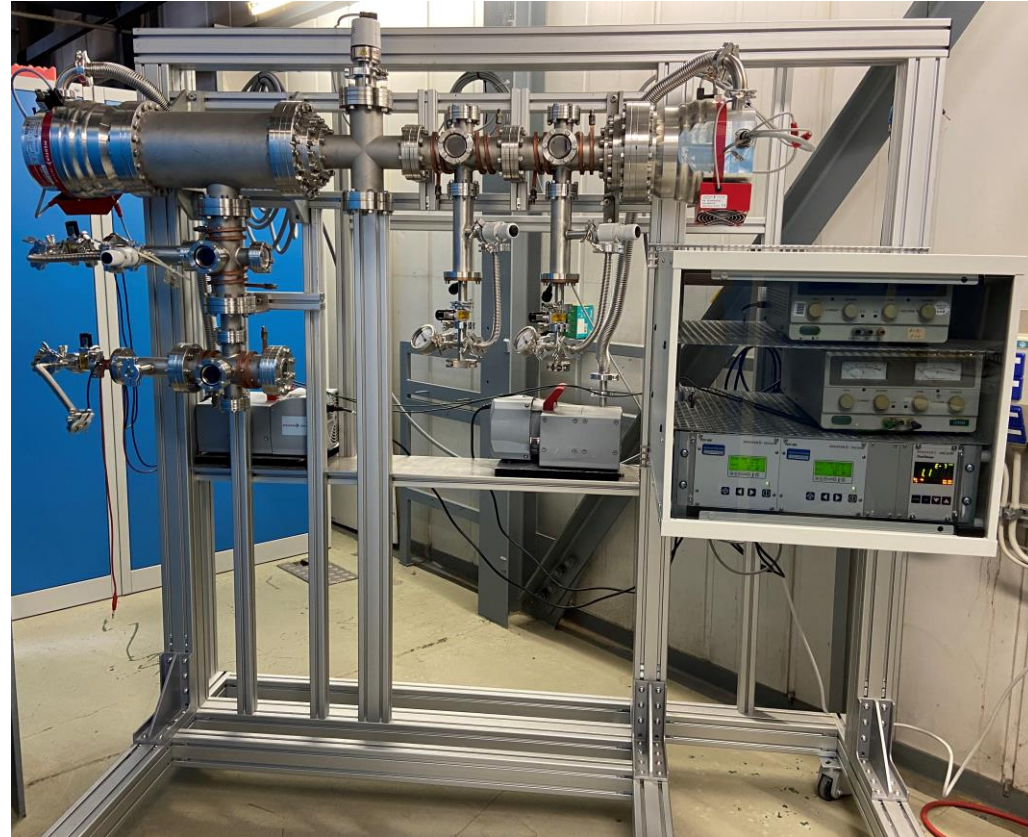
# Oven preparation stand @ HLI

## Purpose:

- Essential tool for conditioning ovens before beam operation
- Minimizes downtime during operation
- Improves beam stability and reproducibility

## Key features:

- **Controlled environment** for oven outgassing and material preheating (e.g. Ni)
- **Simultaneous oven insertion** with 6 airlocks (previously 4)
- **Water cooling system** for ovens and the stand
- **Online monitoring** (planned: 2-3 cameras) for material conditioning
- **Residual gas analyzer** (planned) for better analysis and process control

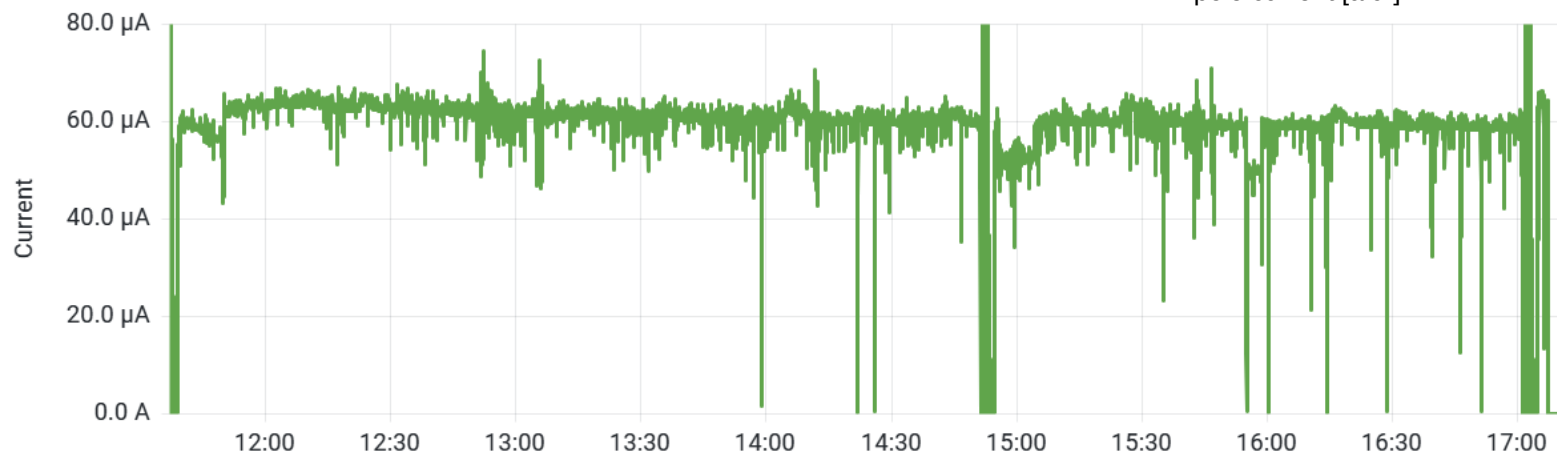
- Set target **50  $\mu\text{A}$   $^{54}\text{Cr}^{10+}$**  for beam intensity, stability, and oven lifetime
- Material consumption w.o. recycling: 8 mg/h

- Target intensity reached on Day 1
- Discharges began on Day 2, increasing in frequency over time, affecting beam stability
- Discharges impacted beam stability, target intensity could not be maintained

## $^{54}\text{Cr}^{10+}$ intensity at the Faraday Cup

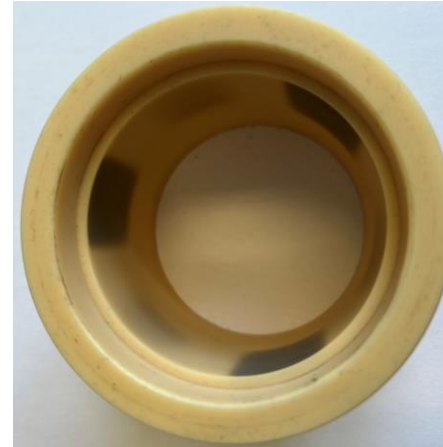
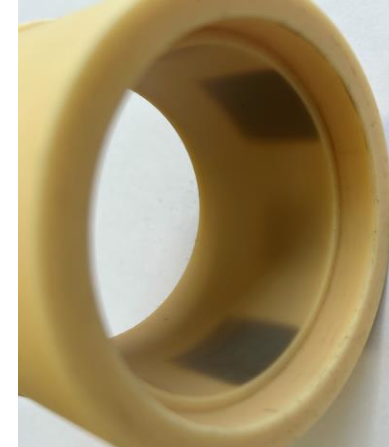
# Discharges during $^{54}\text{Cr}$ beam operation

- After disassembling the ECRIS, metallic traces were found on ceramic insulators in the extraction column
- SEM EDX investigation could not determine the traces material
- Possible explanation: discharges between the screening electrode and high-voltage section (17 kV) due to metal buildup on the ceramic

- Long term operation for  $^{54}\text{Cr}$  is limited by the material deposition on the ceramic isolators in the extraction column.
- The use of a **Ta liner** extends the operational time for  $^{55}\text{Mn}$ , and tests for  $^{54}\text{Cr}$  are planned.

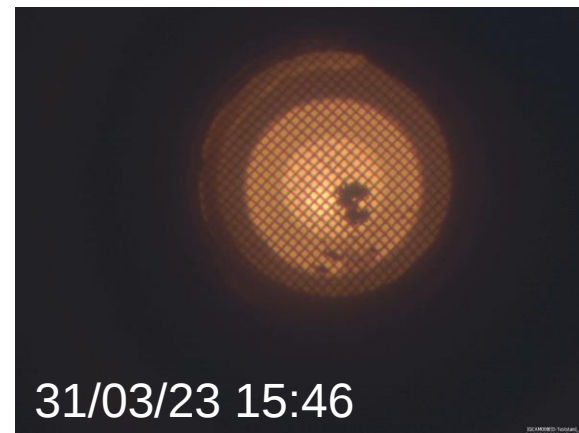
- **Tungsten mesh** installed to prevent parasitic microwave heating
- Condensed Cr material started accumulating on the mesh after a few hours
- Beam operation was stable, but the mesh clogged, reducing beam intensity
- **Oven images** show material gradually decreases inside the oven over 5 days
- Material also condenses around the colder oven orifice; could affect stable beam production
- Real-time monitoring with CCD camera provides feedback on evaporation efficiency and material behavior

30/03/23 12:53\*

31/03/23 13:57

31/03/23 15:46

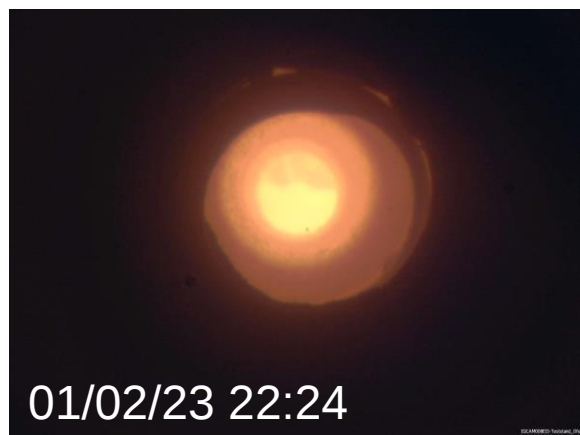
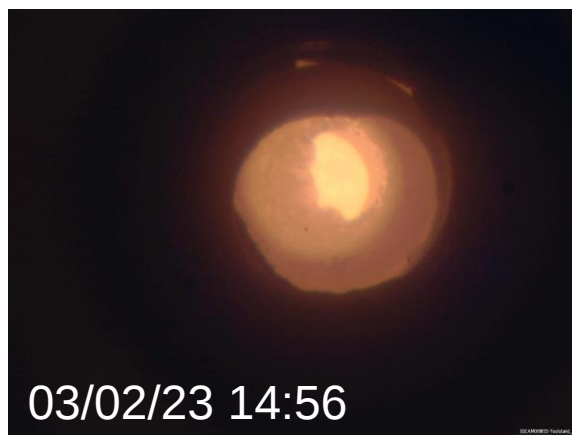
Mesh clogged  
after  $^{54}\text{Cr}$  operation

- **Tungsten mesh** installed to prevent parasitic microwave heating
- Condensed Cr material started accumulating on the mesh after a few hours
- Beam operation was stable, but the mesh clogged, reducing beam intensity
- **Oven images** show material gradually decreases inside the oven over 5 days
- Material also condenses around the colder oven orifice; could affect stable beam production
- Real-time monitoring with CCD camera provides feedback on evaporation efficiency and material behavior

- **Microwave shielding** can prevent parasitic heating of the oven for elements with low sublimation temperature. However, this approach was ineffective for both  $^{54}\text{Cr}$  and  $^{55}\text{Mn}$ , which became clogged after just a few hours to one day of operation due to material condensation.

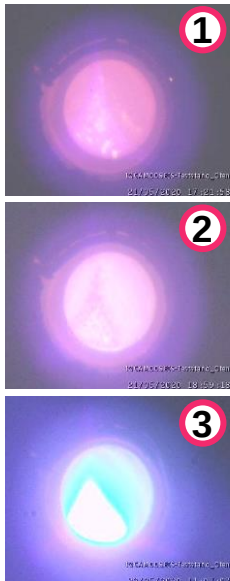
$^{55}\text{Mn}^{9+}$  intensity at the Faraday Cup

- First-time  $^{55}\text{Mn}$  beam production at GSI
- 3 days test at test bench (hot screen used)
- **80  $\mu\text{A}$   $^{55}\text{Mn}^{9+}$  beam intensity achieved**
- Discharges appeared on Day 2
- Discharge frequency was low enough to maintain stable beam production
- Hot screen helped to improve the beam stability
- Less disruptions during operation
- Consumption w.o. recycling: 8.1 mg/h

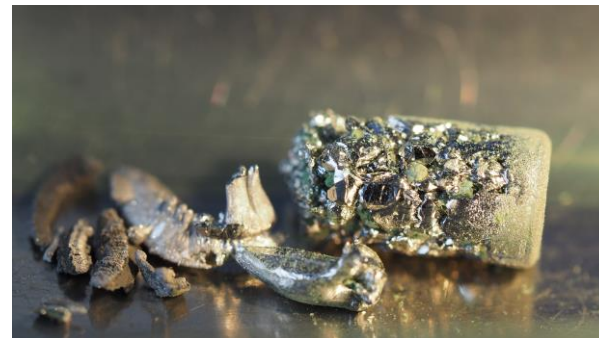
- Test run using **Tungsten mesh**, as with the Cr beam
- The mesh clogged heavily with condensed  $^{55}\text{Mn}$  after one day of operation
- By the end of the test a stable beam could no longer be produced
- **Oven images** show material reduction inside the oven over 2 days
- Material also condenses around the colder oven orifice
- **Condensed  $^{55}\text{Mn}$  (1.1 g)** was recovered, reinserted, and reused in subsequent operations, improving material consumption efficiency

**Condensed  $^{55}\text{Mn}$  (1.1g) from  
the oven after operation**
