eeFACT - 2022

Status report of vacuum system of ESRF Cristian Maccarrone

The European Synchrotron

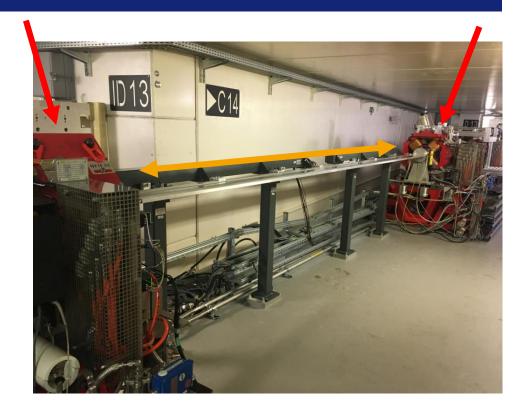
DESIGN - VACUUM CHAMBERS - STRAIGHT SECTIONS

32x STRAIGHT SECTIONS (7m long)

- 2x chamber at extremities for quadrupoles
- Internal "real" straight section 5m long
- 1x Injection
- 3x RF Cavities
- 13x with IN-VACuum Undulator
- 15x with IN-AIR Undulator
 - Aluminum chambers (ID-5000)
 - elliptical section 8 x 56 mm 5m long
 - NEG coated
 - Highest pressures in the SR
 - Cell-14 used to pre-condition NEG coated chambers

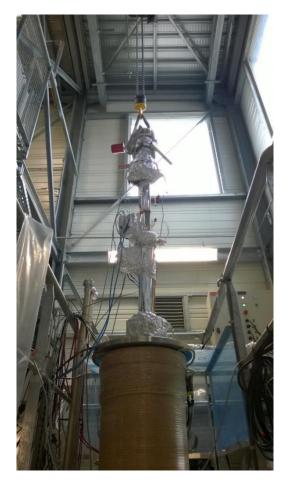
ASSEMBLY – COATING CH1 & CH14 (AND ID CHAMBERS)

CH-1 and CH-14

- All chambers (34+34) NEG coated at ESRF
- 2x chambers per run
- One week each run roughly

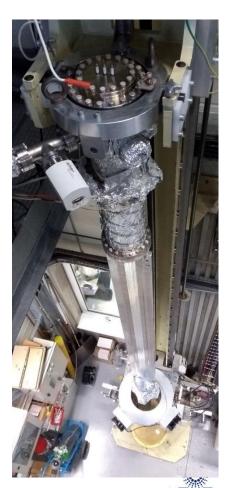
ID

All IDs chambers (22) - All 5m long

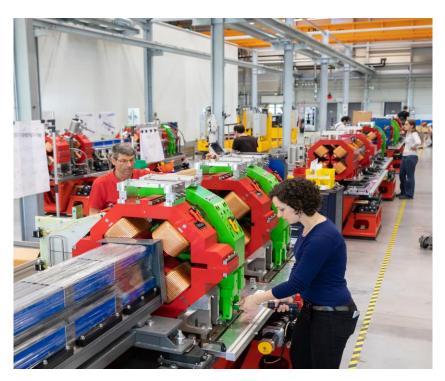
Assembly

- By girder in dedicated area
- Bake-out, alignment
- Stored under N2

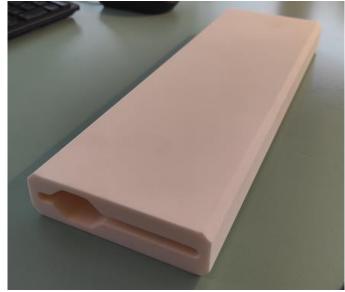
OPERATION – KICKERS' NEW-DESIGN

- No glazing joints (single body)
- Common design for all 4x kickers (today we have one design for K1K4 and one K2K3)
- Production challenging due to internal shape
- Installation foreseen by summer 2023
