# Beam-material issues for instrumentation in a 5 MW monolith

M.A. Hartl, Y. Lee, C. Thomas, J. Habainy, T. Shea (ESS, Sweden)  
David Wragg, Erik Adli, Håvard Gjersdal (University of Oslo, Finnland)  
W. Blokland (Spallation Neutron Source, USA)  
M. Jura (ISIS, Rutherford labs, England)  
M. Tomut & group (GSI, Germany)

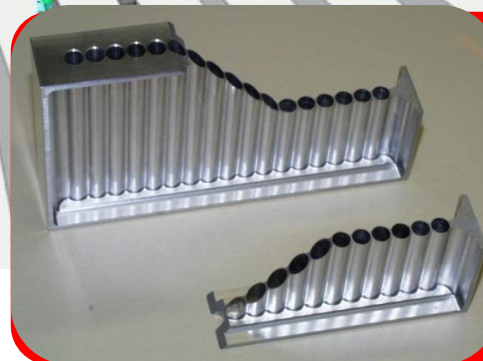
**Coated steel samples**

**Coated Aluminum  
surface samples (Jülich,  
Stony Brook).**
