AGEING OF AIRIX ACCELERATING UNITS

A. Georges, H. Dzitko, M. Mouillet, B. Gouin, CEA DAM Île-de-France, F-91297, Arpajon, (site du Polygone d'Expérimentation de Moronvilliers), France

This paper describes the test-bed: a pair of cells and its driver, and the first results of these ageing tests.

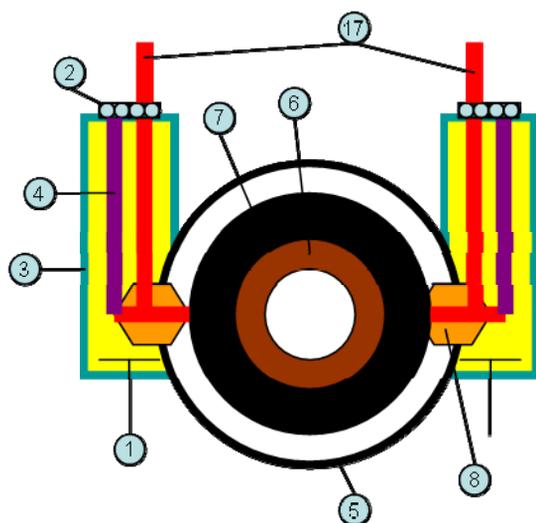
Figure 1: Airix accelerating cell scheme

Each cell is an assembly of an inductive core (7), two matched oil-insulated high voltage (HV) connexions (3), a water-cooled solenoid (6) and two magnetic dipoles for beam deviation, all of those held together under vacuum ($<10^{-5}$ mbar) in a stainless steel casing (5)[2]. The main points of interest are the ageing of the core and of the insulating parts under electrical stress.

The matching at the HV connexion is realised by a resistor (4) in parallel of the cell, while the feedthrough (8) itself separates the oil from the vacuum.

On the cell side, at each HV connexion, we use a capacitive voltage probe (1) to monitor the accelerating pulse, a Rogowski coil (2) to probe the feeding current, and a current transformer to probe the leaking current. We also use B-dots to monitor the magnetising current of each core.

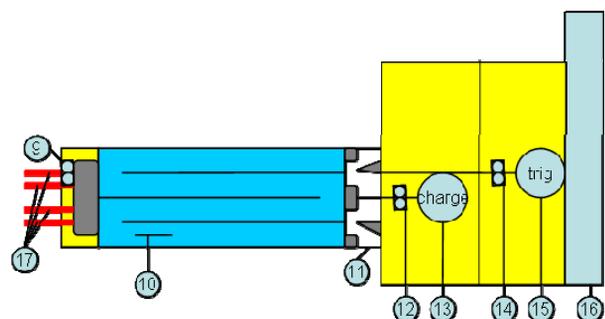
The driver consists of four main parts, the first three forming a HV generator:

- low voltage electronics (16) comprising ancillaries regulation and triggering control-command,
- a slow HV pulsed power part (13) charging a Blumlein line,
- a fast HV pulsed power part (15) triggering a pressurized (4.3 bars) dry air spark gap (11),
- HV junctions, e.g. 4 HV cables (17) and their connectors between the generator and the cell pair.

Figure 2: Airix cell driver scheme

The cables are 14m long and 50Ω impedance.

On the generator side, we use current transformers to probe the triggering pulse of the spark gap (14), the charging current of the Blumlein line (12) and the discharging current of said line (9). We also use a capacitive probe to monitor the voltage of the line (10).

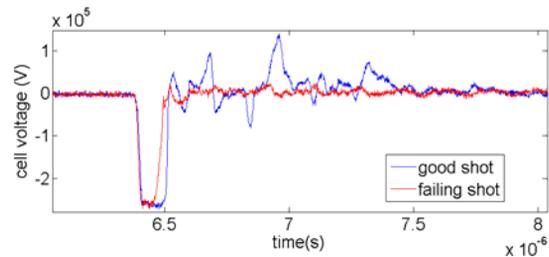
Figure 3: breakdown in oil

Oil Breakdown

23 of these were recorded in 23000 pulses. No correlation between these malfunctions has been made; they seem to appear randomly, with a low probability ($p \sim 1/1000$). It is to be noted that the same phenomenon with the same probability has been observed on Airix.

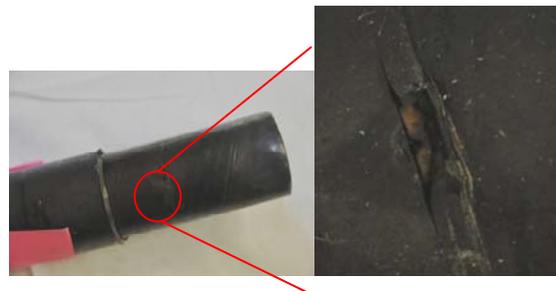
Figure 4: cable breakdown

The last type of malfunction, on the opposite, is harmful, destroying the affected cable. It occurred four times, all of them with the nominal type cable.

It casts doubts on the ability of this old cable to handle mechanical stress, after 12 years of rest.

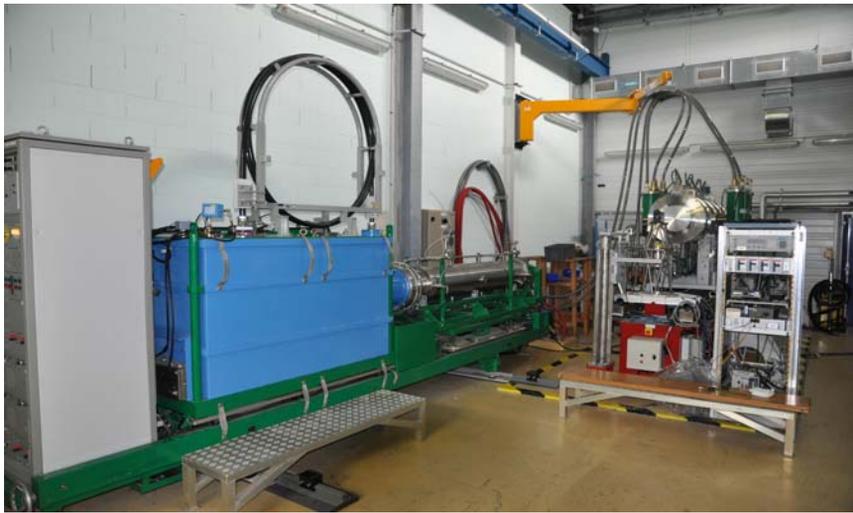
Figure 5: Test bed in use for determination of the lifetime of Airix cells and their driver.
