# STATUS OF THE J-PARC FACILITY

Shoji Nagamiya,

J-PARC Center, 2-4 Shirakata Shirane, Tokai-Mura, Ibaraki 319-1195, Japan

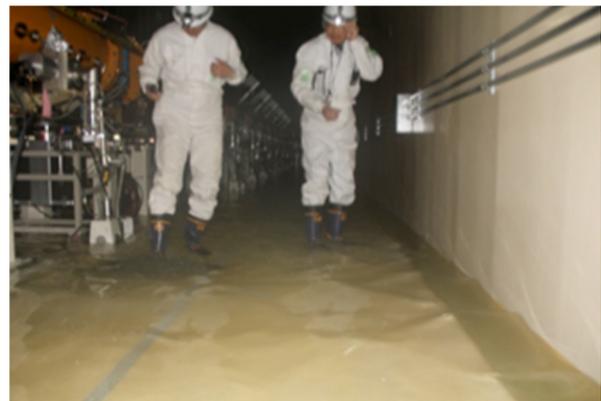
Figure 5: Linac tunnel immediately after the earthquake.

A road in front of the Linac was severely cracked, and a certain area in front of the Linac sank by 1.5 m. The damage inside the accelerator tunnel was fortunately minimal, because the main building had been built with many underpins to support it. But, the earthquake effect at Linac was the most serious among all buildings. Immediately after the earthquake, 100 tons of groundwater was spilled out into the tunnel, as shown in Figure 5. Since the water was highly alkali, we had to use many tons of acids to neutralize it. It took over one week to pump out the water. The next big issue was the problem of ground sank along the Linac tunnel. The middle of the building sank about 4 cm even though there were many underpins. For the moment, we plan to tune

beams toward the downstream to 2.6 cm and then to move them up to the normal height at the end of Linac, as described later.

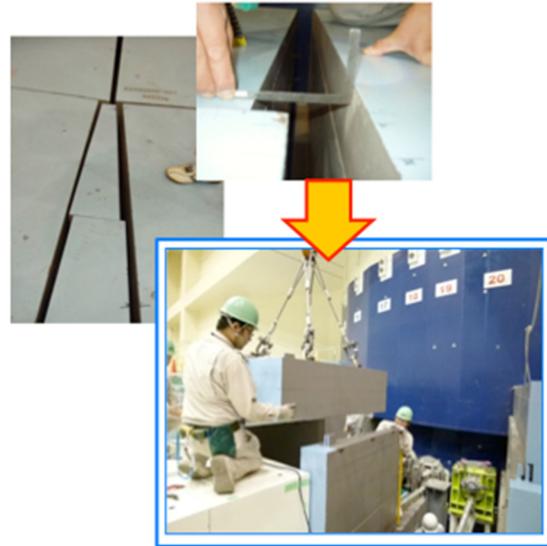
Figure 7: Movement of ion shield. 2,800 tons of irons have to be removed and restacked.

The Materials and Life Science Experimental Facility was relatively in a better condition. The problem here was a significant movement of shielding blocks. For example, 2,800 tons of iron shields near the neutron target area had moved out and, then, were restacked again piece by piece. Other major repair was needed on added buildings. On both sides of the main hall, neutron lines were extended for some equipment into the outside of the main building. For those beam lines we added buildings without many underpins. These buildings sank by 30 cm, so that we had to jack them up to the same level as the main building.
