PRELIMINARY RESEARCH OF HLS II BLM SYSTEM *

F. F. Wu, Y. L. Yang, B.G. Sun, Z.R. Zhou[#], Y.K. Chen, L.L. Tang, P. Lu, J.G. Wang, X.Y. Liu
 National Synchrotron Radiation Laboratory
 University of Science and Technology of China, Hefei, 230029, China

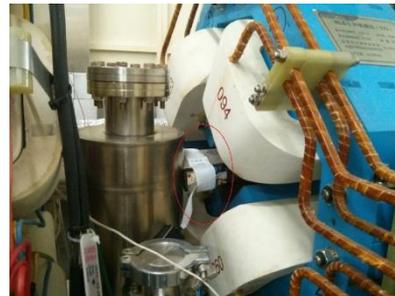
Figure 2: Site installation diagram for beam loss monitors in the HLS II storage ring.

Hefei Light Source II (HLS II) has been upgraded from August 2010 and now enter formal operational phase. It consists of a linac, a transport line and a storage ring. The energy of beam is accelerated to 800MeV when beam reaches the end of the linac and beam is injected into storage ring through the transport line. In order to protect machine, speed up commissioning, conventionally diagnose beam and study beam life, beam loss monitor system is designed for the HLS II storage ring. According to lattice of the HLS II storage ring, beam loss monitors are installed nearby quadrupole magnets [1, 2]. In order to monitor beam loss in different directions of the vacuum chamber, every 16 beam loss monitors are respectively mounted on upper and lower side surfaces of the vacuum chamber in vertical direction and on inner and outer side surfaces of the vacuum chamber in horizontal direction. The layout of beam loss monitors in the HLS II storage ring is shown in Fig. 1. Site installation diagram is shown in Fig. 2.

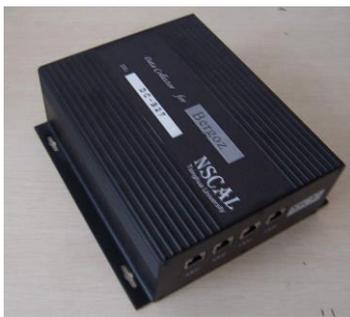
DAQ device is R&D by National Synchrotron Radiation Laboratory of University of Science and Technology of China and Department of Engineering Physics of Tsinghua University. DAQ device is as shown in Fig. 5.

Figure 5: DAQ device for beam loss monitoring
