# SURFACE TOPOGRAPHY TECHNIQUES AT CORNELL UNIVERSITY: OPTICAL INSPECTION AND SURFACE REPLICA\*

M. Ge<sup>†</sup>, F. Furuta, D. Gonnella, D. Hall, G. Hoffstaetter, M. Liepe, T. O'Connell, J. Sears  
Cornell University, Ithaca, New York, USA, 14853.

Surface imperfections significantly limit the performance of superconducting radio frequency (SRF) cavities. The development of surface topography techniques aims to locate the surface flaws in an SRF cavity and profile their geometry details. This effort plays an important role of quality control in cavity productions as well as provides contour information of the defects for understanding quench mechanisms. The surface topography techniques at Cornell University include an optical inspection system and surface replica technique. In this paper, we present the details of the techniques and show features found in the SRF cavities at Cornell.

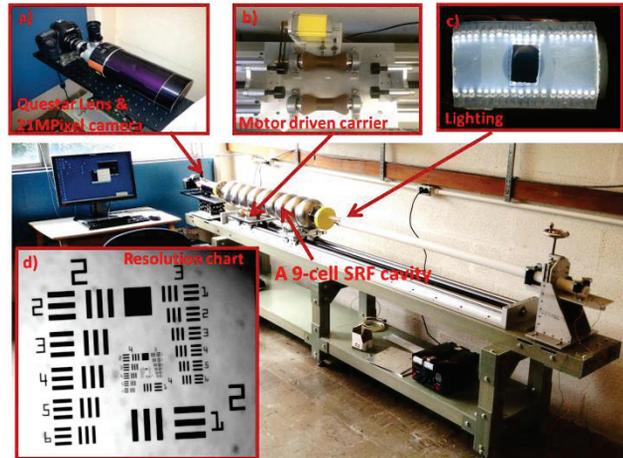
The Cornell optical inspection system, shown in Figure 1, is a Questar long-distance microscope based system. It is equipped with a 21MPixels Canon camera (Figure 1 a)); a motor-driven carrier displayed in Figure 1 b), which can provide rotations and movements of a single-cell or multi-cell SRF cavity; and a light with 40 LED bulbs lays

on two sides of a 45°-tilted mirror providing soft and diffused lighting, which is shown in Figure 1 c). The mirror is hold by a 2m-long Teflon rod.

Figure 1: The Cornell optical inspection system. The subplots a)-d) show the details of the system and the resolution of the system ( $2.77 \mu\text{m}/\text{pixel}$ ).

The system was tested with a 1951 USAF resolution chart. A scaled-and-cropped result is shown in Figure 1 d). The resolution can be calculated by Eq. (1),

In the chart, the patterns can be divided into eight groups, from large to small, numbering 0 to 7. Each group has six elements. Our system can observe the group 7 and the element 1 in the group. Thus the resolution of the system is  $128 \text{ lp}/\text{mm}$ , or  $2.77 \mu\text{m}/\text{pixel}$ .

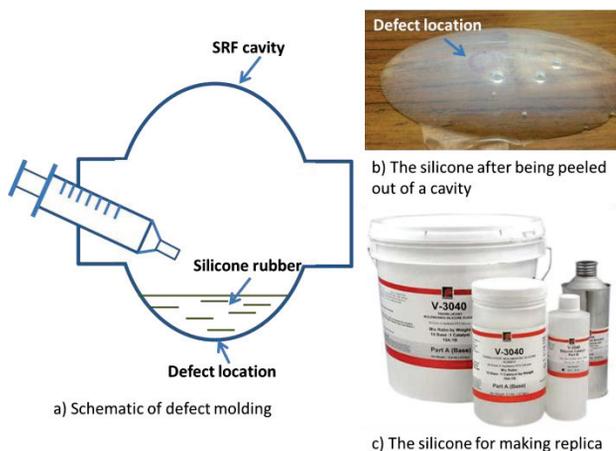
At Cornell, all the features we found were located in single-cell cavities or in the end-cells of 9-cell cavities, where they were reachable by hand. Hence we used a syringe to deliver the replica material to the target region by hand wearing clean gloves; the schematic of the process is displayed in Figure 2 a). After ~16 hour's solidification at room temperature, the surface replica can be peeled out of the cavity by hand, which is shown in Figure 2 b). The material we selected is a two-component translucent silicone-based compound, RTV-3040 (Freeman Mfg., Inc.), exhibited in Figure 2 c). The material can preserve surface details with  $\sim 1 \mu\text{m}$  accuracy. The surface replica produces negative surfaces of a cavity; in

other words, if a pit is located on a cavity, it will produce bump on the surface replica. The 3-D profile of the features on the replica can be measured by a laser confocal microscope with a non-contact scan. Examples of the features found will be presented in the next sections.

Figure 2: Surface replica technique developed at Cornell University.

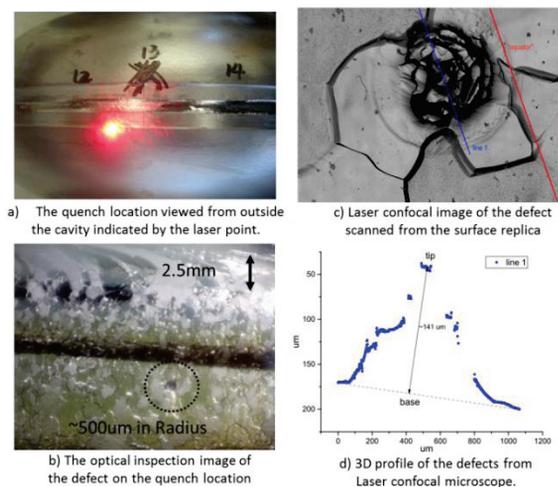
A feature was found in the cavity TB9AES022 which was prepared and tested for the LCLS-II project [11]. The cavity quenched at  $E_{acc}$  14MV/m [12]. The quench location has been detected by Cornell’s multi-cell temperature-mapping system [13, 14] and Oscillating Superleak Transducers (OST) system [15, 16] during vertical tests. Corrdinated with the information from the T-map and OST, the quench location was indicated by the red laser point on the exterior wall of the cavity, shown in Figure 3 a). From inside of the cavity on that spot, the optical inspection system observed a feature located near the welding seam, within the heat-affected-zone, which is shown in Figure 3 b). The radius of the feature is approximately  $500\mu\text{m}$ .

From the inspection image, it’s impossible to judge if the feature is pit or bump. Surface replica therefore has been made on that spot. 3-D scans of the feature were done by Fermilab with their laser confocal microscope. A top-view 2-D image of the feature from the microscope is shown in Figure 3 c) in which the red line indicates the direction of the equator; the slicing direction of the feature from the 3-D topography is depicted by the blue line which is parallel to the equator. The contour of the feature is shown in Figure 3 d). Instead of a pit, this feature is a bump,  $\sim 141\mu\text{m}$  high. A possible reason for this feature is a welding bead that was accidentally attached on the surface during the EB Welding. The bump has been removed by tumbling, increasing the maximum gradient to 26MV/m [17].

Figure 3: The defect observed on the quench location of TB9AES022 by inspection system and its surface replica.

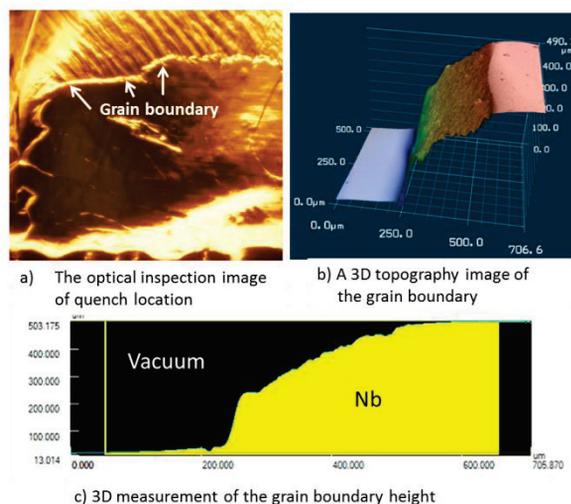
The large-grain single-cell cavity LR-5 quenched at 24MV/m. After an inspection of the quench location in the cavity [18], the results indicate the grain boundary might have sharp edge causing the quench. The grain boundary is shown in Figure 4 a). A surface replica on that region was made; it showed that the total height of the grain boundary is about  $500\mu\text{m}$  (Figure 4 b) and c)). The step depicted along the horizontal axis at position 200-250 $\mu\text{m}$ , is very steep: its angle is close to  $90^\circ$  and its height is about  $250\mu\text{m}$ .

Figure 4: Sharp grain boundaries observed in the single-cell cavity LR-5 with the height of the step  $\sim 500\mu\text{m}$  in totals.

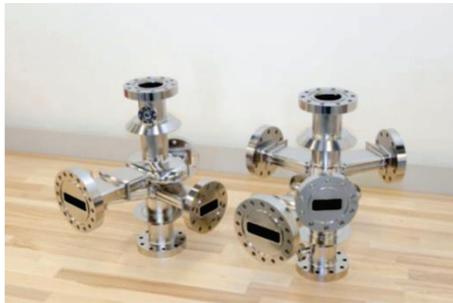
Argonne’s Short-pulse X-ray (SPX) project explored crab cavities to generate a continuous train of deflected bunches [19]. Since the mechanical structure of the crab cavity is very complicated as shown in Figure 5 a), it has significant technical challenges in fabrication, especially

a) Two crab cavities for the SPX project.

Figure 5 Argonne's Crab cavities and the not fully penetrated welding seams observed by Cornell optical inspection system.

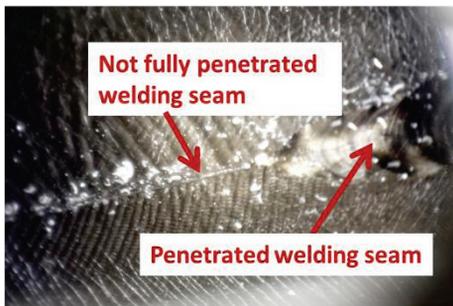
in EB Welding. This is because the heat capacity along the equator welding seam is un-uniform due to the three waveguide ports connected to the cavity equator. Hence the welding power has to be adjusted on the joint of the waveguide and equator. Otherwise, incomplete penetration welding could happen on some spots. Thereby optical inspection is a very necessary step to verify good welding quality.

b) An inspection image of equator region indicates the unpenetrated welding seam.

Cornell University inspected two crab cavities of the SPX project after the EB Welding. Because of the structure of the cavity, it is very difficult to rotate the cavity body by the carrier of our inspection system. Hence we kept the cavity fixed and rotated the mirror during the inspection. Several not fully penetrated spots on the joint of the waveguide and equator were observed in the cavities. Figure 5 b) shows an example image of the not fully penetrated seam which is a very narrow line, not covered by melted material. On the right-side of the seam, by contrast, it is the full penetrated seam which becomes much wider than on the left side, because the melted material covered the seam sufficiently. All the not fully penetrated welding has been repaired by re-welding since then.
