## DEVELOPMENT OF S-BAND RF WINDOW FOR LINEAR COLLIDERS

A. Miura and H. Matsumoto\*  
Nihon Koshuha CO., LTD.

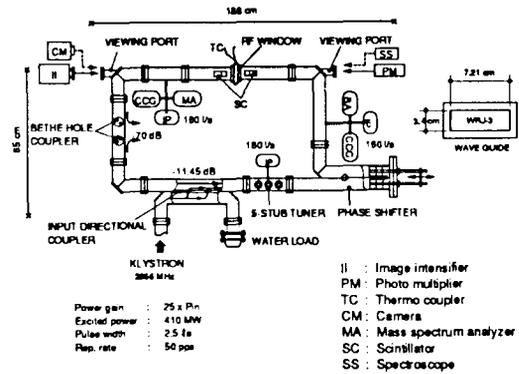
Fig. 1 The diagram of the resonant ring

The diagram of the resonant ring is shown in Figure 1. Photo multiplier tubes installed on a downstream view window are used to measure the time profile of light emissions from the alumina disk. On the outer wall of the RF window Alumel-Chromel thermocouple detectors were installed to monitor temperature rise of the alumina disk.

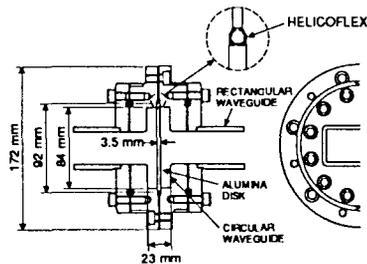
Fig. 2 A schematic diagram of the rf window

A schematic diagram of the window structure is shown in Figure 2. The vacuum on both sides of the alumina disk is separated by the Helicoflex. Since it allows to replace the alumina disk easily without disturbing the window frame.

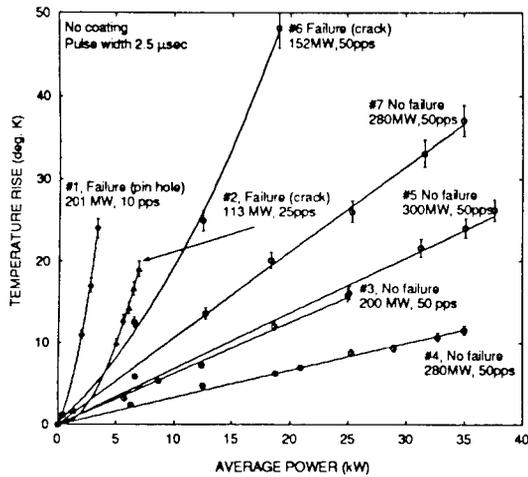
Fig. 3 Temperature rise at the window frame as function of the average power for each sample

Figure 3 summarizes the results of the experiment, showing the observed temperature rise at the window frame as function of the average power for each sample. This results are show case of maximum repetition rate of each samples.

Sample #5: After running at 300 MW at 50 Hz. No failure occurred. Figure 3 shows that the temperature rise with sample #5 is

very similar to that of sample #3. No melting spots or cracks were found on the disk after 500 hours of operation.

Sample #7: After running at 280 MW at 50 Hz. No failure occurred. Figure 3 shows that the temperature rise with sample #7 is 1.5 times larger than them of sample #3 and #5. It is clear that temperature rise depend on porosity.

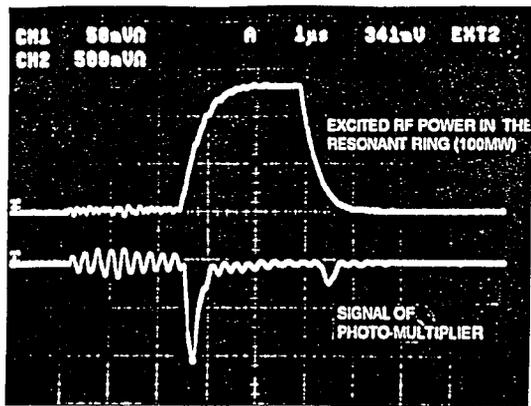
Fig. 4 The time profile of the light emission from sample #3

Sample #3: After running up to 200 MW at 50 Hz. The test was terminated at that moment. The alumina disk has seen no damage. Figure 4 shows the time profile of the light emission from sample #3. The signal trace is superimposed with the RF power profile. At the rising and falling edge of the RF pulse, when the power transmission reaches near 10 MW, light emissions for a few hundred nano-seconds are clearly seen. We understand that although the canonical operation power was well above the multipactor regime, during the pulse transient time the disk momentarily experiences the power level where multipactor is prominent. Therefore, for real-life RF window disks, TiN coating is still required.
