BEAM-INDUCED HEATING OF THE KICKER CERAMICS CHAMBERS AT NSLS-II*

Abstract

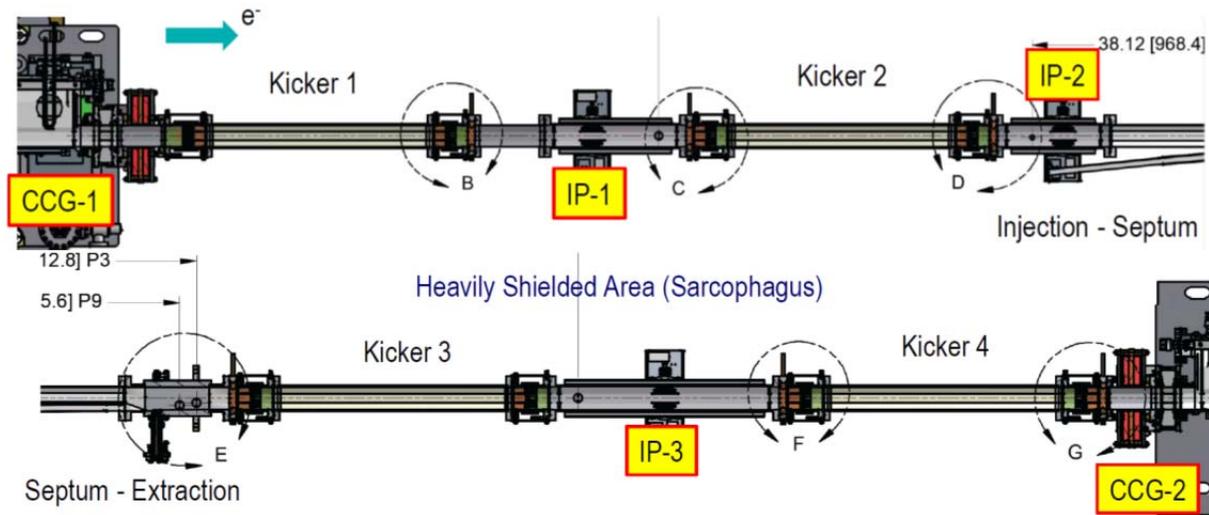
Figure 1: NSLS-II injection straight section (Cell 30).

matic layout of the injection straight section is shown in Fig. 1. The kicker chambers have a ceramic length of 755 mm and octagonal profile of 76 mm (H) x 25 mm (V) which match the cross section of adjacent bellows and chambers. The original specification of the kicker ceramic chambers called for a $2\mu m$ thick coating of Ti- on the entire inner surface with $\pm 10\%$ thickness uniformity.

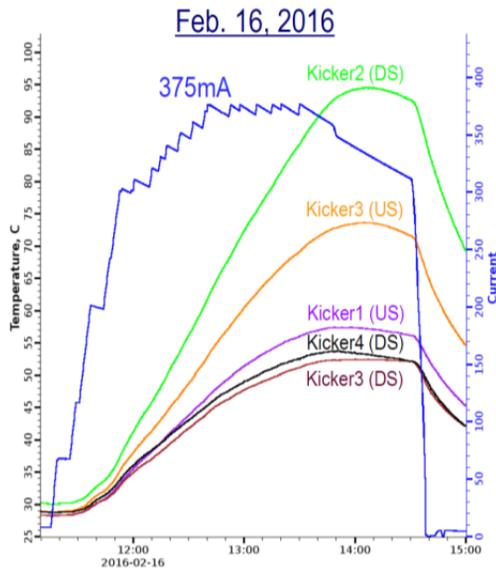
Figure 2: Temperature rise monitoring as a function of time at $V_{RF} = 1.5MV$ with $M = 1080$ bunches (Bare lattice).

Heating of the ceramics chambers has been observed during machine studies with an average current of $I_{av} = 375mA$ and a standard filling-pattern of $M = 1080$ bunches (Fig. 2). Several temperature RTD sensors have been installed near each transition from ceramic to stainless steel. This transition is made of Ni42 (42% of Nickel-Iron), which is used as to better match the thermal expansion of the ceramic.. It was observed that the downstream end of the kicker 2 chamber was showing a much higher temperature than the others. The maximum temperature of the Kicker2 downstream chamber as well as the other kicker chambers is shown in Fig. 2. In addition a temperature gradient was observed across the Kicker 3 chamber,

$T_{3,US} \sim 75^\circ C$ upstream (orange trace of Fig. 2) and $T_{3,DS} \sim 55^\circ C$ downstream (purple trace of Fig. 2). As can be seen from Fig. 2 the temperature of the chamber had not reached steady state after one hour with $I_{av} = 375mA$ (blue trace of Fig. 2) stored in the ring. The beam current was lowered due to concern of potential damage to the resulting from the unexpected heating. During beam operation at low current, we were able to collect temperature data as a function of average current. It should be noted that, between 6-7 hours are require to reach a steady-state temperature. Figure 3, shows a plot of the temperature distribution as a function of average current. This relation appears to be quadratic fitted to a curve ($T \sim I_{av}^2$). Based on this data the heating appears to be a result of resistive wall heating rather than synchrotron radiation. Tempera-

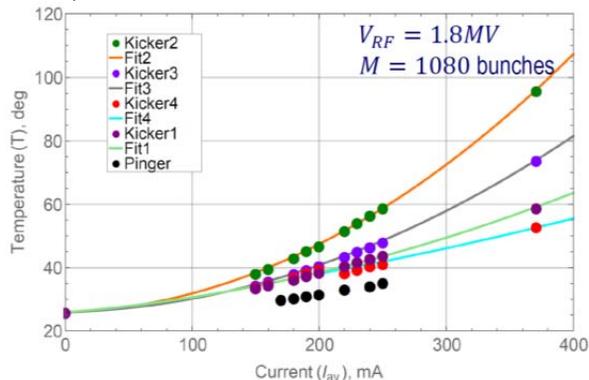
Figure 3: Temperature measurements as a function of average current. Data collected during the regular operation, except points at $I_{av} = 375mA$. Those data are preliminary, since the heat source did not reach steady state temperature.

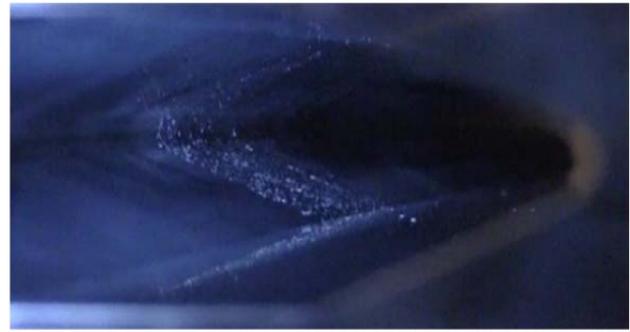
Concerns over the excessive heating measured on the Kicker2 chamber prompted us to inspect the interior of the chamber. Once opened, the Ti-Coating found to be damaged as shown in Fig. 4. Significant colour change was also clearly apparent when compared to the spare chamber which was installed (Fig. 5). The damaged Kicker 2 chamber was replaced with the pinger chamber and spare chamber was installed in the pinger location.

Figure 4: Kicker 2 chamber internal view after de-installation from the storage ring. O-Ring damaged shape of Ti-coating observed at the upstream of the chamber.

A method to accurately measurement the Ti-coating thickness and its uniformity is under development. Five new ceramic chambers are currently being fabricated to replace the existence ones. Further work to increase the air flow and using cooled air to remove heat, is continued. Stripping and recoating the damaged chambers as well as the possibility of increasing the coating thickness on the existing chambers is being considered. Newly coated chambers will be tested under real beam conditions in one of the available straight section. Effect of the ceramics chambers on the instability thresholds and on the total impedance of the ring is currently under study.

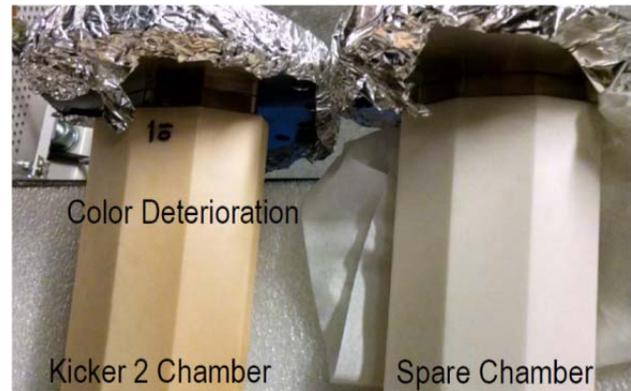
Figure 5: Comparison of the spare chamber and the Kicker 2 chamber after its de-installation from the ring.

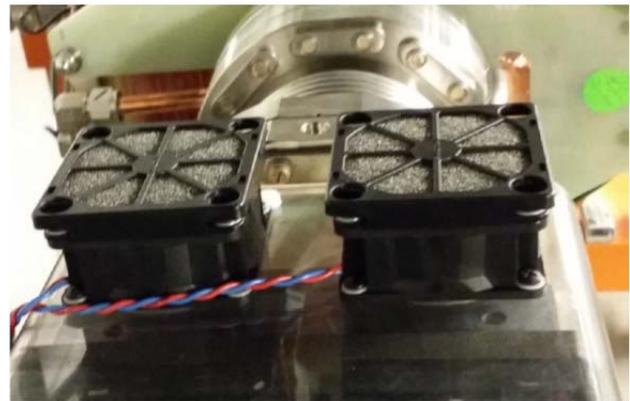
Figure 6: Cooling fans installed on the safety plastic shielding of each kicker pulse magnet.

To improve the heat removal, forced air cooling fans have been installed in to the kicker enclosures as a temporarily solution (Fig. 6). Figure 7 shows a side view of the pulsed magnet enclosure with cooling fans installed and air flow direction indicated.

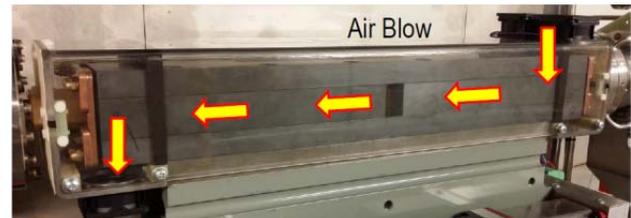
Figure 7: Side view and the schematic layout of the air flow through the kicker pulse magnet, where the ceramics chamber installed.

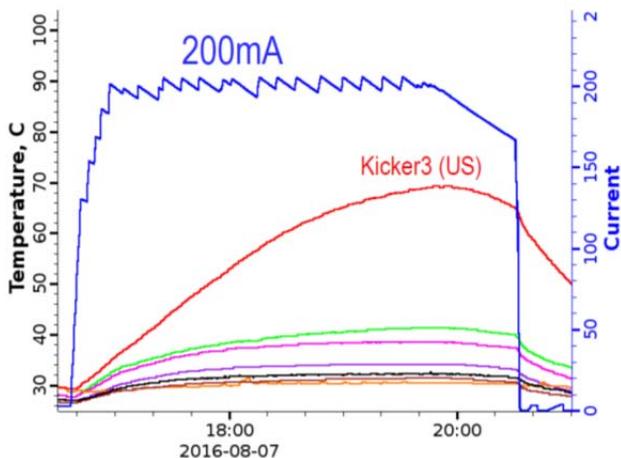
of the upstream side of the Kicker3 chamber. To confirm that the main source of the heating is due to the resistive wall, we reduced the average current by a factor of 2 and the number of bunches by a factor of 4 (Fig. 8). Running with $I_{av} = 200mA$ in $M = 270$ bunches is similar to operation with $I_{av} = 400mA$ in $M = 1080$ bunches, since $T \sim I_{av}^2/M$ for beam induced heating. The bunch lengthening effect due to Potential-Well Distortion (PWD) needs to be taken into account when the intensity per bunch is large enough. Assuming small effects from PWD we compared the temperature rise for the two discussed cases.

The experiments showed a significant decrease of the chamber temperatures when the cooling fans are on. The temperature rise on all of the ceramics chambers was below $40^\circ C$ except for one. The upstream end of Kicker 3 showed a temperature rise up of $T_{3,US} \sim 70^\circ C$ with the cooling fans on during both considered cases. After two hours the temperature did not reach the steady state.

Figure 8: Beam studies at $I_{av} = 200mA$ with one train of $M = 270$ bunches.

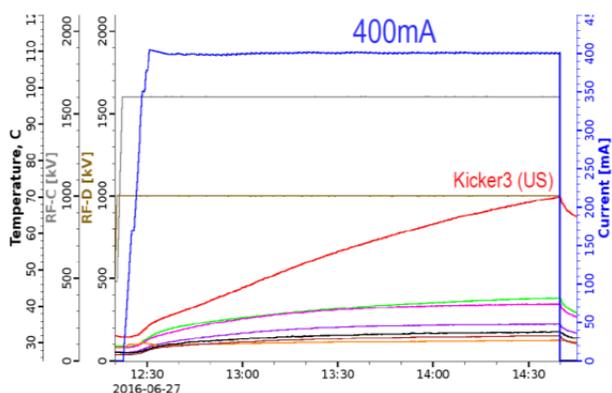
Figure 9: Beam studies at $I_{av} = 400mA$ with one train of $M = 1080$ bunches.

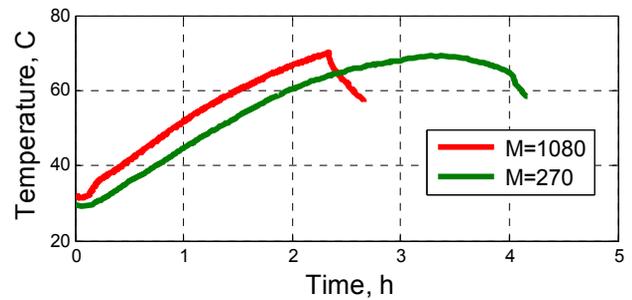
Figure 10 shows a plot of the temperature rise as a function of time for the two beam conditions described above. With some small discrepancy, the temperature effects reflect the behaviour we expected.

Figure 10: Temperature rise comparison as a function of time. Time is in hours. Number of bunches is M .

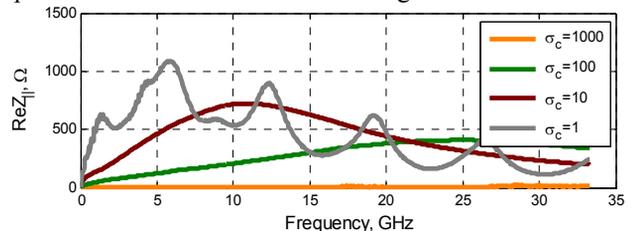
To understand the beam-induced heating due to resistive wall, the longitudinal impedance of the ceramic chambers has been calculated numerically using the GdfidL code [1]. Varying the electrical conductivity (σ_c) at fixed frequency, we were able to see the frequency spectrum change from broad-band resonator impedance to generation of the narrow-band impedance peaks (Fig. 11). Further decreasing the electrical conductivity makes the spectrum noisy. The loss factor (k_{loss}), estimated for a 3mm bunch length, increases with decreasing conductivity and stays constant for $\sigma_c < 1 S/m$. To estimate the power loss accurately we need to know the electrodynamic parameters of the ceramics chamber at different frequencies and with different Ti-coating thickness.

Figure 11: Real part of the longitudinal impedance simulated by the GdfidL code up to 32GHz for different electrical conductivities of the ceramics chamber.
