THE AGS ELECTROSTATIC SEPTUM

J. Hock, T. Russo, J. Glenn, K. Brown

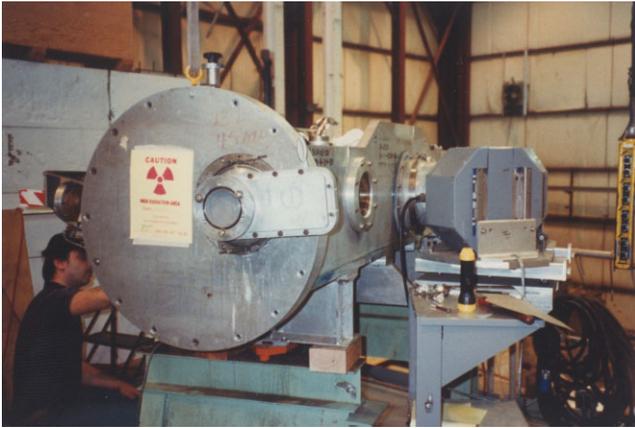
Figure 1: The Old AGS Electro Static Septum

The previous slow beam extraction electro static septum in the AGS was designed in 1981. Research documented at the Fermi Laboratory was used as the base line for this design. The septum consisted of a ground plane of .002" diameter wire tungsten-rhenium alloy (75%W 25%Re) with a hollow welded titanium cathode assembly. The vacuum chamber is stationary and the septum is moved with a pair of high vacuum linear feed throughs.

After years of beam time, the frequency of failures increased. The vacuum system design was poor by today's standards and resulted in long pump down times after repairs. The failures ranged from broken septum wires to a twisted cathode. In addition to the failures, the mechanical drive system had too much backlash, making the operating position difficult to repeat. The new septum needed to address all of these issues in order to become a more reliable septum.

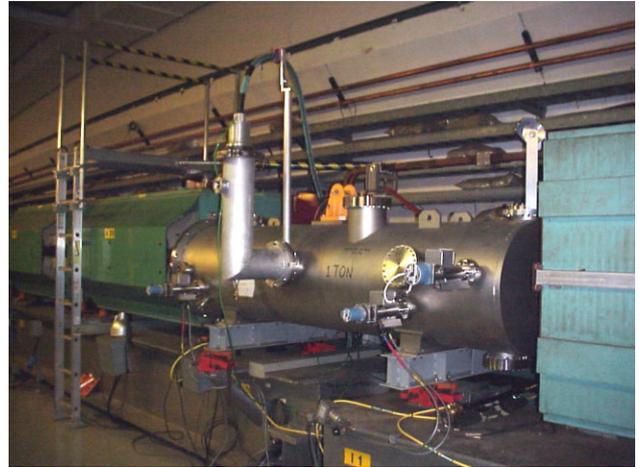
Figure 2: The New AGS Electro Static Septum

The vacuum chamber material was changed to stainless steel with knife-edge flanges and copper gaskets. The septum assembly was slid into the chamber on linear bearings, so the septum could be removed quickly from the chamber during maintenance. All materials used in the septum were compatible for high vacuum. All mating surfaces were vented and all blind tap holes were assembled with vented bolts. The pump down time was reduced from 6 hours to less than an hour.

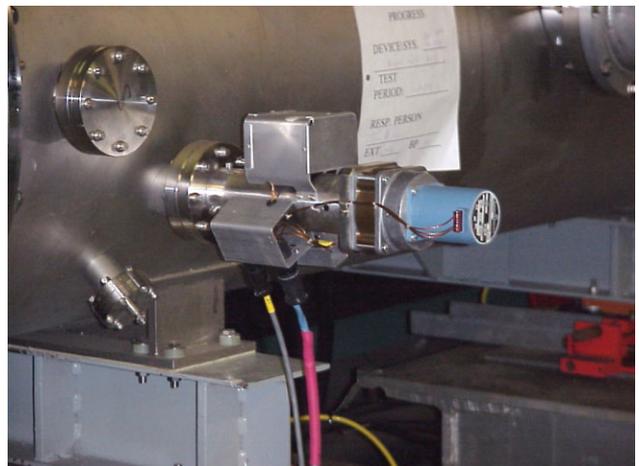
Figure 3: The Linear Drive Installed On The Septum

The mechanical linear actuators were designed with all the control components (limit switches, feedback potentiometer, and drive motor) mounted to the same unit. The actuator is attached to the vacuum with a flange, and the septum with a pin, for quick removal from the high radiation area. The backlash was minimized by adding a tension spring on the septum assembly, opposite the linear drives, thus always loading the drive system in one direction. The feedback potentiometer was mounted directly to the actuator shaft with an anti-backlash gear.

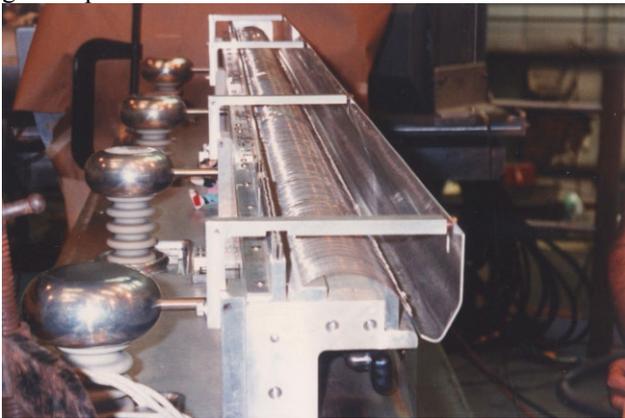
Figure 4: AGS Old Electro Static Septum

In an effort to prevent the proton beam from breaking the septum wire, the geometry and material of the wire was addressed. The wire was mounted to the septum on a c-shaped support between two tension springs. The spring tension provided stiffness to the fragile wire, minimizing its deflection induced by the electrical field, and pulls the wire away from the cathode if it breaks. The tensile load on the wire from the springs is small (.25#) due to the small cross sectional area of the wire. The wire is attached to the springs by twisting a loop in the end of the wires, causing slight slippage at initial tensioning of the wire. A consistent wire length was difficult to maintain. The varying lengths of the wire, coupled with the varying properties of the springs yield different tensile load on the wires, hence different displacements caused by the 60 kV electro static field. The different deflections of the wire meant that the ground plane was thicker than .002".

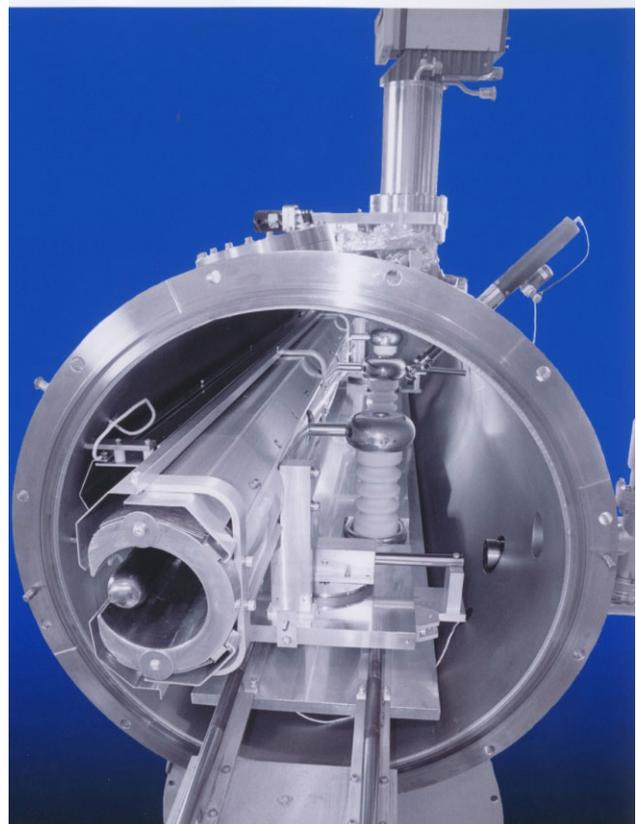
Figure 5: The New AGS Electro Static Septum

The new AGS electro static septum uses a .001" thick by .035" wide W 95% Re 5% alloy foil strip. The large cross sectional area allows the foil to have a higher tensile load than the wire, yielding less displacement from the electro static force. The theoretical displacement for the foil is .0003" as compare to the wire .003". The stiffer foil also reduces the displacement due to the different spring properties and lengths of the foil.

Although the foil strip septum is thinner, the total length of material is 26.25" as compared to the wire, which is 3". The predicted losses at the septum will increase, but reduce the losses for the downstream slow beam extraction devices.
