TRIUMF ISAC RF SYSTEM IMPROVEMENTS AFTER 2 YEARS OF OPERATIONAL EXPERIENCE

I. Bylinskii[#], Z. Ang, S. Fang, K. Fong, R. Kumaran, J. Lu, R. Poirier,
TRIUMF, 4004 Wesbrook Mall, Vancouver, Canada

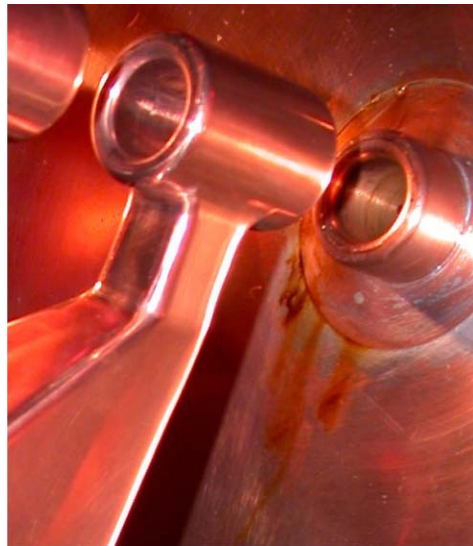
dedicated to the reliable operation of DTL rf amplifiers, couplers, tuners, problem troubleshooting and upgrades. Once a year all the DTL cavities were opened for inspection and assessed for problem. In the DTL tanks #3 and #4, soldering flux patches were observed around the nose cones (see Figure 1). This was traced to be a manufacturing defect, when the flux residuals were trapped in a pocket behind the nose cone and then came out during rf conditioning. Evaporating flux contaminated some critical rf surfaces, including rf coupler window, which eventually overheated and broke. A few attempts were required to clean off the flux residuals from the tank surface.

Figure 1. Soldering flux patch in DTL tank #4

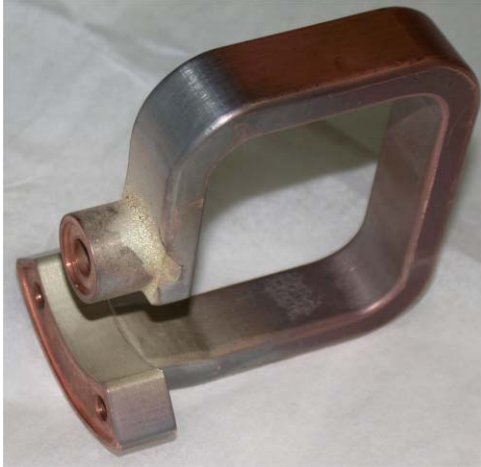
of those. In DTL buncher #2 a silver alloy evaporated from the coupling loop soldering joint (see Figure 2) and coated all the surfaces around including the ceramics (see Figure 3). Three other couplers failed in DTL tank #5 due to overheating, showing darkened ceramics with dramatically degraded isolation properties (DC resistivity dropped from few MOhm down to ~ 30 kOhm).

Figure 2. Buncher #2 coupling loop with a failed soldering joint.

Test studies brought us to a conclusion that in most cases coupler coating is triggered by a secondary electron emission discharge (multipactoring). In DTL tank #5, for instance, it happened during abnormal operation of an automatic starting procedure. After its rf controls operational parameters were readjusted the failure never happened again. To reduce the coupler failure risk some other preventive measures were taken:

- All coupling loops were copper plated to eliminate the soldering alloy exposure to the rf field.

- All couplers were equipped with Omega OS36 infrared thermocouples, which are pointed on the ceramic window.
- High standing wave (VSWR) protection was introduced into rf controls .

An easy and economical restorative solution has been found for the degraded couplers. It involves an abrasive removal of the coating by means of a sand blaster. With this procedure 4 malfunctioning couplers were rebuilt to their original specifications. In future we plan to incorporate a multipactor sensor into coupler design.
