## THE ASSEMBLY OF THE LHC SHORT STRAIGHT SECTIONS (SSS) AT CERN: PROJECT STATUS AND LESSONS LEARNED

V.Parma, N.Bourcey, P.Campos, R.Feitor, M.Gandel, R.Lopez, M.Schmidlkofer, I.Slits,  
CERN, Geneva, Switzerland

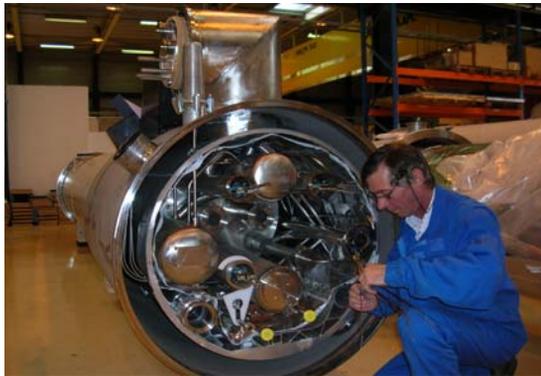
Figure 2: The QQS of a finished SSS.

The degree of complexity depends essentially on the number of components to be mounted in the QQS (helium phase separator, cryogenic tubing, insulation vacuum barrier, etc.), the related welding work and associated leak detection. Welding is mostly done manually with frequent intermediate leak testing since, due to the intricate component integration in the QQS (Figure 2), most welds become inaccessible for repair at a later stage. Leak detection using helium mass spectrometry is extensively used for this purpose.

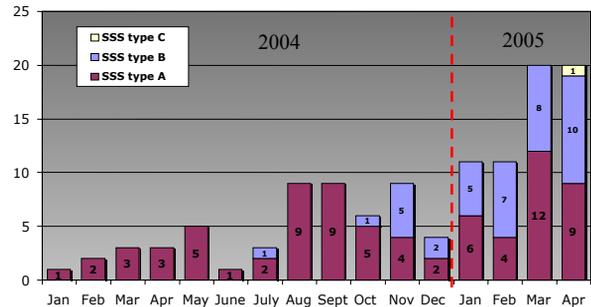
Figure 3: Monthly production of SSS.

The assembly of the SSS started in January 2004. After a difficult start up phase in the first months, the production rate progressively ramped up and has reached since 2 months a monthly rate of 20 SSS (Figure 3). 117 SSS have been assembled at this date, covering almost all the SSS types for the arcs.

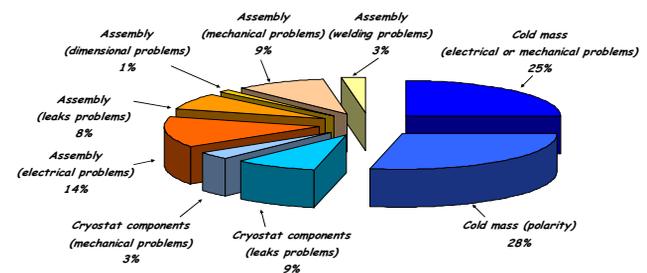
Figure 4: Break-down of NC on first 117 SSS.

Figure 4 gives the break-down of the NC, by frequency and type, encountered in the first 16 months of assembly. 86 NC have been detected and treated during the assembly of the first 117 SSS. 67% come from bad quality of components, whereas 33% come from assembly problems.

Despite not being the most numerous, leaks are amongst the most time consuming NC to treat, particularly when localizing small leaks (~10-7 mbar/l/s).

The most recurrent electrical NC detected on the very first cold masses were polarity errors from wrong routing or labelling of the corrector magnets bus-bars. To cope with this serious error, the SSS now go systematically through a final polarity check executed with a computer driven test set-up minimizing risk of human errors.

Up to date, about 5 SSS are affected by serious electrical NC (dielectric weakness in the corrector circuits), mainly experienced during electrical tests in cryogenic operation. Further investigation is needed but two SSS have already been dismantled and the cold masses will have to be disassembled for inspection. The use of reflectometry with pulsed electrical signals for localization of dielectric weakness in the circuits is presently under development for diagnostics.

Non conforming components, not detected in industry, were assembled in the SSS and discovered during final leak testing. For one component, the origin of the flaw was traced back to a faulty heat of raw material used for making flanges. The consequences were severe, as about 50 SSS were assembled and three exhibited leaks which were difficult to repair. Investigation by a non destructive method using an eddy current device for detecting surface cracks was done on some 10 SSS in assembly, and one more potentially leaky flange was found. For the remaining SSS, which had all passed final leak testing, it was decided not to replace the component. The same investigation method was used to inspect the full batch of components before use. No defect was found.

However, the number of NC were reduced from 4 per SSS during the first 30 assemblies to less than 1 per SSS today, indicating a clear sign of improvement in the quality of components and learning in the assembly process.
