# FACED ISSUES IN REA3 QUARTER-WAVE RESONATORS AND THEIR SUCCESSFUL RESOLUTION

A. Facco<sup>+</sup>, C. Compton, J. Popielarski, L. Popielarski, J. Crisp, K. Elliott, M. Hodek, M. Johnson, M. Leitner, I. Malloch, D. Miller, S. Miller, D. Morris, D. Norton, R. Oweiss, J. Ozelis, K. Saito, N. Usher, G. Velianoff, D. Victory, J. Wei, K. Witgen, , Y. Xu, S. Zhao, Facility for Rare Isotope Beams (FRIB),  
Michigan State University, East Lansing, MI 48824 USA  
<sup>+</sup> INFN - Laboratori Nazionali di Legnaro, Padova, Italy

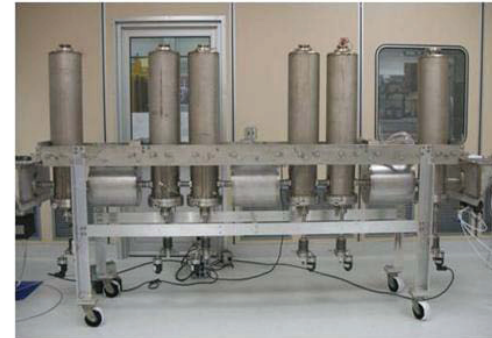
- First SRF linac at MSU,  $\beta=0.041$  QWRs in operation since 2 years
- Excellent test bench for FRIB QWRs
- Operation  $T=4.5\text{K}$

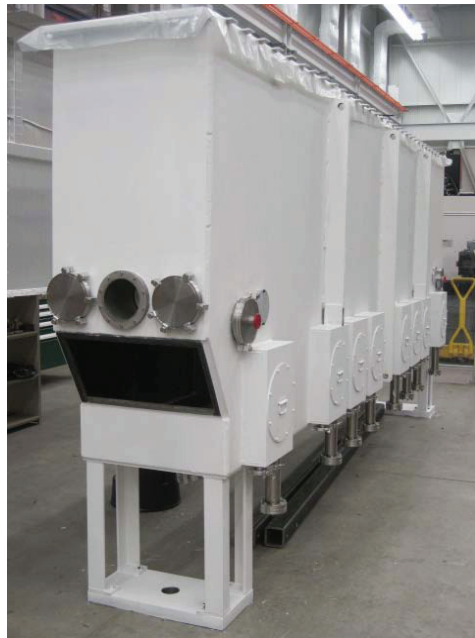
- Refurbishment of existing ReA3 cavities successfully completed
- All cavities exceeding specifications both for ReA and FRIB
- Construction of ReA3 cryomodule with MSU side couplers close to completion
