STUDY ON LOCAL CHEMICAL TREATMENT FOR RECOVERY FROM SURFACE OXIDATION BY HPR PROCESS ON SRF CAVITIES*

H. Guo[†], P.R. Xiong, Z.X. Shi, Z.M. You, Y.K. Song, W.M. Yue, A.D. Wu, Y.M. Li, T. Tan, Y. He, S.H. Zhang, Institute of Modern Physics, Chinese Academy of Sciences, Lanzhou, China

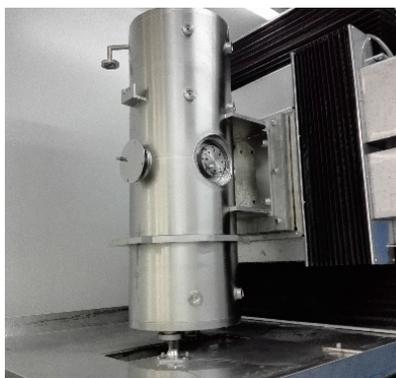
The new automated HPR system consisting of cavity fixture, a wand and nozzle has been designed and installed at IMP (see Fig. 1). It has 5 axles. The cavities can be moved and rotated, which make sure all ports of cavity can be cleaned without disassembly. The nozzle of HPR system have three fan jets, two side and one top (see Fig. 2).

Figure 1: Automated HPR system.

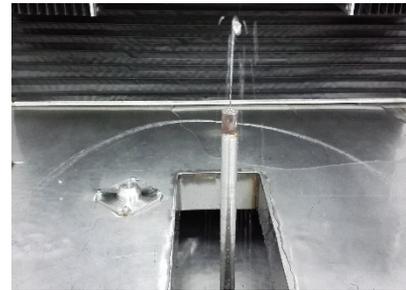
Figure 2: The nozzle of HPR system.

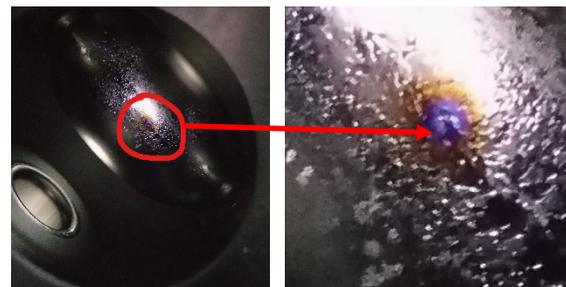
During the HPR process of HWR015, the distance between nozzle and surface of inner conductor is too close (less than 50mm). The water sprayed from top jet impacted the surface for a long time. Then a bluish violet spot appeared on the centre of the surface (see Fig. 3). This spot is oxide layer caused by long time HPR, and it is certified by Tyagi and Sertore. [1,3,4] There were 4 cavities have oxide layer, and it is prepared for crymodule immediately. So a method should be found to solve this problem as soon as possible.

Figure 3: Bluish violet spot on the surface of inner conductor.

Local chemical treatment is the fastest method. It is use acid to etching the oxidized spot and remove the oxide layer. In order to test the result before and after local chemical treatment. Samples experiment have been done first.

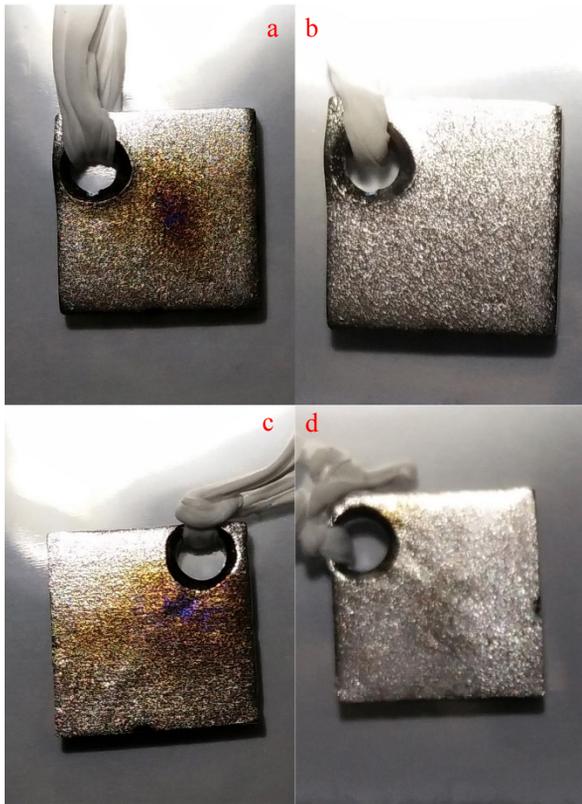
At beginning, we prepared two samples of niobium which were impacted by HPR for 180 second. The surface of samples is oxidized obviously. (see Fig. 4 a and c). Two acids have been prepared for recovery experiments. The first acid is HF (40 wt%), the other one is BCP acid (HF: HNO₃ : H₃PO₄=1:1:2). The parameter of experiment see Table 1. After acid etching, the oxide layer disappeared obviously. Thus we can use these methods on cavities.

Figure 4: Two niobium samples oxidized by HPR and after chemical treatment (a and c are oxidized by HPR, b is etched by HF, d is etched by BCP acid).

Sample	a,b	c,d
HPR time	180s	180s
Acid	HF (40 wt%)	HF: HNO ₃ : H ₃ PO ₄ =1:1:2
Etching time	60s	90s

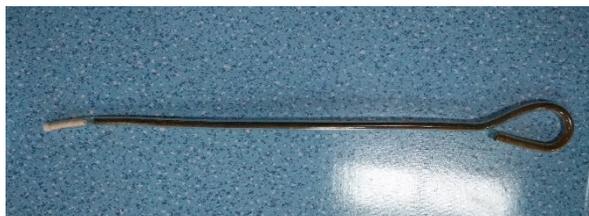
In order to protect the surface of cavity from scratching, a special tool has been made. As shown in Fig. 5, the tool is fixed by iron wire which is long enough to enter into cavity and touch the surface of inner conductor. There is PVC tube covered the wire. At the top of the PVC tube, the non-woven fabric has been pressed into tube which is used for acid dipping.

Figure 5: A special tool for surface recovery.

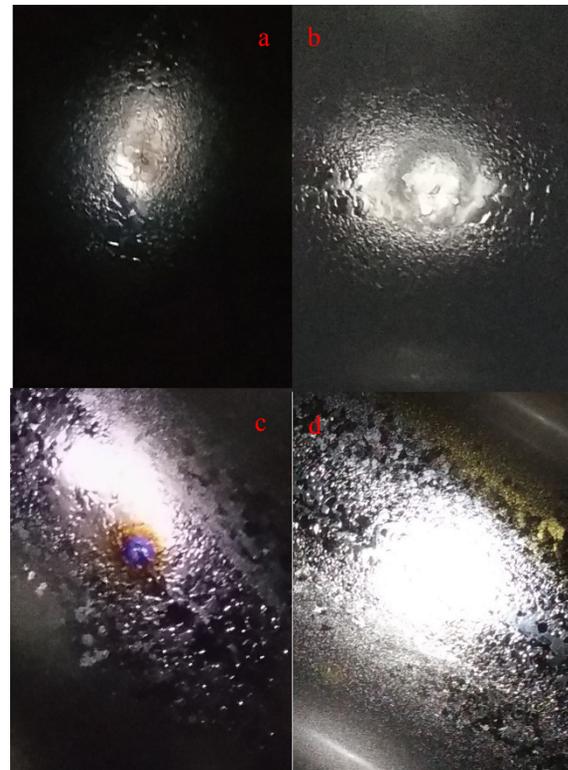
After the acid preparation and tool preparation, the surface of inner conductor has been recovered in cleanroom. As shown in Fig. 6. A is the picture before etching, b is the picture after BCP acid etching. Compared with a and b shown the oxide layer is removed, but the acid left an etching mark (a cycle around the etching area). c is the picture before etching, d is the picture after HF etching. Compared with c and d, it can be shown the oxide layer is removed thoroughly. In addition, it has no marks left on the surface after etching.

Figure 6: Surface recovery of the cavities inner conductor.

According to photos shown, the HF is the best choice to remove oxide layer, and the BCP acid would leave an etching mark on the surface. The cavity recovered by BCP acid has a bad performance compared with cavities recovered by HF. In the further the amount of oxide should be test, and the performance drop off by surface oxide layer of cavities should be verified during vertical test.
