MEASUREMENT OF THE VIBRATION RESPONSE OF THE EXFEL RF COUPLER AND COMPARISON WITH SIMULATED DATA (FINITE ELEMENT ANALYSES)

Abstract

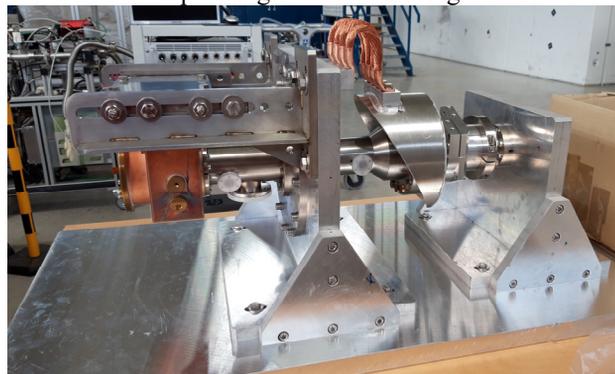
In June 2019 we performed a vibration study on the EX-FEL coupler. We assembled the coupler on a test support (Figure 7) and instrumented it with various sensors to measure the acceleration during a shaking test performed at the BFSV Verpackungsinstitut Hamburg GmbH.

Figure 7: The coupler on the test support.

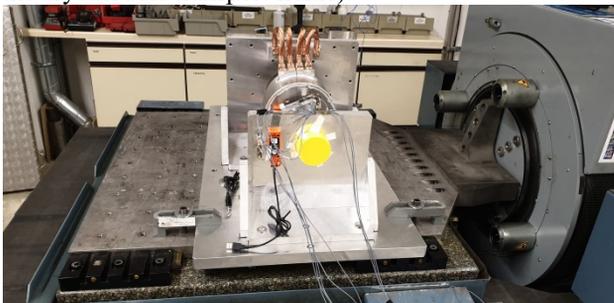
The shaking test was performed with a Vibration tester Unholtz-Dickie Corporation – SA60-T1000/AR. The vibration test rig was set up with a horizontal test axis. The coupler was position like in Figure 9, with the antenna axis perpendicular to the shaking axis (to simulate vibration in the longitudinal direction once the coupler is installed on the cryomodule transport frame).

Figure 9: The coupler on the shaking table.

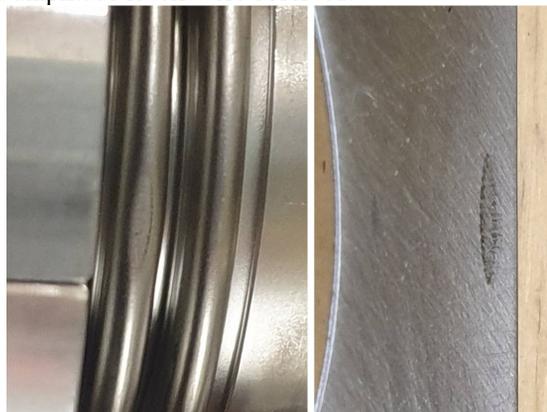
Therefore we decided to remove the linking part and have a look at it. Once removed, it showed a clear damage at the closest point to the bellows and the bellows itself had something like a dent at the corresponding point (see Figure 12).

Figure 12: Left, the dent on the bellows – right, the damage on the linking part.
