Never run your ECR ion source with argon in afterglow for 6 months!

D. Küchler, J. Ferreira Somoza, A. Michet, V. Toivanen
CERN, BE/ABP/HSL, 1211 Geneva 23, Switzerland

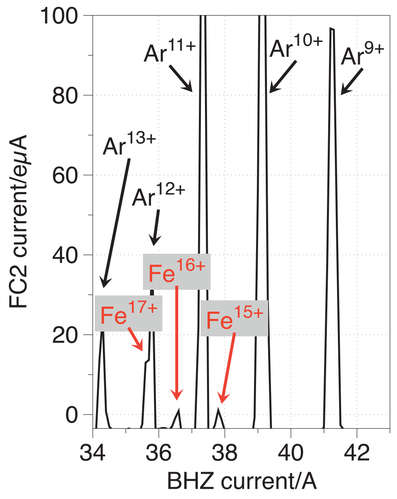
In 2013 already after 10 weeks of operation first sputter marks could be seen in the plasma chamber and in the ion beam co-extracted iron ions could be found.

After a period of 6 months the plasma chamber was taken out and measured. The spots where the plasma is lost dominantly are clearly visible and along these loss lines grooves up to 100 µm deep were measured (the chamber has a wall thickness of 2mm). During the lead operation only some marks were visible at the same spots.

As the first tests in 2013 showed already after 10 weeks of operation some degradation of the source hardware, it was decided to do a preventive maintenance after roughly 6 months of operation where plasma chamber and extraction system were replaced with spare parts.

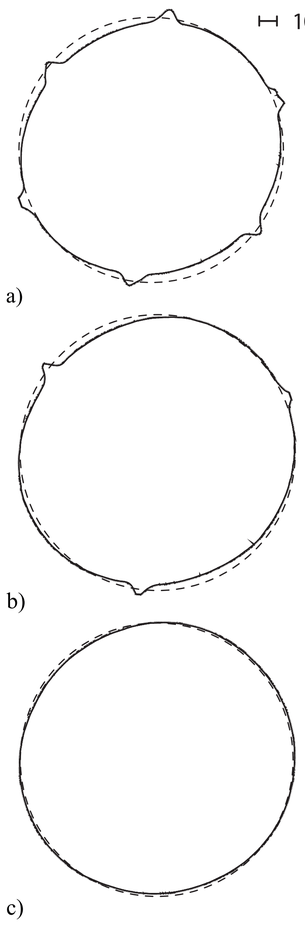
The measured deviation of the plasma chamber surface from the ideal circle (dashed). The values are amplified by a factor 100. The inner diameter if the chamber is 78 mm.
The measurement was taken a) roughly in the middle of the chamber, b) at around a quarter of the chamber length and c) at the extraction end of the chamber.

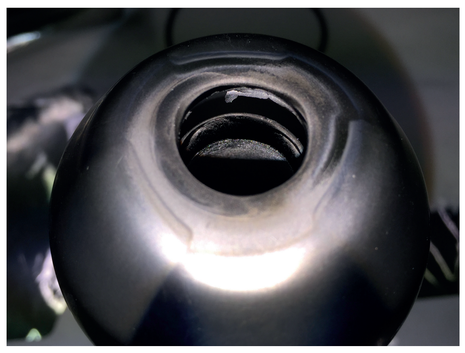
The aperture of the intermediate electrode showed clear sputter marks and some metal flakes after removal from the source.

But it was revealed as well that such a long term operation can be quite detrimental for parts of the source and the linac. Preventive maintenance is essential under such conditions. Eroded and metallized parts need to be replaced in time. The vacuum pumps need to be closely surveyed as the pressure in the machine is not the only indicator of the healthiness of the vacuum system.

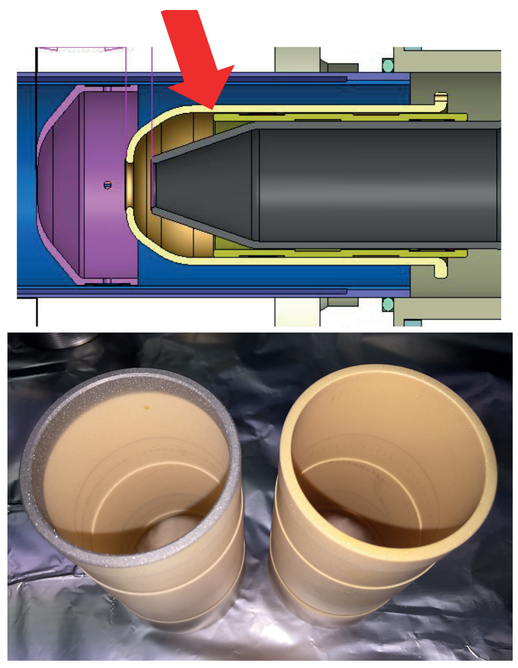
The insulator between the intermediate and the ground electrode was partially metallized on the side which is facing the extraction aperture.

The top part of the figure shows the position of the insulator and the side of the metallization. The electrodes from left to right: plasma electrode (purple), intermediate electrode (yellow) and ground electrode (grey).
In the lower part of the figure the left insulator shows a clear metallization on the top after around 6 months of argon beam operation. The right lower part shows for comparison an insulator that was used around 8 months during lead beam operation.

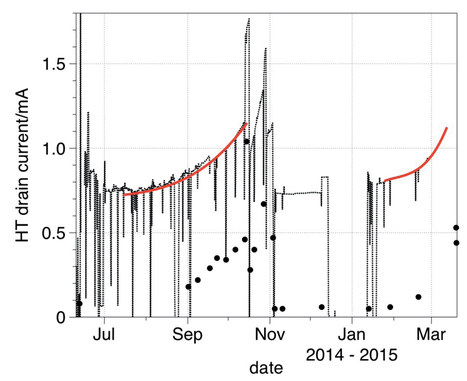
An indication that there is some metallization of the insulators was there already during the operation. It could be seen at the behaviour of the current of the extraction high voltage. While the extracted ion current stayed quite constant and therefore also the fraction of the high voltage current related to the ions the drain current went up over time. The change of the high voltage current was relatively constant most of the time and could be fitted with a cubic function. Why it is a cubic function is not well understood.

The current of the extraction power supply. The dotted line is the total current when the plasma is on, the dots show some selected values of the drain current when the plasma is off. The red curve represents a cubic fit of the current.
In November there was the source maintenance. Due to the clean insulators the drain current dropped down, but over time started to rise again.

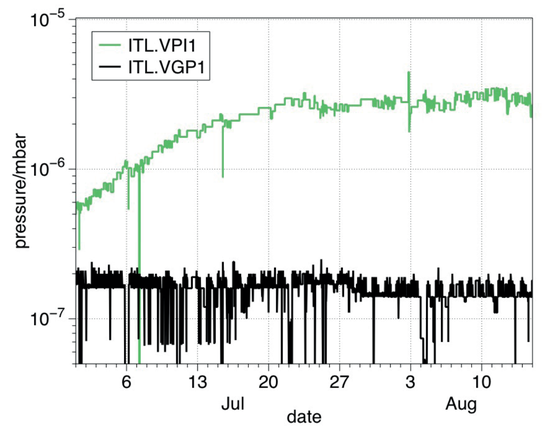
During the running period it was realized that while the pressure in the linac stayed quite constant the current in the ion getter pumps was rising. The effect was very pronounced in the LEBT but could be seen also in the ion getter pumps of the RFQ. This behaviour is not fully understood, but it may be related to leakage currents inside the ion getter pumps due to the coating of insulators.

Vacuum measured in the LEBT with a Penning gauge (ITL.VGP) and in one of the of the ion getter pumps in the LEBT (ITL.VPI).
The current measured in the ion getter pump is taken as measure for vacuum pressure.

After the argon ion run the pumps recovered slowly (partially supported by baking). But the ion getter pumps directly after the source which have seen most of the argon had to be replaced.

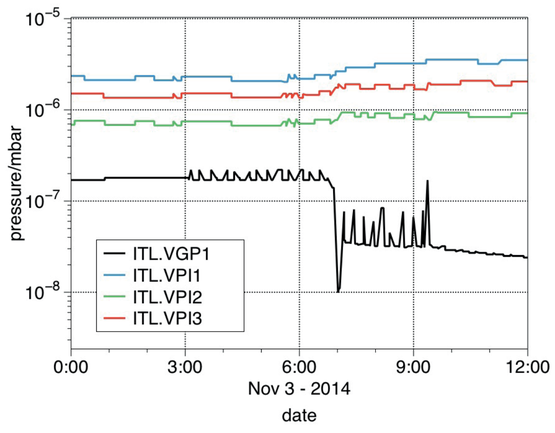
In addition there was the counter-intuitive observation, that when the gas injection into the source was stopped or the source was separated from the LEBT by closing a valve, the current/pressure in the ion getter pumps near to the source went up.

Vacuum measured in the LEBT with a Penning gauge (ITL.VGP) and in the ion getter pumps (ITL.VPI). At 7:00 the LEBT was separated from the source with a valve.
