REPAIR TECHNIQUES OF SUPERCONDUCTING CAVITY FOR IMPROVEMENT CAVITY PERFORMANCE AT KEK-STF

Ken Watanabe*, Hitoshi Hayano, Eiji Kako, Shuichi Noguchi, Toshio Shishido, Yasuchika Yamamoto, KEK, Ibaraki, Japan; Yoshihisa Iwashita, Kyoto ICR, Uji, Kyoto, Japan

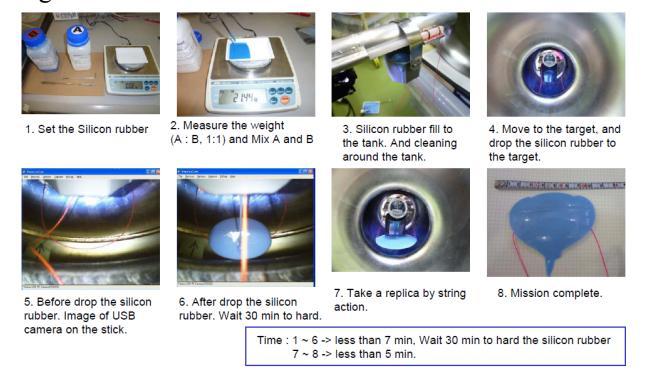
Figure 2: Tool and flow to take a replica.

The 2D profile of the defect can be measured by Kyoto camera system, however measureable axis is Z-axis only. In case of the defect with steep angle, the 2D profile can't be measured by limitation of the measureable wall gradient. The replica method is useful method to cover it.

The special tool and flow to take a replica inside cavity is shown in Fig. 2. This tool is applied for equator region of the multi-cell cavities. The replica materials are used the silicon rubber (Wacker dental ADS931) and Stycast (2850FT). The time to get one replica is about < 1 hour. A made replica by silicon rubber is negative. To obtain the positive geometry, the Stycast used to copy it. The Stycast is very hard material and good reproducing the surface condition. The 3D profile can measure by the laser microscope, 3D digital microscope and the surface roughness measuring machine to use copied replica to Stycast. It also can be used the bench test of local grinding to check the surface condition after grinding and fitting between niobium material and grinder head.

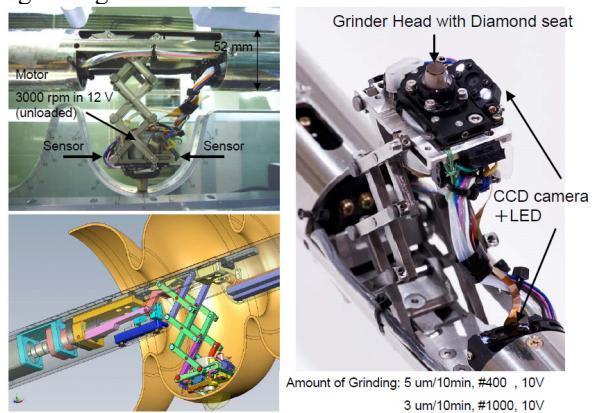
Figure 3: Local grinding machine.

Developed local grinding machine shows in Fig. 3. This machine can grind a geometrical defect at inside cavity. The cylinder size and head structure is optimized to the 1.3 GHz 9-cell cavity for ILC. The location which can be ground is the equator between ± 10 mm from joint point and top of the iris. For example, in case of the bump, the defect can be removed easily. The time to remove one bump (Example, defect size is ϕ 500 µm with 100 µm height) is < 1 hour. In case of deep pit (depth is about 100 µm), the time to remove one deep pit is about 10 hour. There is under studying to achieve the reduction of hours of grinding.
