OPERATIONAL EXPERIENCE AT THE INTENSITY LIMIT IN COMPACT CYCLOTRONS

G. Cojocaru and J. Lofvendahl, TRIUMF

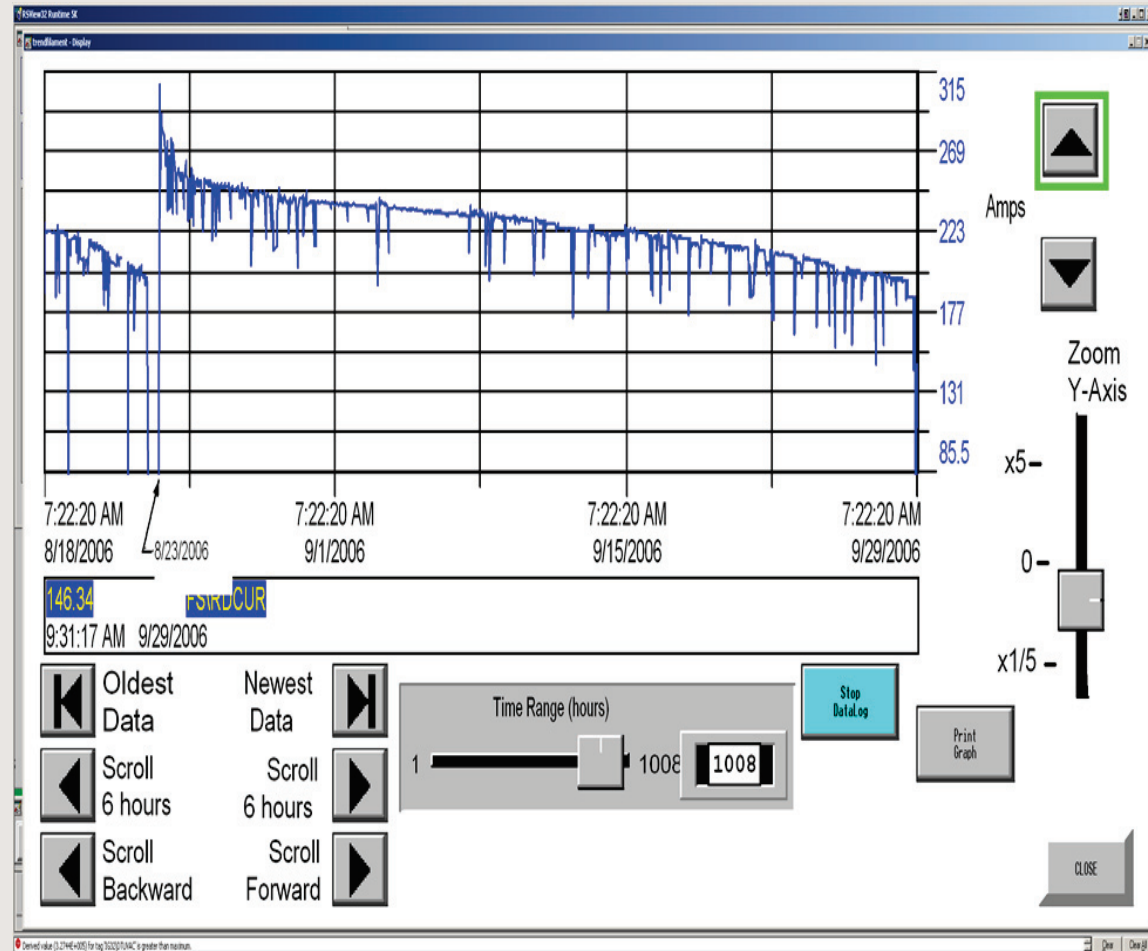
TR30-1 filament current over 37 days of lifetime

Filament lifetime

- 35 days lifetime
- 5 hours maintenance

Affects **only uptime**, not beam amplitude before and after the change

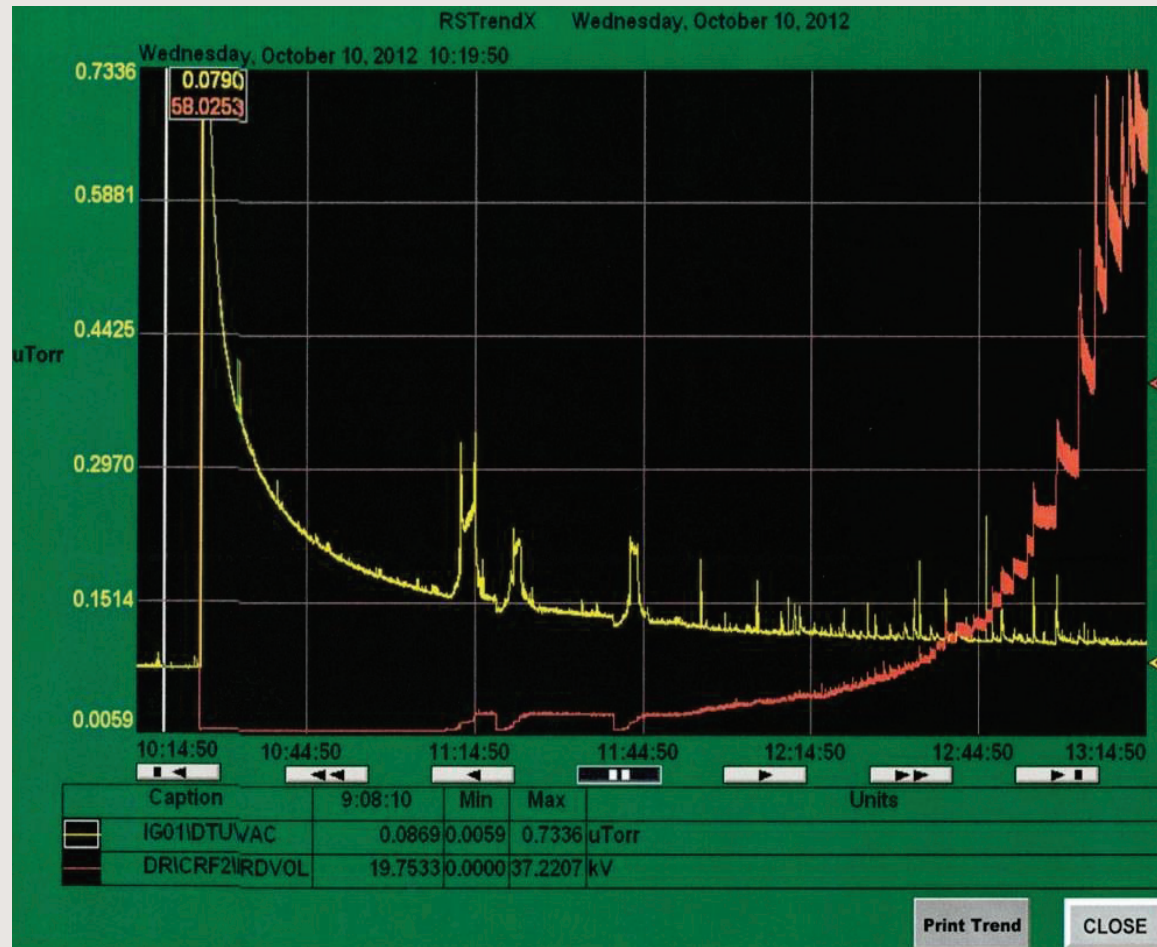
Tank pressure recovery after a carousel change (in yellow) and Dees voltage during RF conditioning

- There is typical beam deterioration during the lifetime of an individual foil due to its physical depreciation, which could be compensated by beam tuning and higher extracted beam
- New foil needs additional beam tuning, eventually a new carousel is necessary
- 5 hours to complete a carousel replacement
- Work is followed by tank RF conditioning
 - Affect both **beam amplitude** before and after the changes and **uptime**

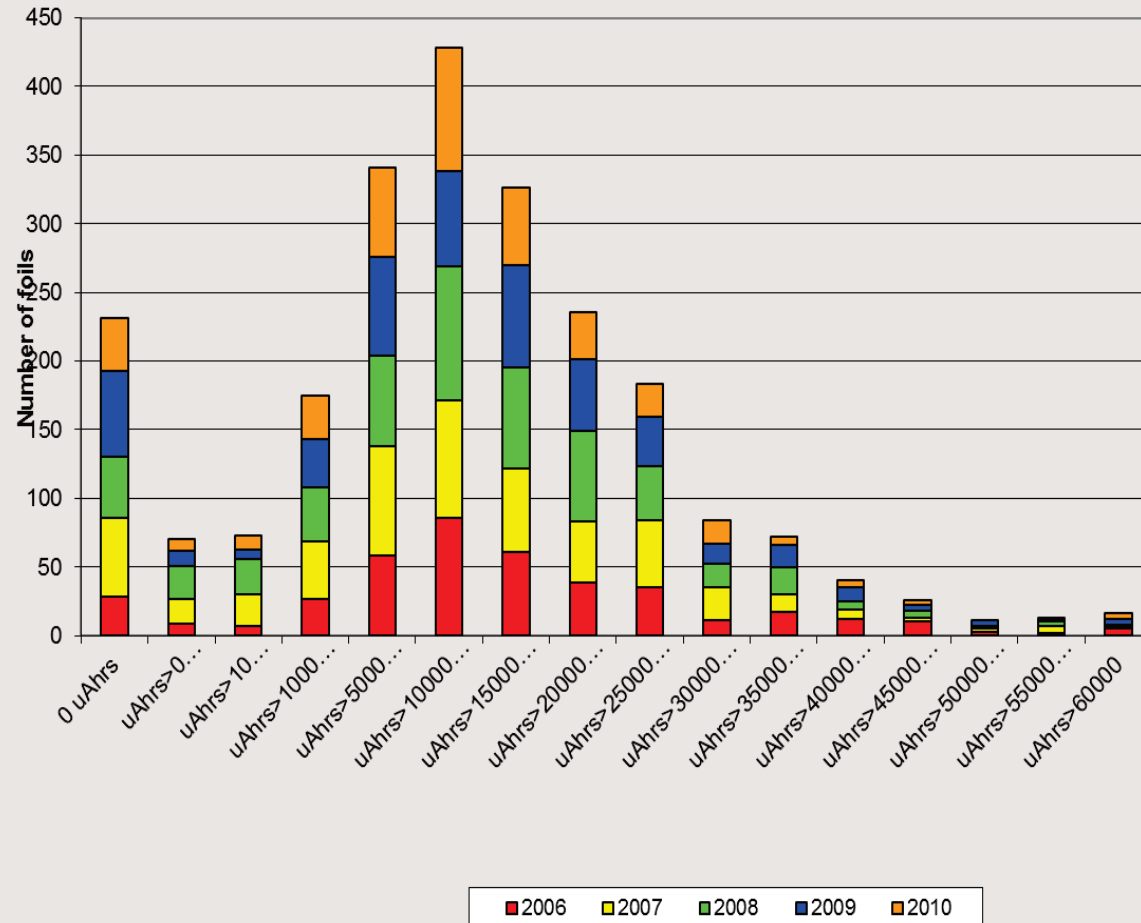
Foil Data (2325 foils)

- 2325 foils over 5 years on all 4 beam lines (both cyclotrons)
- Average charge is about 15mAh
- No difference in average charge related to beam level
- Differences are related to beam instability on the foil scheduled or inadvertent

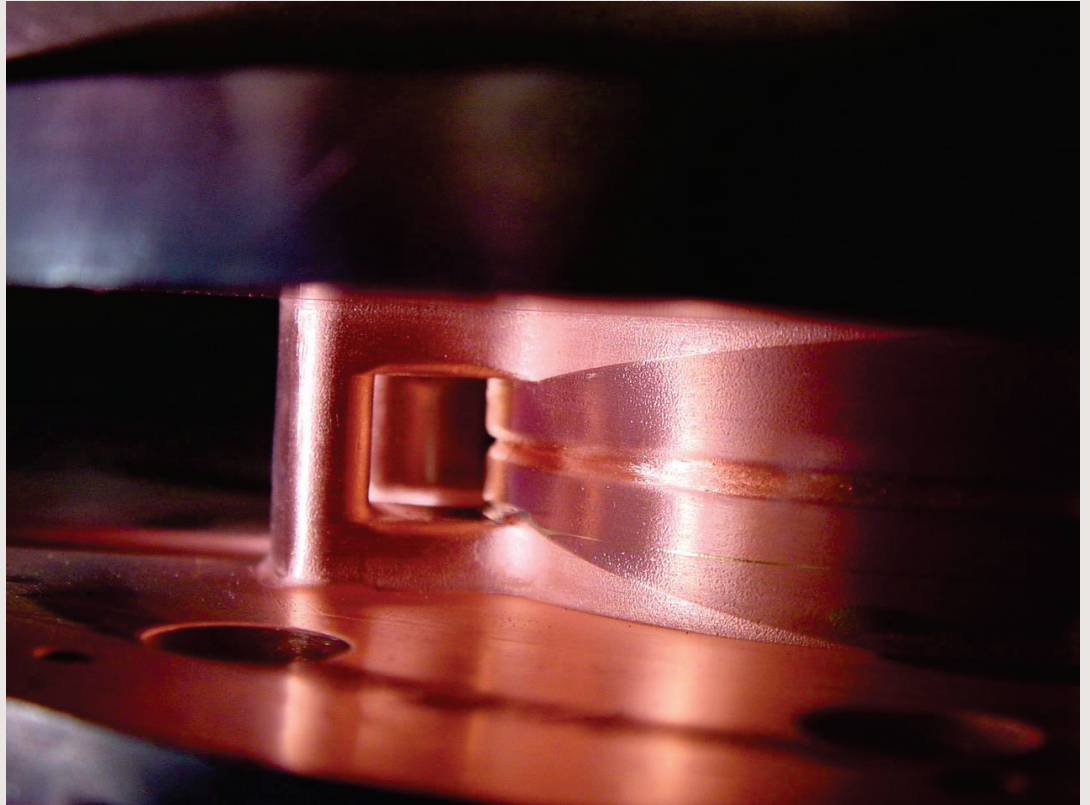
TR30-2 Centre Region post
after 2 years of beam

- Average accelerated current is limited by phase acceptance
- Space charge, both transverse and longitudinal are also limitations
- These limitations are becoming more evident when beams $>1\text{mA}$ are accelerated
- About 10mA DC currents have to be produced by the Ion Source to accelerate $>1\text{ mA}$. We observe a overall transmission deterioration at these current levels
- Unaccepted beam ends on different parts of the Centre Region

- Sputtering of metal surfaces is evident with its detrimental consequences in this area
- Beam stability, RF stability are affected
- Beam amplitude is eventually affected
- Misalignment during this process, and possible after maintenance due to conditions in the tank will further contribute to overall transmission deterioration
- Maintenance and beam recovery take about a week
 - Cool-down (high radiation fields and contaminated parts)
 - Complex work, alignment involved in a difficult space
 - Vacuum recovery
 - RF conditioning

Affects both **beam amplitude** before the repair and **uptime**
