RADIATION DAMAGES AND CHARACTERIZATION IN THE SOLEIL STORAGE RING

N. Hubert[#], N. Béchu, P. Brunelle, L. Cassinari, C. Herbeaux, S. Hustache, J-F. Lamarre, P. Lebasque, F. Marteau, A. Nadji, L. S. Nadolski, Synchrotron SOLEIL, Gif-sur-Yvette, France

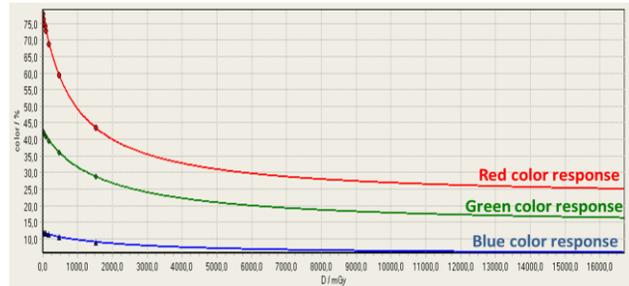
Calibration curves show a good sensibility to radiation for the red (low dose) and the green (high dose) colours, while the blue cannot be used (Fig. 5).

Figure 5: Calibration curves: amplitudes of the red, green and blue colours in function of the dose. For their better sensitivity only red and green can be used for dose measurement.
