# *Beam Commissioning Status of Superconducting Crab Cavities in KEKB*

MOOCMH03  
(May/2010)

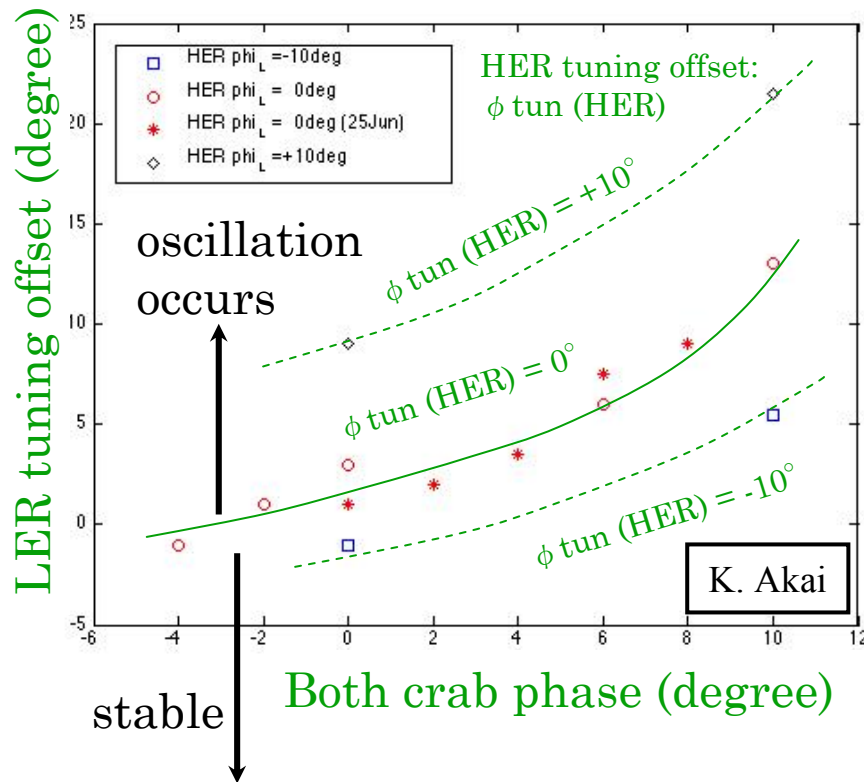
Oscillation phenomenon was observed at high beam current in beginning of beam commissioning in 2007.

Tuning phase offset :  $+5^{\circ}$  (HER)  
 $-8^{\circ}$  (LER)

crab phase :  $>+10^{\circ}$  (HER/LER)

Oscillation is suppressed!

Akai-san found remedy for suppression of this oscillation.
