ANALYSIS OF KICKER NOISE INDUCED BEAM EMITTANCE GROWTH*

W. Zhang[#], J. Sandberg, L. Ahrens, M. I. Blackler, J.M. Brennan, M. Blaskiewicz, W. Fischer, H. Hahn, H. Huang, N. Kling, M. Lafky, G. Marr, K. Mernick, J. Mi, M. Minty, C. Naylor, T. Roser, T. Shrey, B. van Kuik, A. Zelenski, BNL, Upton, NY 11973, USA

Over the last few years, physicists have occasionally observed the presence of noise acting on the RHIC beams leading to emittance growth at high beam energies. While the noise was sporadic in the past, it became persistent during the Run-11 setup period. An investigation diagnosed the source as originating from the RHIC dump kicker system. Once identified the issue was quickly resolved. We report in this paper the investigation result, circuit analysis, measured and simulated waveforms, solutions, and future plans.

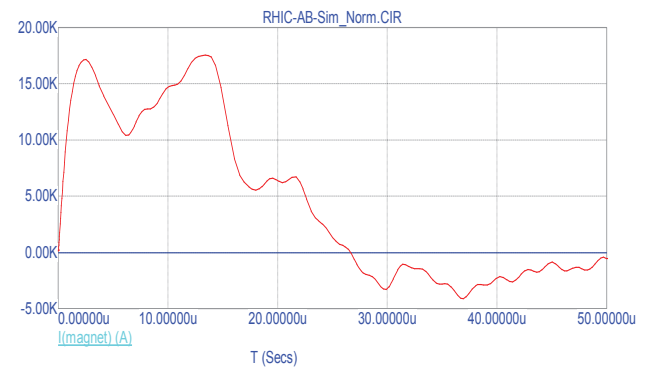
Figure 6: Simulated kicker current waveform at 27 kV charging voltage.

Each of the beam dump kicker modulators is capable of discharging up to 22 kA of pulsed current to deflect the beam. Its PFN voltage tracks the main dipole field from injection to full energy at store. In normal operation, it is charged to 27 kV, and the discharge current is 18 kA. Figure 6 shows the simulated current waveform.
