VACUUM BRAZING OF THE NEW RFQ FOR THE J-PARC LINAC

T. Morishita*, Y. Kondo, K. Hasegawa, JAEA, Tokai, Japan

Abstract

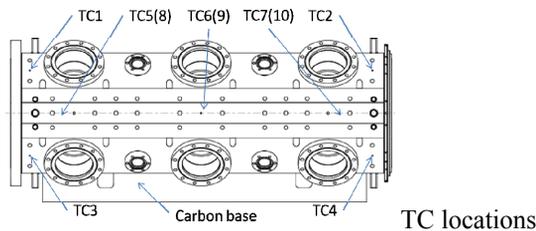
(numbers in parenthesis on opposite side)

We found the vacuum leak at the stainless-steel flange location indicated in Fig. 2. We speculate that nonuniform heating during the brazing was the cause. The heating speed of the vacuum furnace was set to be 300 degrees C/h from the room temperature up to 600 degrees C. This heating speed may have been too fast for uniform heating of the vanes. Figure 3 shows the measured temperature

We think that the leaking flange was pushed out by the unequal differential thermal expansion of the vane and then brazed at a mismatched position. We tried re-brazing by putting additional brazing alloy near the leak, however, the vacuum seal failed. We then removed the stainless-steel flange with a dry-cutting method and re-brazed. The method of securing the stainless-steel flange was changed from the staking to bolting with a compression spring. The spring is made of a carbon fiber composite. The strength of this spring is constant in a temperature range up to 1000 degrees C.

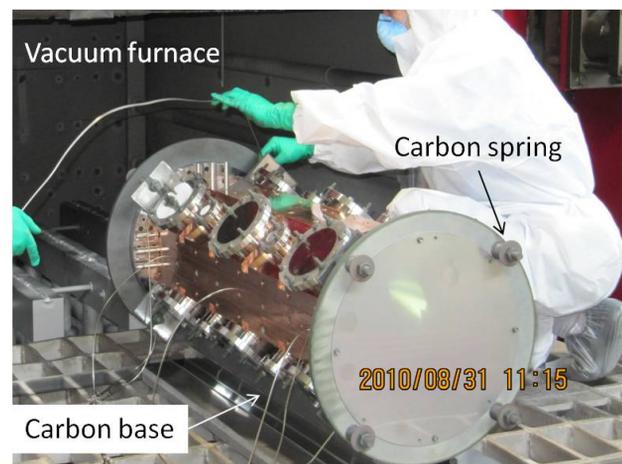
Figure 4: Setting the TCs on the cavity to monitor the temperature during the brazing.

At the brazing of the first unit, the major vane in the bottom position became hotter than the other vanes. The heat flow from the carbon base (where the blackness and thus temperature is higher) should be decreased. Therefore, we put ceramic spacers between the bottom

face of the cavity and the carbon base, and in addition the carbon base was covered by a stainless-steel plate.
