OVERVIEW OF RECENT STUDIES AND MODIFICATIONS BEING MADE TO RHIC TO MITIGATE THE EFFECTS OF A POTENTIAL FAILURE TO THE HELIUM DISTRIBUTION SYSTEM *

J. Tuozzolo, D. Bruno, A. Di Lieto, G. Heppner, R. Karol, E. Lessard, C.J. Liaw, G. McIntyre, C. Mi, J. Reich, J. Sandberg, S. Seberg, L. Smart, T. Tallerico, Y.R. Than, C. Theisen, R. Todd, R. Zapasek, BNL, Upton, NY 11973, U.S.A.

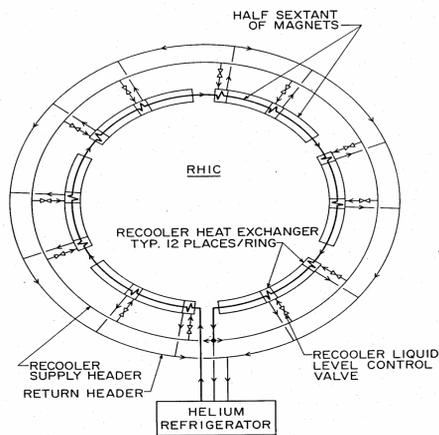
Figure 1: RHIC Distribution System.

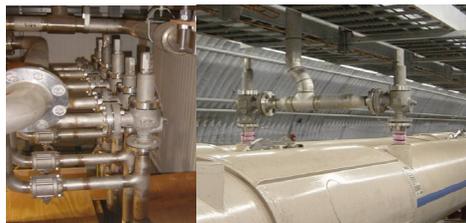
RHIC was designed to be pressurized as high as 17 atm. in the magnet line. This allowed significant overhead for quench events and for long power interruptions. During construction and after major repairs the piping was tested to 10% over this value in accordance with ASME code requirements. All of the distribution piping in the RHIC tunnel and in valve boxes in the RHIC service buildings have relief valves which vent outside the enclosures (Fig. 2) to prevent off normal events from creating ODH issues.

Figure 2: Process Line Reliefs with External Vents.
