# INSPECTION AND REPAIR TECHNIQUES FOR THE EXFEL SUPERCONDUCTING 1.3 GHz CAVITIES AT ETTORE ZANON S.P.A: METHODS AND RESULTS

G. Massaro<sup>#</sup>, N. Maragno, G. Corniani, Ettore Zanon S.p.A, Schio, Italy  
 C A. Matheisen, A. Navitski, DESY, Hamburg, Germany  
 P. Michelato, L. Monaco, INFN Milano-LASA, Segrate, Italy

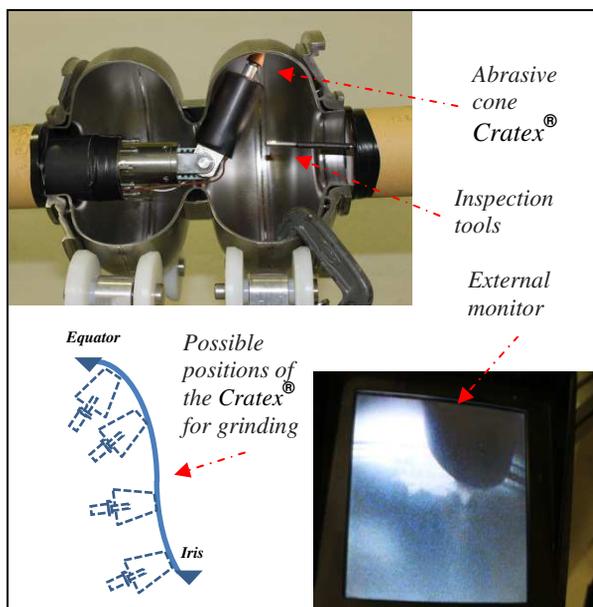
Figure 2: Grinding tool and possible grinding area.

As shown in Fig. 2, the grinding system is able to remove the defects on the equator and iris welds and on the tapered area of the cells.

The Cratex<sup>®</sup> cones are mounted on the head of the grinding tool (see Fig. 2). A "position controller", located on the opposite side of the rod defines the angular position of the grinding head, and the longitudinal positioning is performed by displacement of the whole grinding tool on the table guides.

The grinding operation starts with the coarse-grained abrasive cones and is monitored by means of the Extech HDV600, boroscope connected to an external monitor (see Fig. 2).

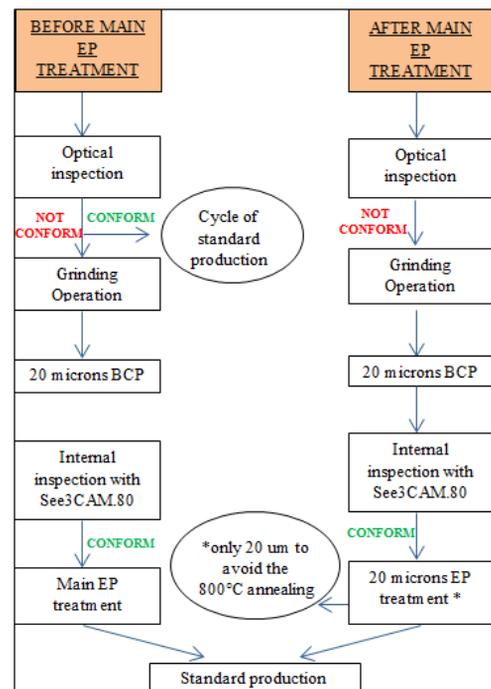
Figure 3: Production cycles after grinding operation.

After the complete removal of the defects, as confirmed by the optical inspections both at EZ and DESY (see Fig. 4), the cavity has followed the production cycle according to the scheme shown in Fig. 3.

The defects have been successfully removed with the grinding techniques, as shown in Fig. 6 and the cavity has followed the production cycle according to the scheme shown in Fig. 3 for the cavities that received already once the main EP treatment.
