# **Study of the Lead Evaporation from the Oven of the GTS-LHC Ion Source**

## **The GTS-LHC Micro Oven**

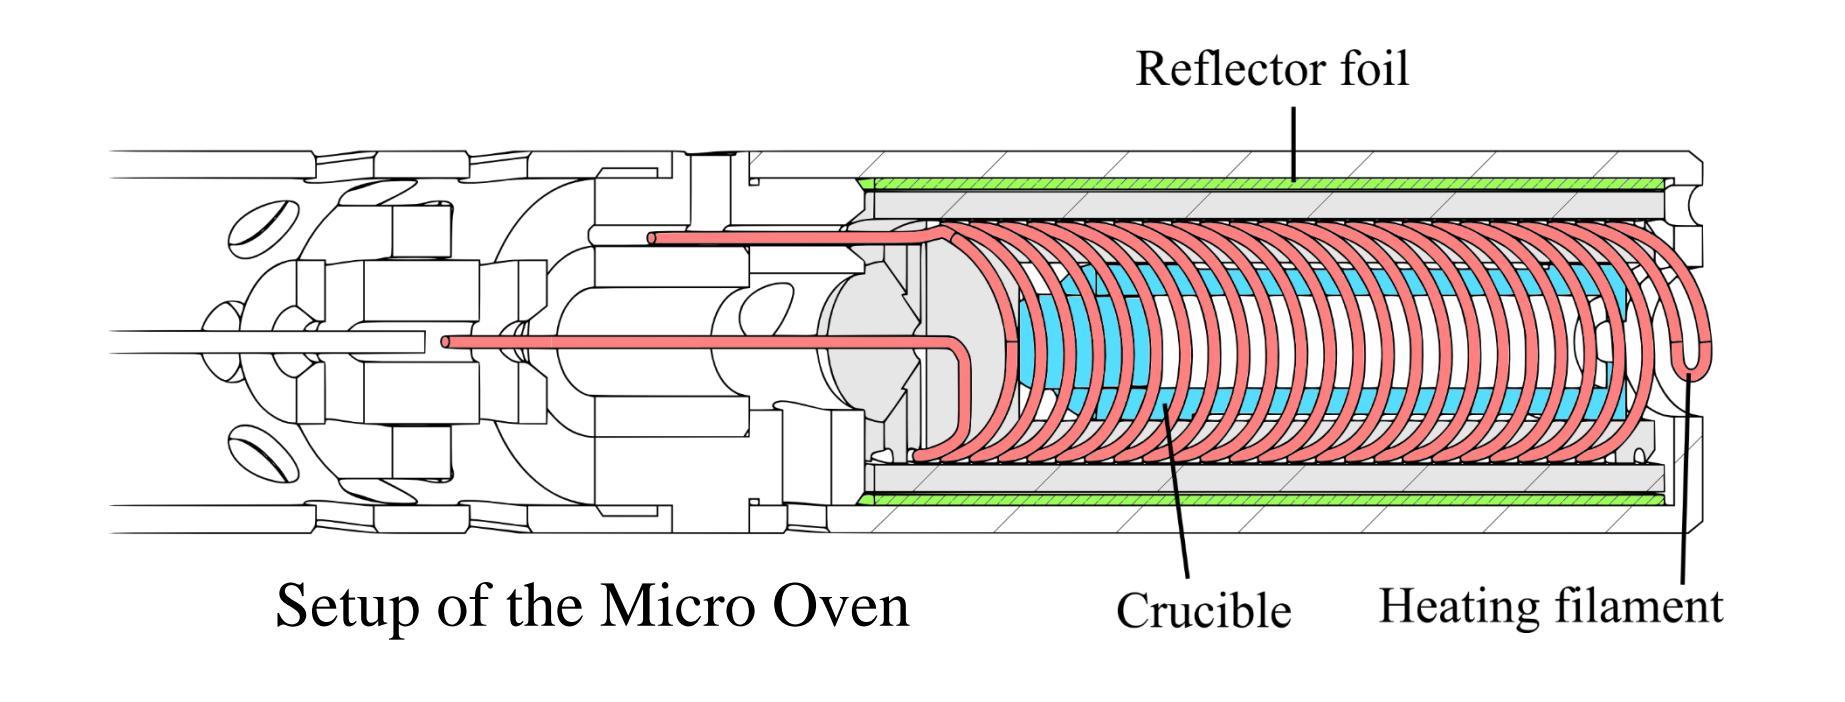
- Lead for evaporation is inside a manually filled crucible.
- Resistively heated with a tantalum filament wound as a double helix.
- Outside layers help to insulate and distribute heat evenly over the crucible.

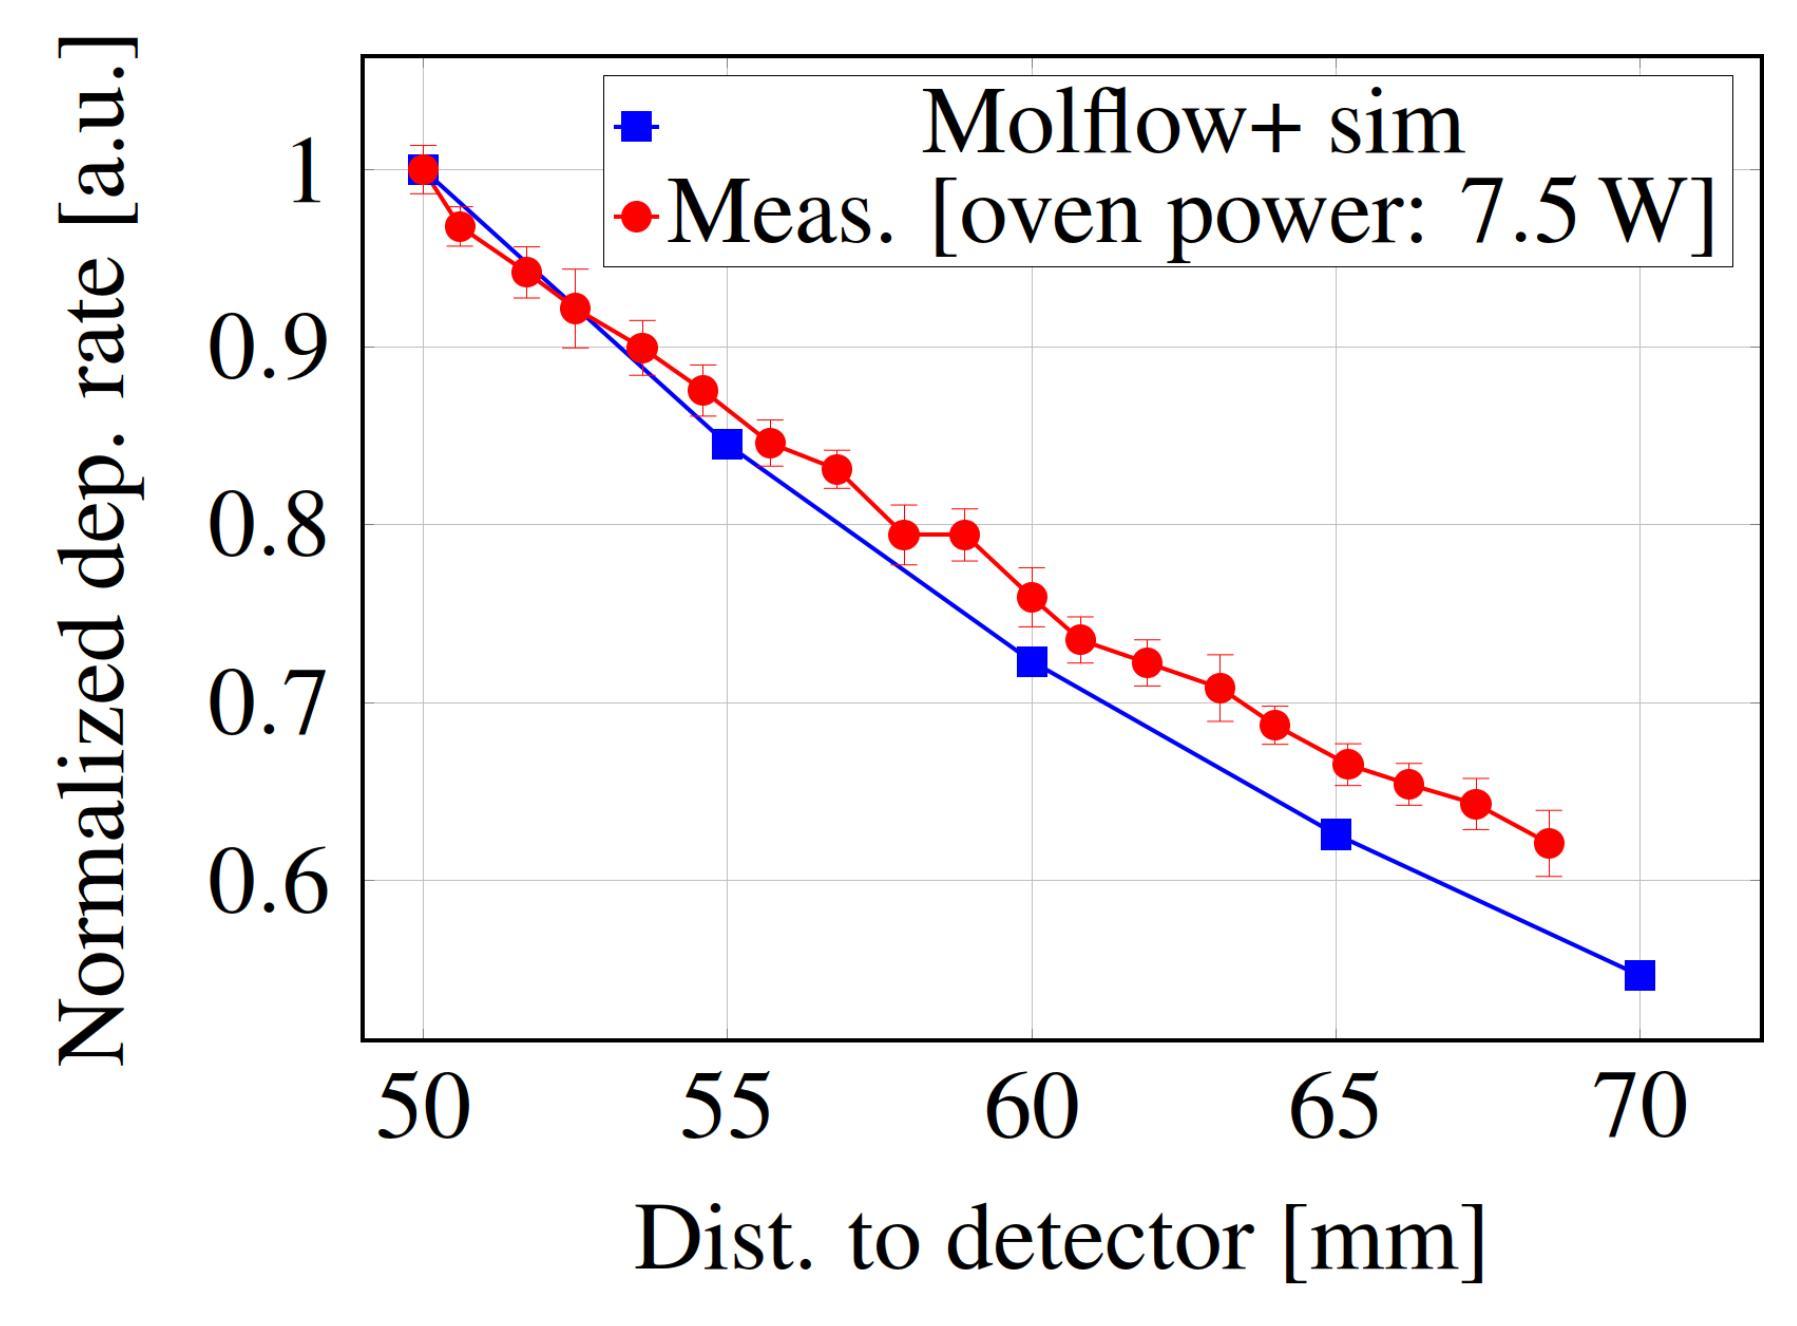
Molflow+ predicts the signal reduction on the deposition sensor when the oven is moved away from the detector at a stable evaporation rate. This can be tested:

The simulation can be used to study the deposition of lead on the inner oven cover.
