SNS Injection Foil Experience

HB2010

By Mike Plum, Ring Area Manager

Brief history of SNS stripper foils

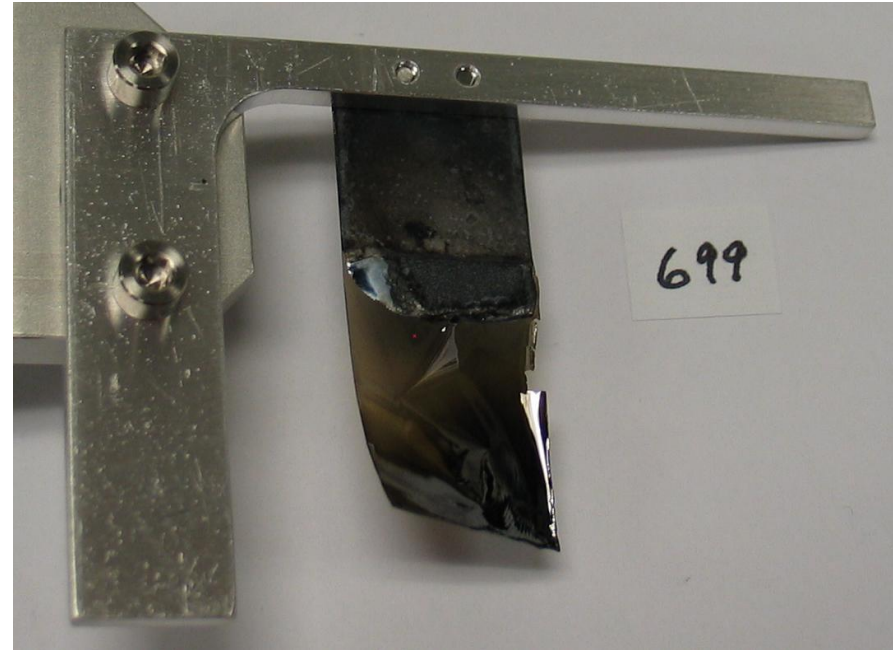
New foil

Typical foil damage before May 3, 2009

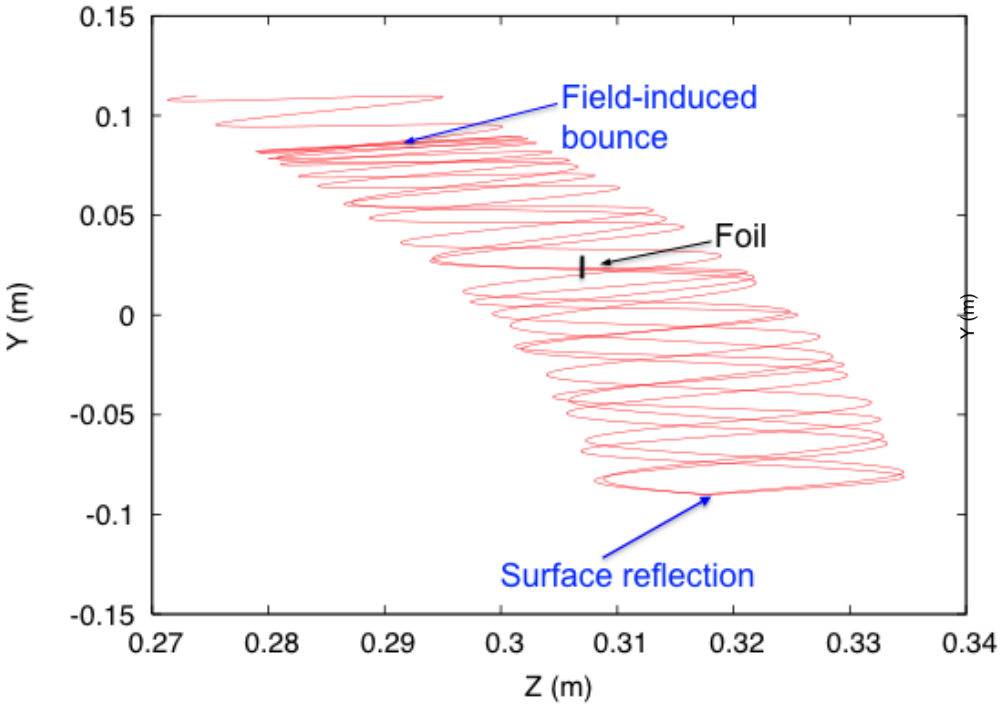
Simulation - Side view

Reflected convoy electrons (S. Cousineau)

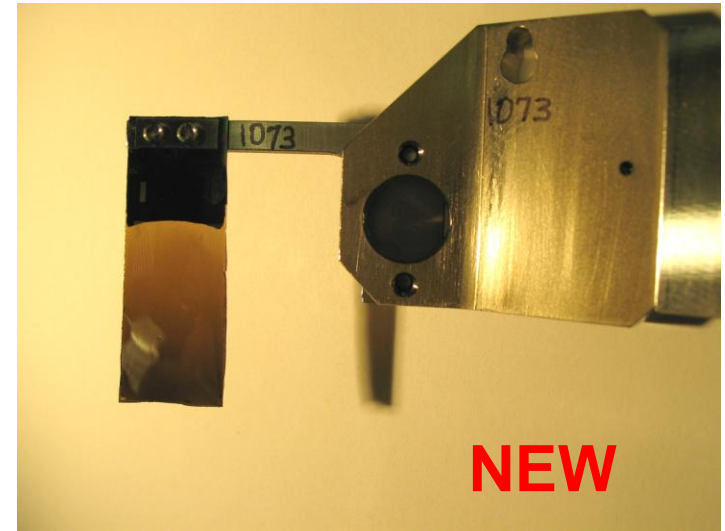
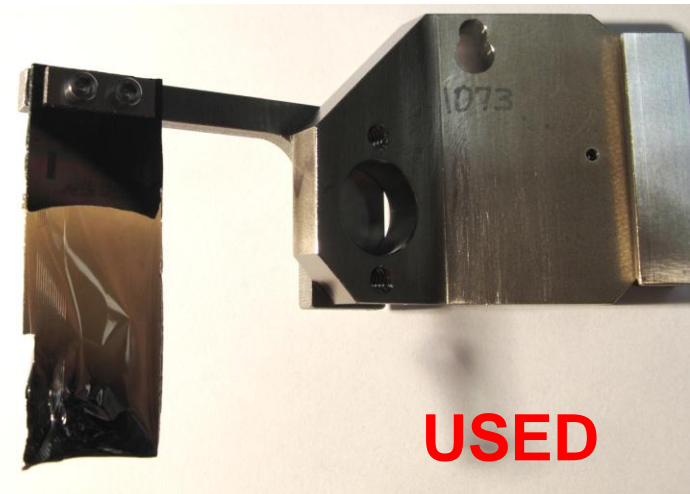
Foil and bracket modifications

- A single foil was used for each of the next two run cycles.

- High-temperature material with low coeff. of thermal expansion (Ti)
- Bracket material removed from path of convoy electrons (both arm and leg cut off)
- All foils mounted at the “+1 cm” position
- Bracket arm and clamp are machined flat and then polished for good electrical contact

- Longer free-standing length (was 25 mm, now 30 – 35 mm)

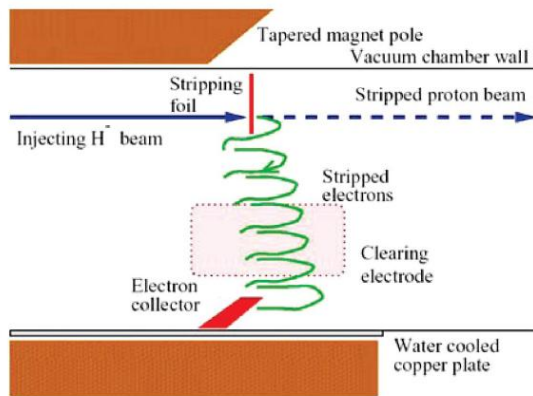
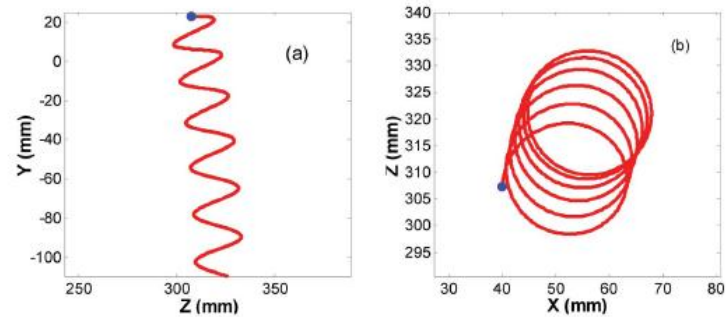
- Prior to May 18, when we installed a new type of foil bracket, the main cause of foil failures was due to convoy electrons hitting the foil brackets

FIG. 2. (Color) Trajectory of a stripped electron from the foil's center. (a) Orbit in vertical and longitudinal plane and (b) in horizontal and longitudinal plane. The blue point is the position where the electron was emitted.

Convoy electrons from a 1 GeV H^- beam have 545 keV energy, gyroradius 12 mm, pitch $\sim 16 - 23$ mm. A 1 MW beam has ~ 1 kW power in the convoy electrons.
