Abstract

During high power tests of the 1.3 GHz LCLS-II cavity on the test stand at Fermilab an anomalous rise of temperature of the pickup antenna in the higher order mode (HOM) coupler was detected in accelerating gradient range of 5-10 MV/m. It was suggested that the multipacting in the HOM coupler may be a cause of this temperature rise. In this work the suggestion was studied, and the conditions and the location, where multipacting can develop, were found.

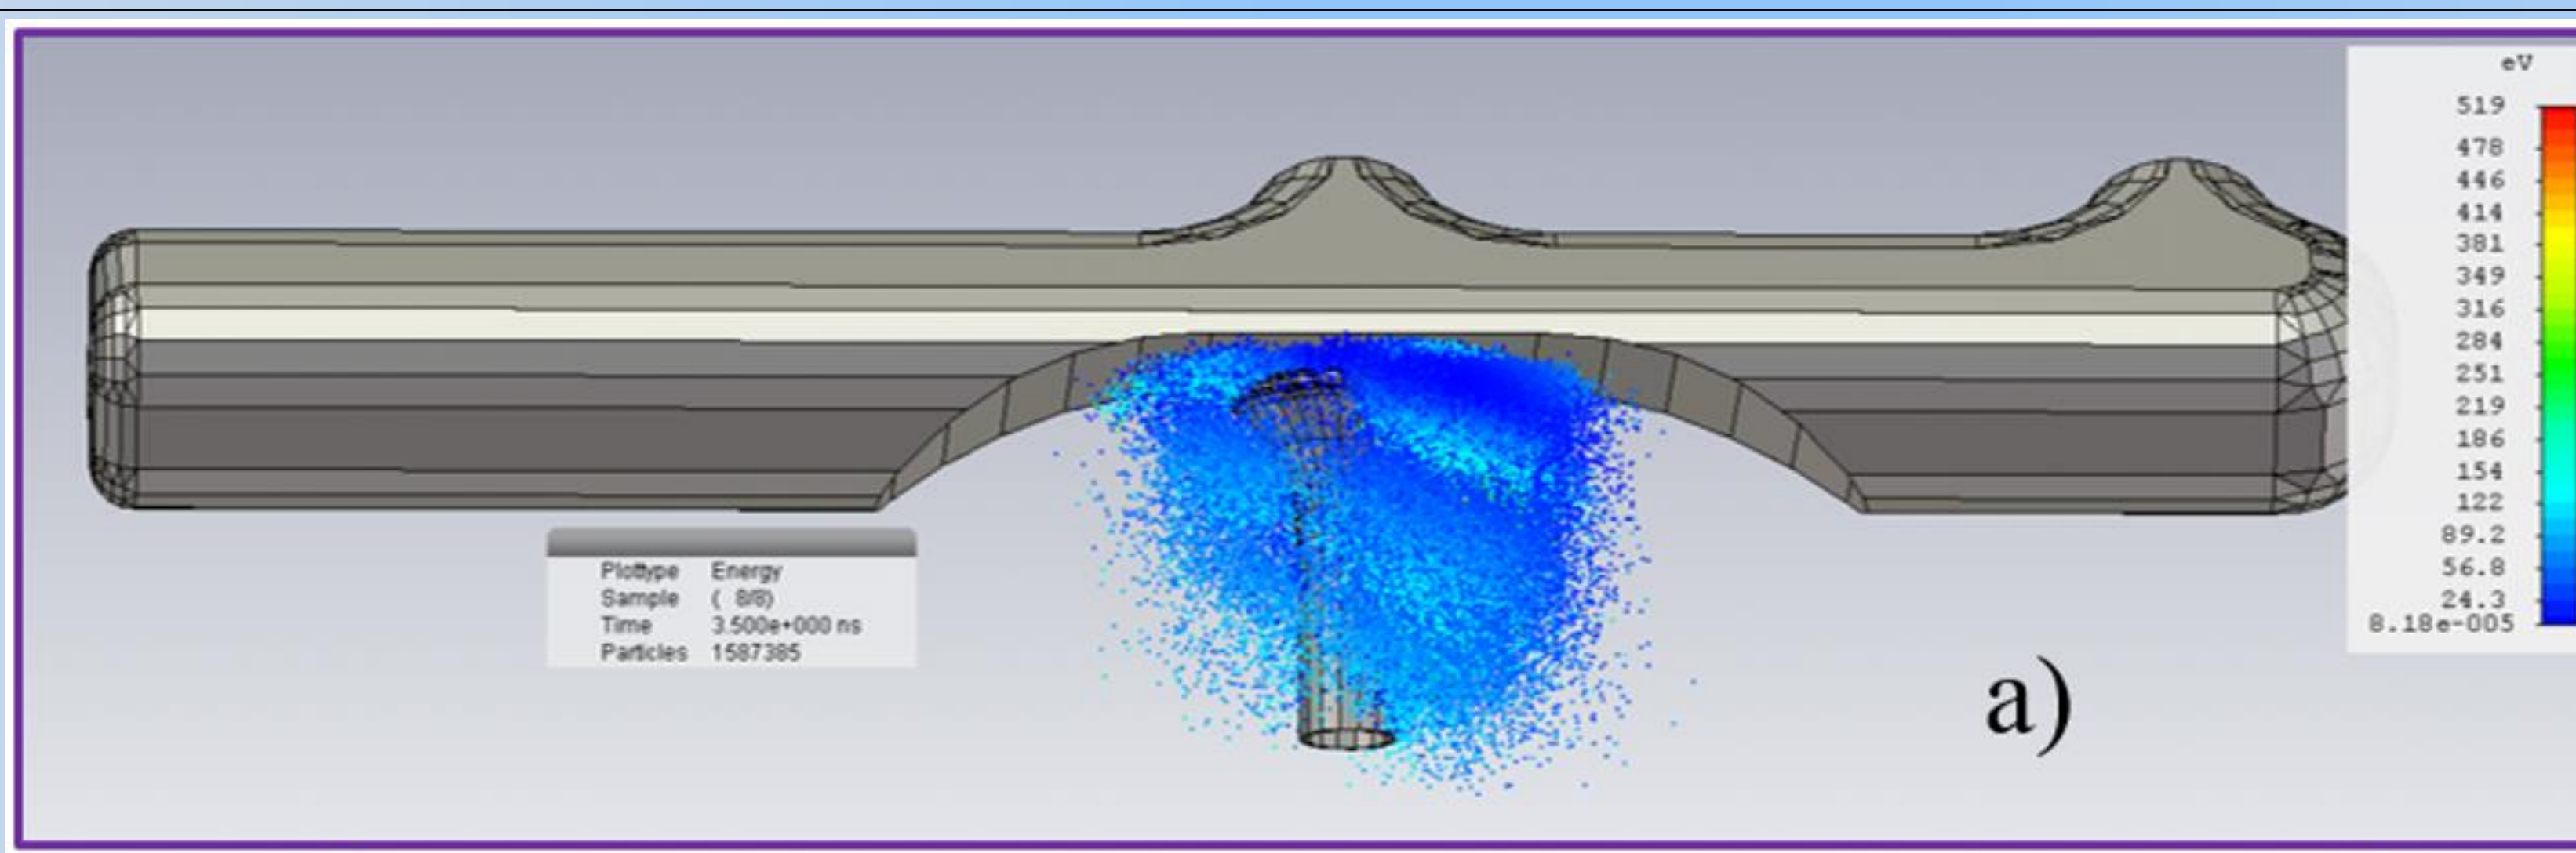
The MP process that could explain the antenna heating would be multipacting directly in the coupling gap. But normally for nominal gap size of 0.5 mm there is no conditions for multipacting, since parameter $f \cdot d < 80-90$ MHz·cm. On the other hand, parameter $f \cdot d$ is very sensitive and exceeds the threshold already at $d=0.615$ mm. It is possible that such small deviation can happen due to inaccurate assembly or misalignment. Additionally a deviation of the filter gap size from optimal value redistribute the fields and increases uniformity and average level of electric field component normal to the antenna tip surface.
