AUTOPSY RESULTS OF FAILED LITHIUM COLLECTION LENSES AT THE FNAL ANTIPROTON SOURCE*

P. Hurh[#], A. Leveling, FNAL, Batavia, IL 60510, USA

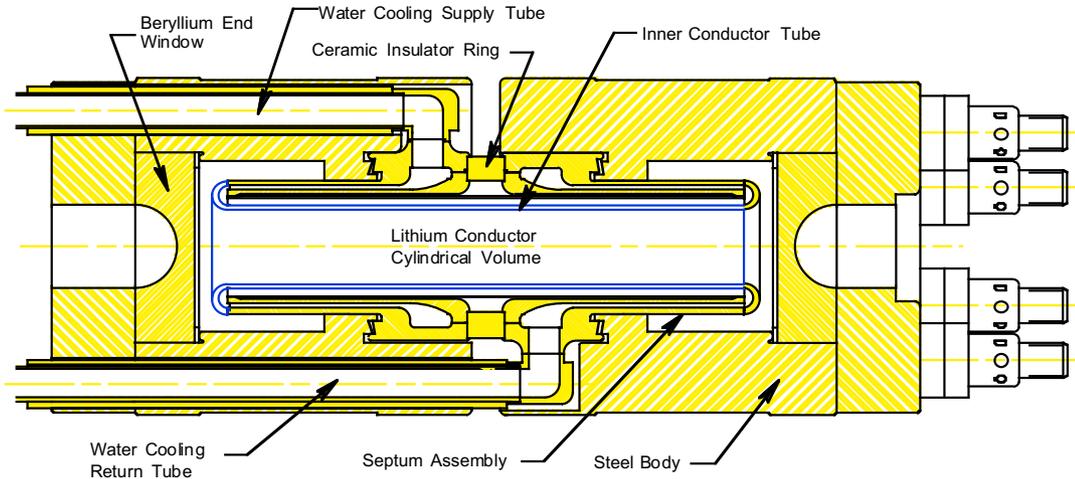
Figure 1: Cross-section diagram of Collection Lens Device. Septum conductor tube is shown in blue.

The cross-section of the Lens assembly and septum is shown in Figure 1. The septum of a Collection Lens serves two functions. Firstly, it contains the structurally soft lithium in the cylindrical shape of the central conductor. Secondly, it cools the central lithium conductor by removing heat deposited by the current pulse and the beam pulse from the conductor into a Low Conductivity Water (LCW) system.

The most highly stressed part of the septum is the conductor tube. Stresses arise from several loading sources such as thermal expansion from the current pulse (nearly 500 kA at operating gradient) and the beam pulse, magnetic forces from the current pulse, and structural loading from clamping bolts and lithium filling pre-load. This tube directly contacts the lithium central conductor cylinder on its inner radius surface (1 cm radius) and directly contacts longitudinally flowing LCW on its outer radius surface. The conductor tube wall thickness is 1 mm. It is this conductor tube of each Lens that was the subject of this investigation.
