EXPERIENCES ON RETREATMENT OF EU-XFEL SERIES CAVITIES AT DESY

A. Matheisen, B.v.d. Horst, N. Steinhau-Kühl, N. Krupka, P. Schilling, S. Saegebarth
DESY Hamburg, Germany

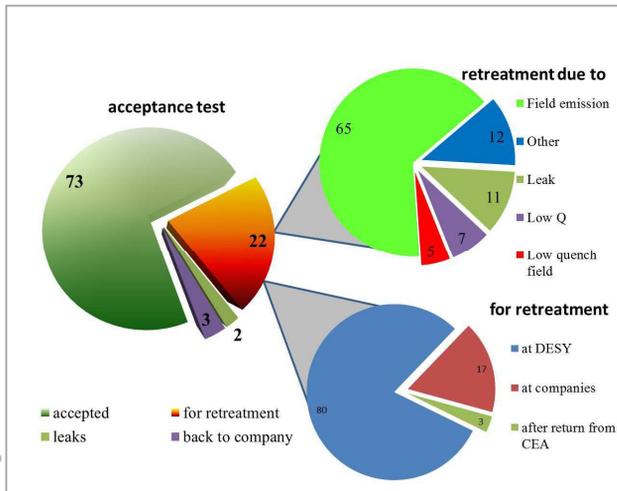
Figure 3: Ratio, given in percent, of 671 resonators tested after delivery that required a retreatment.

From the about 671 cavities, tested as received from industry until July 2015, about 22 % need to be retreated (Fig. 3).

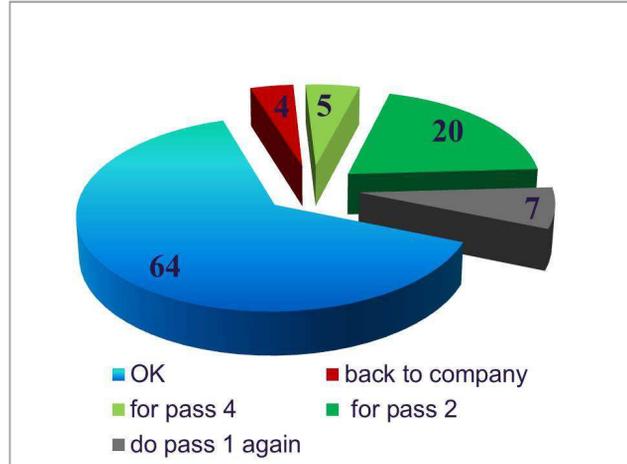
With first retreatment at DESY by pass RP1 more than 64 % of the cavities could be recovered. 20 % had to be retreatment in a second time, 4 % were send back to company after analysis of limitation and 5 % were dedicated to pass RP4. 7 % of the resonators showed a leak or requested special investigations before further treatment by redoing RP1 again (Fig. 4).

Figure 4: Success rate in percent for 155 cavities after 1st retreatment by RP1.

In average the usable gradient improved by 8 MV/m after 1st retreatment with sequence RP1.

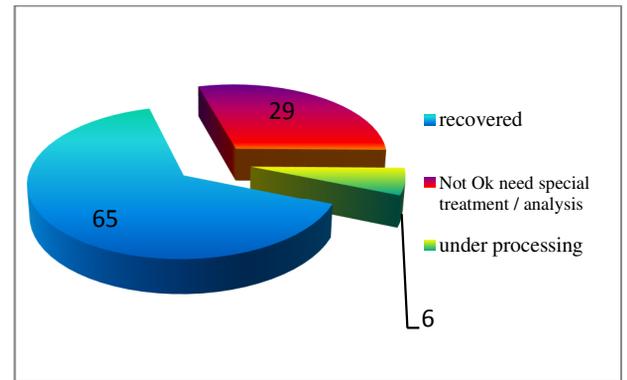
After 2nd retreatment by BCP +120 °C baking (pass RP2) more than 65 % recovered and were installed to modules (Fig. 5).

Figure 5: Success rate (displayed in percent) for 17 cavities retreated by pass RP2 at DESY.

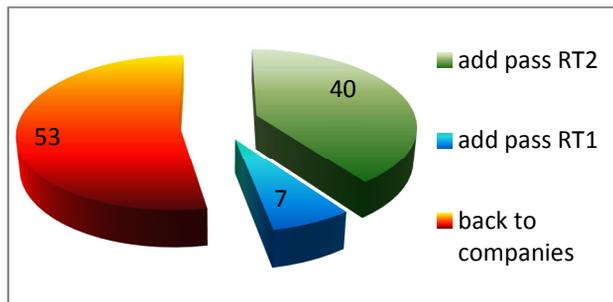
Resonators not recovering after pass RP1 and pass RP2 were applied, were inspected by the Obacht optical system in pass RP4. On all of them surface irregularities are found [3]. These cavities were sent back to companies for repair.

Figure 8: Decisions (displayed in percent) made for the 15 Cavities after pass RP4.

The company removed the cavities from the helium tank and repaired these areas [10]. Usable gradients up to 35 MV/m without field emission loading are reached after repair of the defects at the company [10].
