European XFEL: Accelerating Module Repair at DESY.

D.Kostin*, D.Reschke, S.Sievers, M.Wiencek, N.Krupka, S.Saegbarth, J.Schaffran, M.Schalwat, P.Schilling, M.Schmoekel, N.Steinhou-Kuehl, B.v.d.Horst, J.Eschke, K.Jensch, E.Vogel, H.Weise, DESY, Hamburg, Germany.

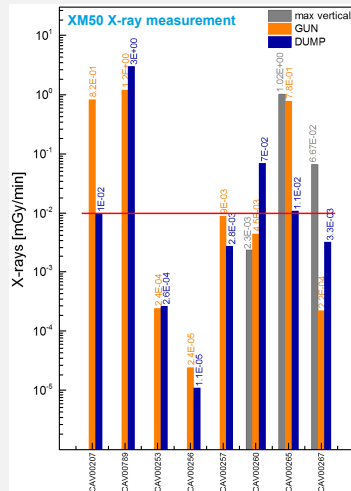
Module History

- Module XM50 was delivered to DESY in Jan. 2016 after the assembly at CEA (Saclay).
- Identified problems during the assembly:
 - Leak at angle valve;
 - Beam line leak;
 - Beam line pumped accidentally before warm coupler parts were installed.
- Module XM50 1st test in Feb. 2016 showed a degradation of the cavities' performance – mostly with strong gamma radiation – dark current caused by field emission (see the diagram →).
- Decision was taken not to install/use the module XM50 in the Eu-XFEL and re-assemble it after cavities' re-treatment.
- After disassembly XM50 cavities underwent HPR at DESY: 7 cavities after HPR and VT were accepted for XM50.1 assembly. CAV00207 had a cold leak during 2nd VT and was accepted after the exchange of the flanges, another HPR and VT.
- XM50 re-assembled at DESY to XM50.1 and tested in Apr. 2019: only one cavity (#2) degraded (without FE).
