# OPERATIONAL EFFICIENCY OF THE AIRIX ACCELERATOR SINCE ITS COMMISSIONING

H. Dzitko, V. Bernigaud, L. Buche, Y. Collet, S. Combacon, A. Georges, G. Gobert,  
B. Gouin, G. Grandpierre, M. Mouillet, R. Nicolas, D. Reynaud,  
CEA, DAM, DIF, F-91297 Arpajon, France,  
Polygone d'Expérimentation de Moronvilliers

AIRIX is a high current (20 MeV, 2 kA) electron linear induction accelerator used as a 60 ns single shot X-ray source in order to perform hydrodynamic tests using nonfissile substitution materials within the frame of the so-called CEA Simulation Program.

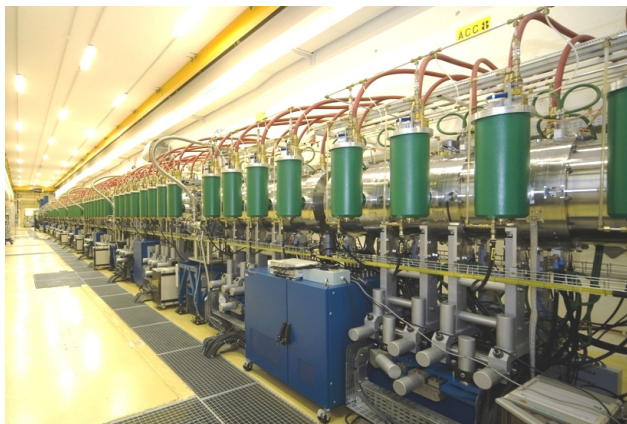
Figure 1: View of the 64 AIRIX induction accelerating cells. Each cell delivers 250 kV to the 2 kA electron beam.
