STATUS OF E-XFEL STRING AND CRYOMODULE ASSEMBLY AT CEA- SACLAY

C. Madec, CEA-Saclay, IRFU/SACM

CEA contributes to the
E-XFEL Cold Linac construction
through
String Assembly in Clean Room (WP9)
and **Module Assembly (WP3)**

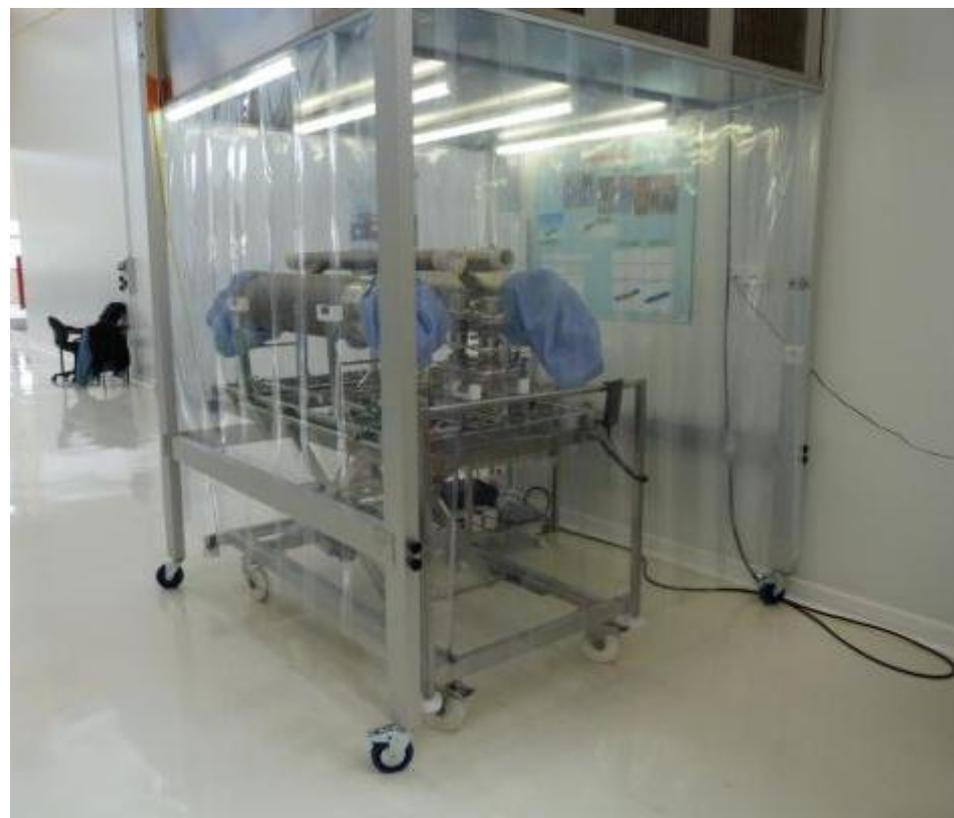
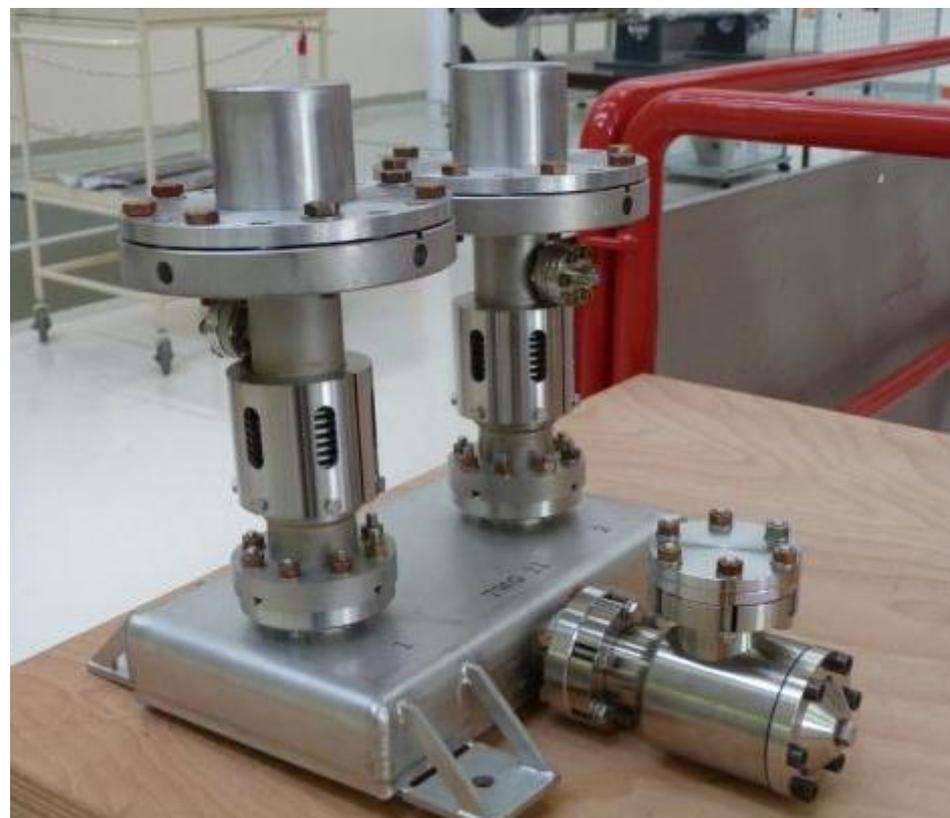
Cavity and Coupler Reception (ISO5-CR-WS1)

0.a Cavity and coupler reception

0.b Cavity and coupler washing

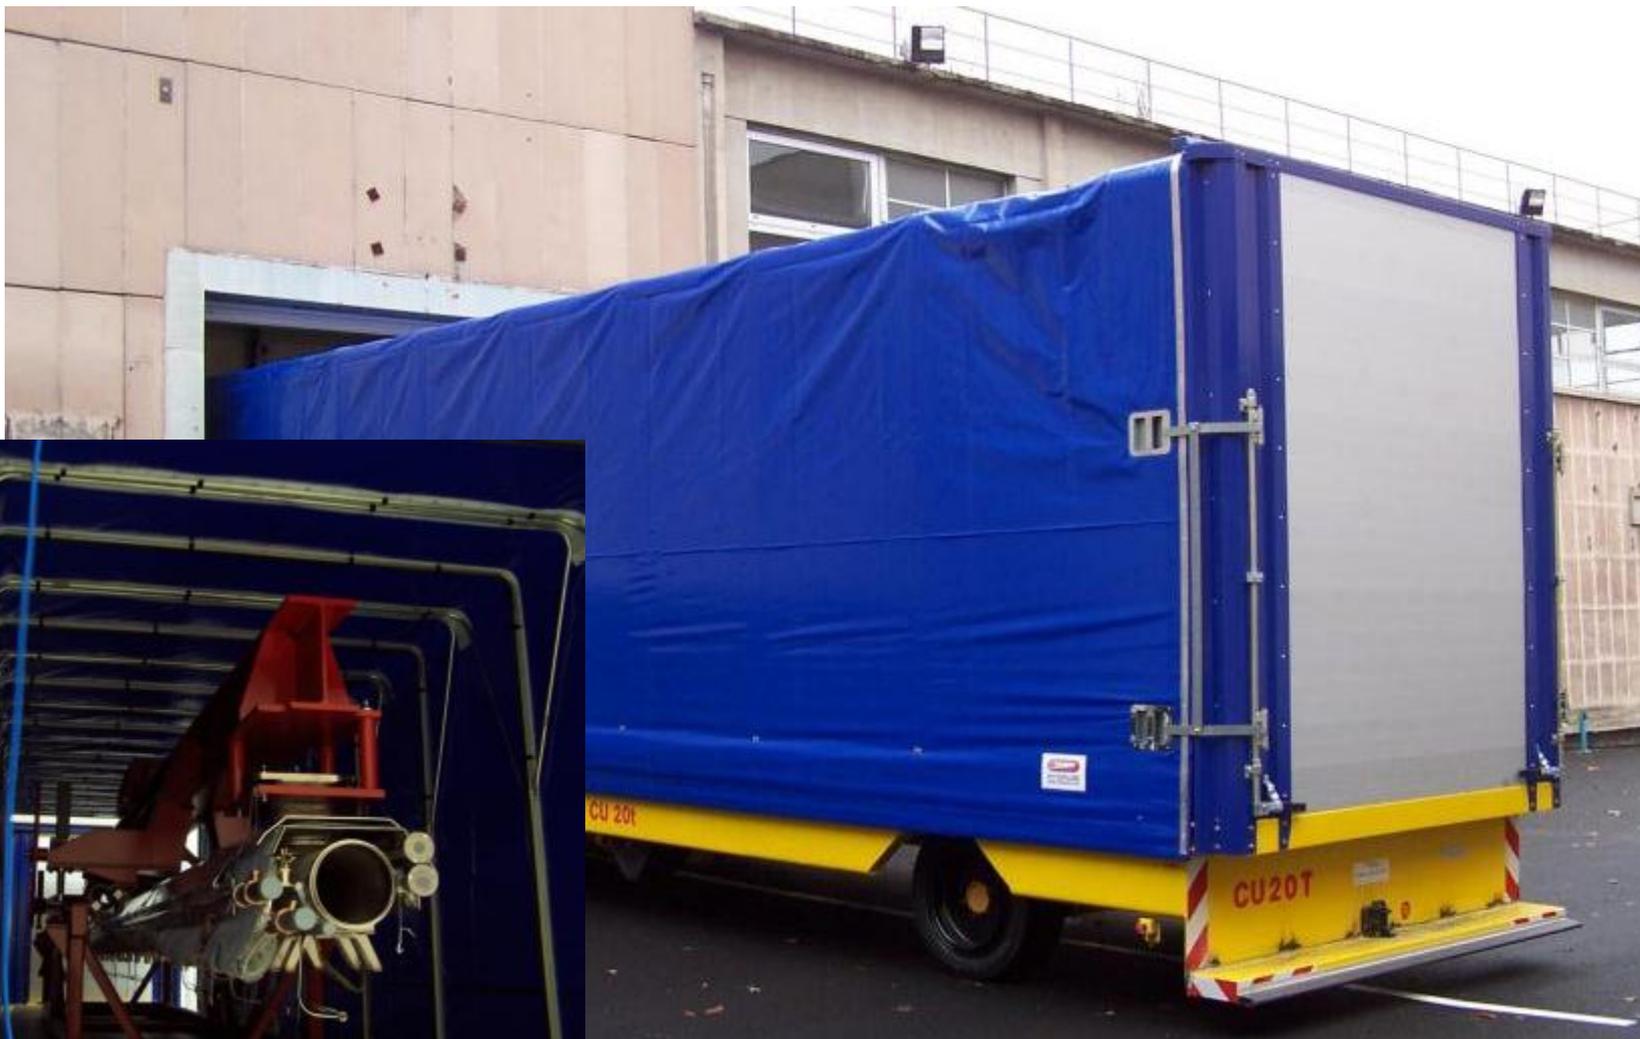
The electrical transfer vehicle is fully operational.
Spares have been ordered for all critical parts (e.g. battery, etc...)

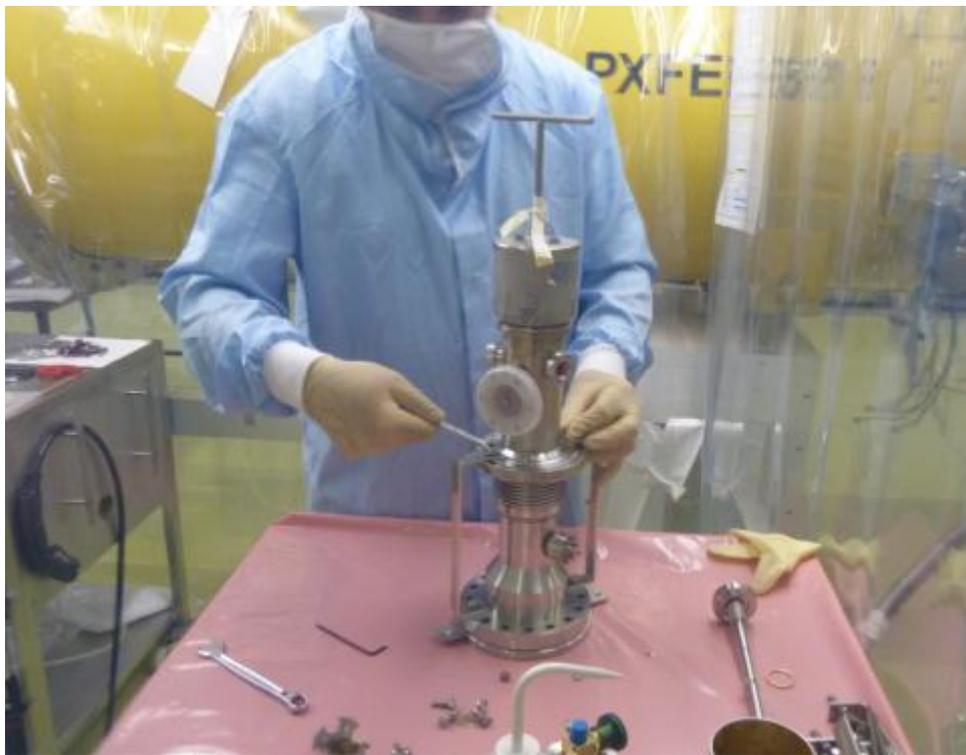
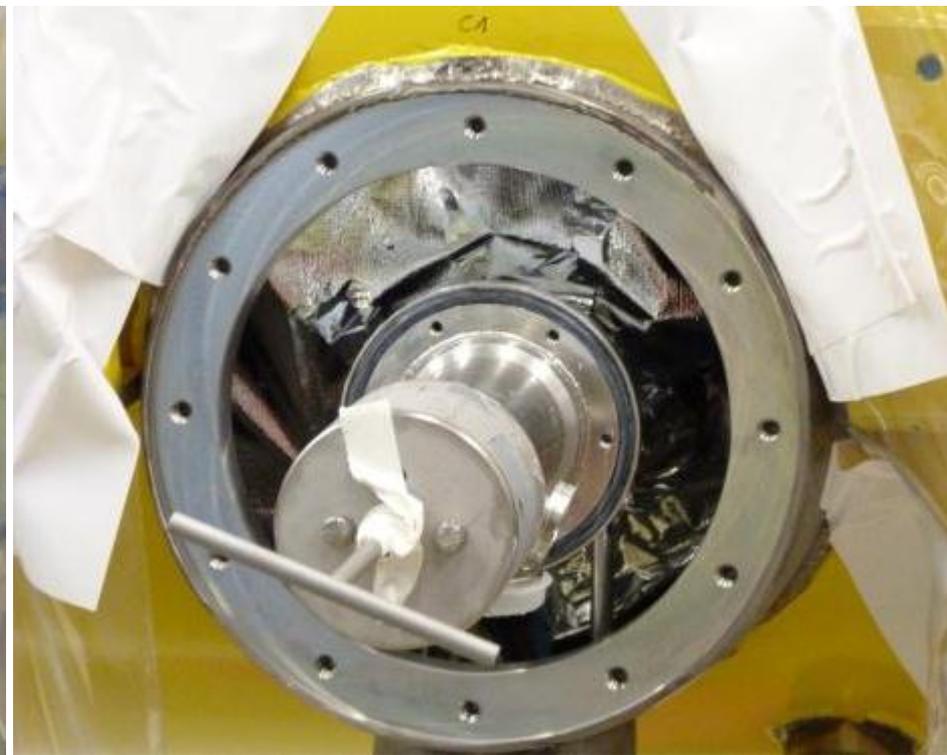
5. Coupler Warm Part assembly (CO-WS1&2)

5.a coupler warm part assembly

5.b coupler pumping line assembly

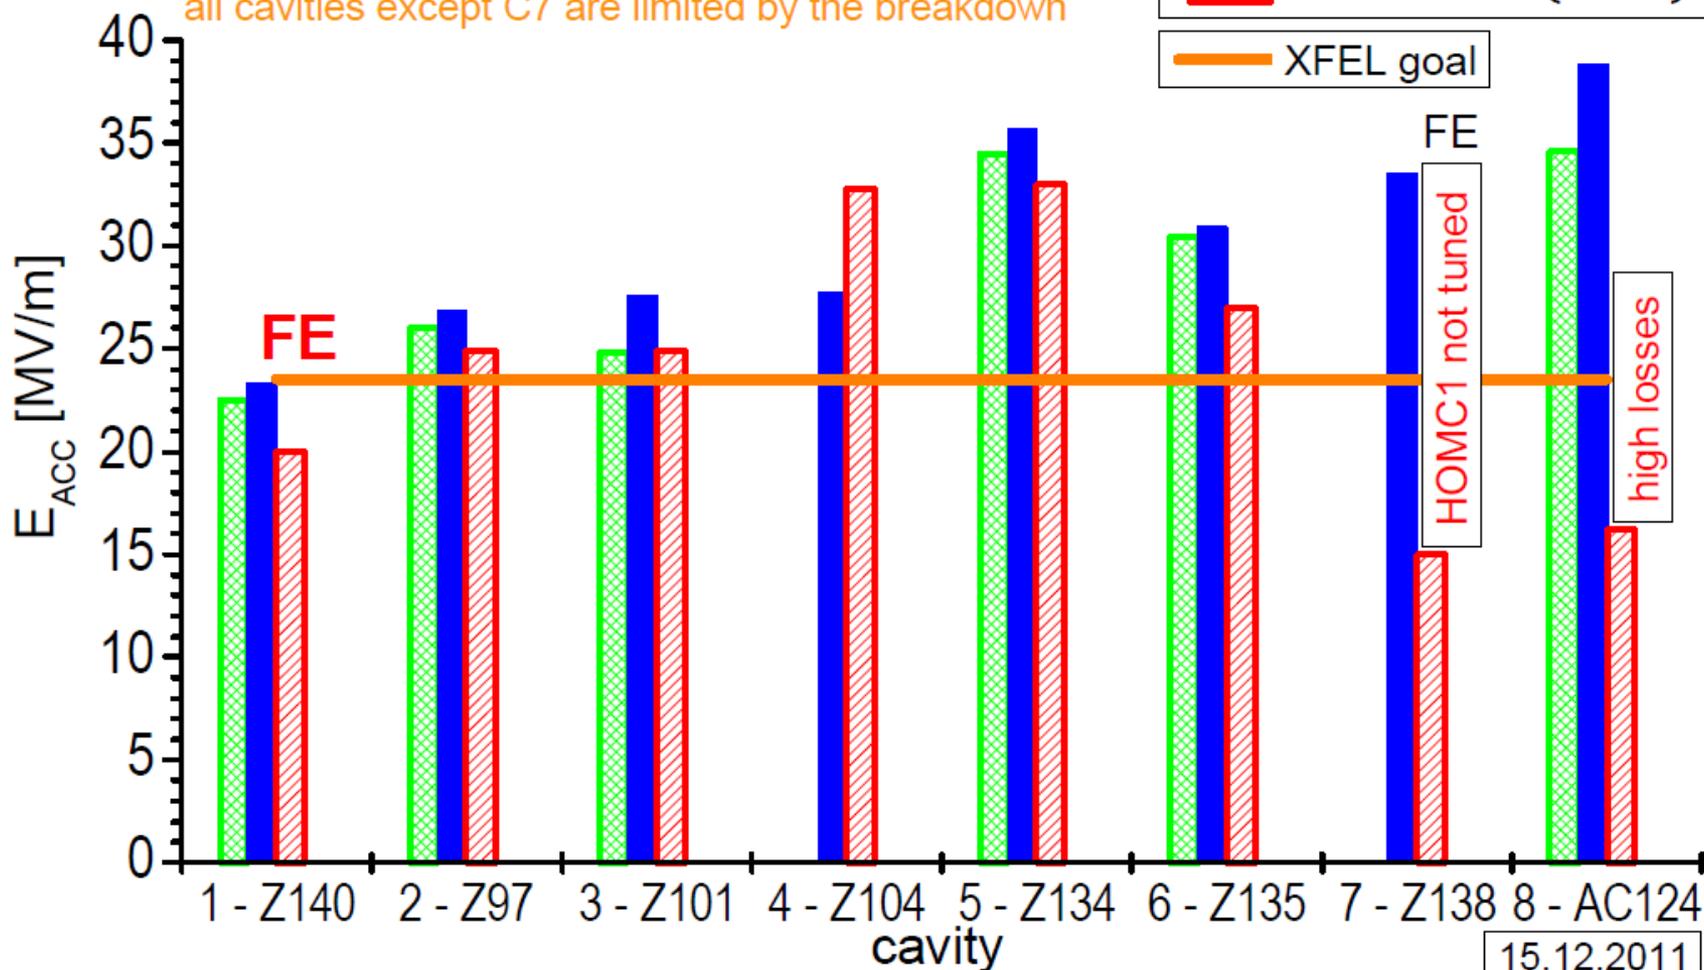
PXFEL3_1 CMTB Test

Cavities gradient limits

all cavities except C7 are limited by the breakdown

- PXFEL3_1 : cavity 1 (FE) and cavity 8 (HL) do not reproduce their VT performances. The causes is not identified:
 - coupler contamination through common waveguide box ?
 - particulate contamination during string assembly ?
 - shocks during transport CEA-DESY: (4g on frame, 1g on cryomodule) + (2g on frame ,2g on CM) events ?

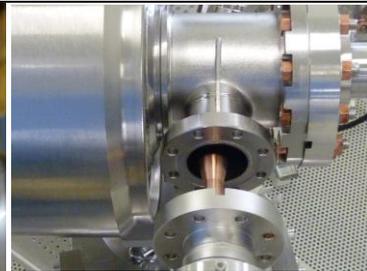
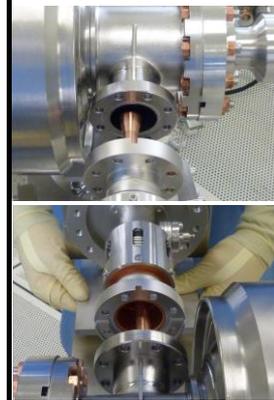
Example:

| Irfu | | European XFEL | | NON CONFORMANCE REPORT / CHANGE REQUEST | | Reference |
|--|---|---|---|---|---|---|
| The coupler antenna is tilted in the horizontal plane, the coupler being in the support frame ready for connection to the cavity. The bellow holders were in position and tighten. | | | | | | |
| The tilt of antenna axis was estimated at the half of the slot flange (for the leak test) i.e. 2.5 mm at the top of the antenna the tilt was about approximately 4 mm (cf. drawing page 4). | | | | | | |

tilted coupler antenna

| Irfu | | European XFEL | | NON CONFORMANCE REPORT / CHANGE REQUEST | | Reference |
|--|---|---|---|---|---|---|
| On Friday 17th, we dismantled the coupler AC3C2 from the cavity Z141 and checked the antenna (pictures page 2, during disassembly). The coupler is now mounted back on a TWG. | | | | | | MINOR : |
