# LHC COMMISSIONING AND FIRST OPERATION

S. Myers, CERN, Geneva, Switzerland

### Abstract

A description is given of the repair of the LHC after the accident of September 2008. The LHC hardware and beam commissioning and initial operation are reviewed both in terms of beam and hardware performance. The implemented machine protection measures and their impact on LHC operation are presented.

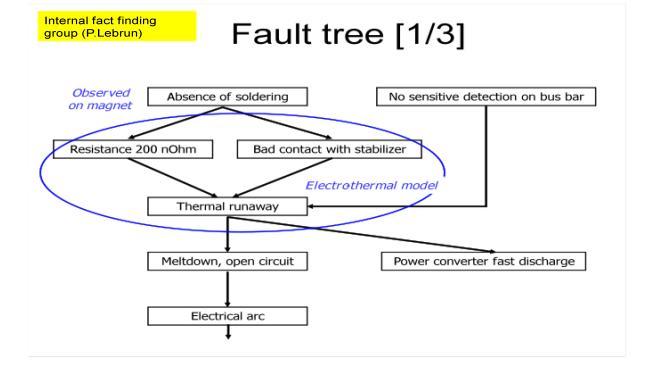
Figure 1 shows the first page of a three page fault tree describing in detail the evolution of events immediately following the thermal runaway.

Figure 1: Fault Tree following Investigation.

hnical
There was an absence of solder on the offending magnet interconnect giving a contact resistance of 220nΩ (design ~1nΩ)
There was poor electrical contact between the sc cable and the copper stabilizing bus-bar
The fault detection of the interconnect was not sensitive enough
The pressure relief ports were under-dimensioned

• The anchorage of the magnets to the tunnel floor was inadequate.

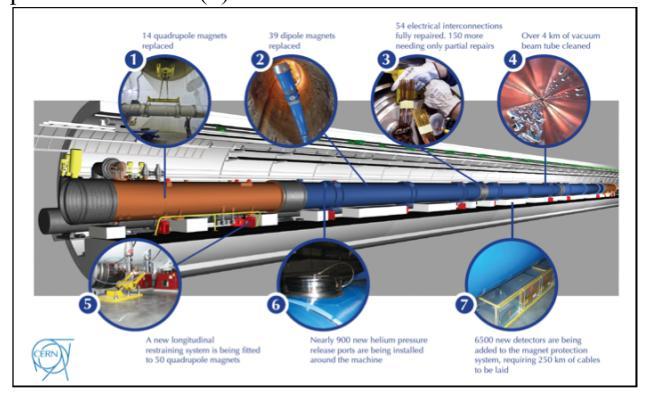
Figure 2 shows a schematic of the main elements of the repair in the damaged part of the tunnel. A total of 39 dipole magnets (marked 2 in diagram) were required to be

01 Circular Colliders A01 Hadron Colliders replaced. This of course used up all available spares. In addition 14 quadrupole magnets needed to be replaced (1) and a total of 54 damaged magnet interconnects needed full repair (3) with around 150 extra (3) needing partial repair. More than 4km of ultra high vacuum beam tube (4) required removal of pieces of super-insulation and black soot followed by careful cleaning [7]. A new longitudinal restraining system (5) was designed and installed on 50 quadrupole magnets. All existing flanges on the magnets were equipped with additional pressure relief ports (typically 10cm diameter) and 20 cm flanges were cut on dipoles and equipped with double size pressure relief ports. In total 900 helium pressure relief ports were added (6).

Figure 2: Schematic of the main elements of the repair.

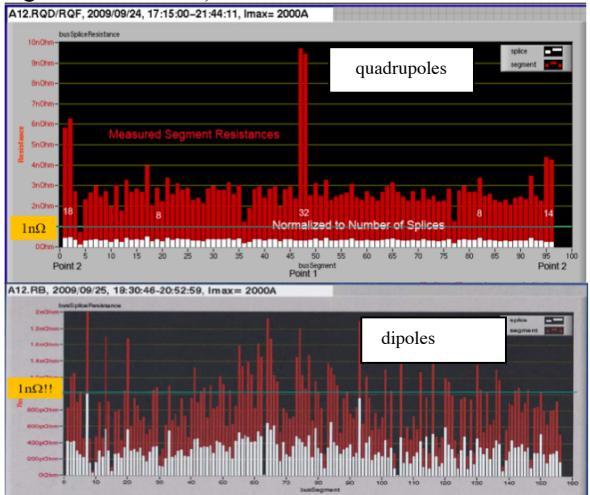
Figure 3: Measurements of the resistance of the sc intermagnet splice resistances (white lines are the calculated resistances of the splices).

A major task was the upgrade [8] of the magnet protection system which had proved too insensitive to fully protect the interconnect splices. The new design is now 3000 times more sensitive than the older system and involved 6500 new detectors (7) and the installation of more than 250km of cable. A major added advantage of the new magnet protection system was that it gives the possibility of measuring [9], to sub n $\Omega$  precision, the resistance of all inter-magnet splices in the machine (see Figure 3 for results).

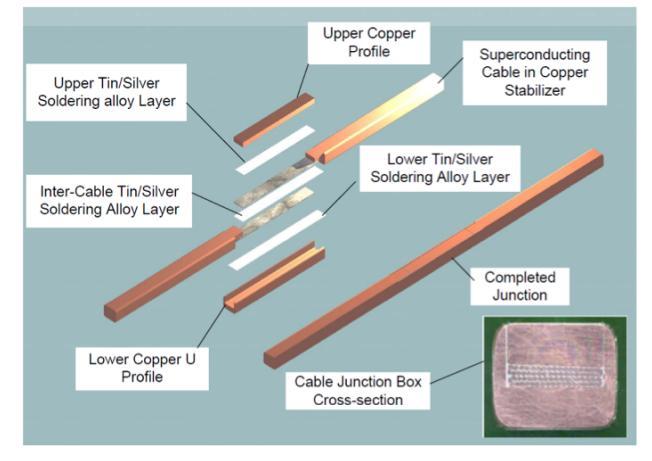
Figure 4: Exploded Diagram of an inter-magnet bus-bar.

The procedure for producing an inter-magnet bus-bar is depicted in Figure 4. The solder has two important functions, firstly to ensure good electrical contact between the two sc cable braids and secondly to ensure electrical continuity between the 2 copper profiles and the left copper sheath (bus-bar), and the right copper sheath. A little thought should indicate that if there is not electrical continuity across the copper stabilizer then the decaying current following a quench will flow through the sc cable which is no longer superconducting and possibly cause thermal runaway.

The completed inter-magnet bus-bar splice is designed for two separate functions. Firstly, at sc temperatures, to provide perfect electrical contact between the joined sc cable braids. And secondly, at non sc temperatures (in the event of a quench for example) to ensure electrical continuity across the copper sheath. Hence in the event of a quench and the sc cable has a finite resistance, the copper sheath "shunts" the current away from the sc cable while the stored energy is being extracted from the magnet. In this way the sc cable is protected in case of a quench by the large cross-section of the copper stabilizer.

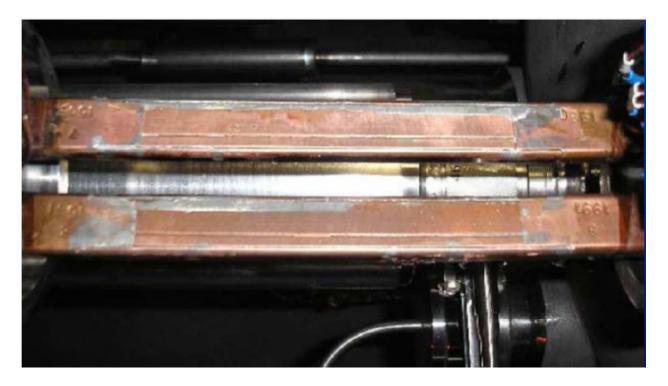
Figure 5 shows a photograph of a completed busbar as installed in the LHC.

Figure 5: Bus-bar as installed.

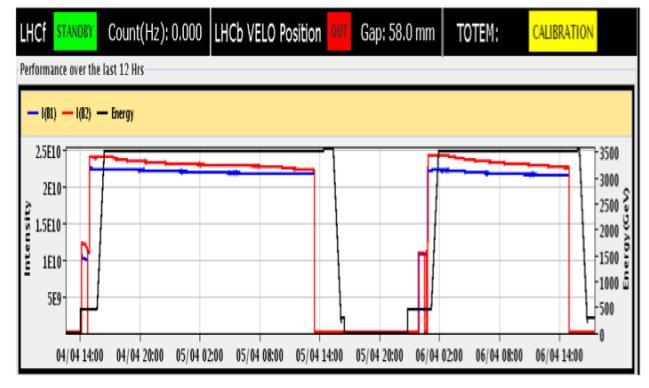
A special media day was organised for March 30, 2010 when the first collisions at 7TeV centre of mass energy was planned. Collisions were optimistically planned to occur at 09:17 precisely! In reality the first two attempts resulted in beam losses for minor technical reasons. On the third attempt at around 13:00 the beams were successfully brought into collision [11] to much applause and cheering. Figure 7 shows the first (and second) physics run at the new record collision energy.

Figure 7: First Physics Runs at 7TeV cm (blue/red plot is intensity of: beam 1/2 resp; black is the beam energy).

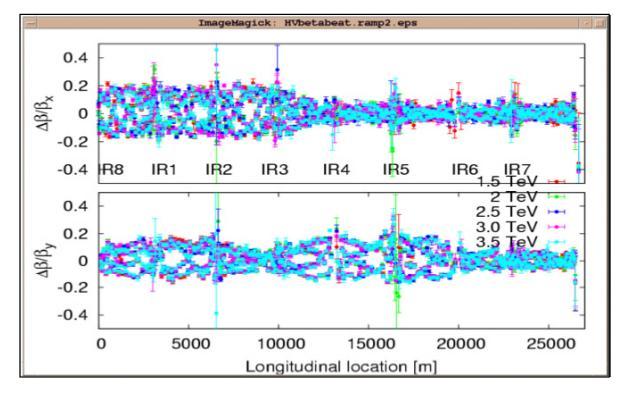
The collimation system [5] is part of the machine protection system and the collimators must intercept almost the totality of any beam losses if they are to protect the rest of the machine. The hierarchy of the collimation system (primary, secondary, and tertiary) must be respected. This implies a stringent control of the  $\beta$  functions and the closed orbits at the collimators at all beam energies and throughout the "squeeze" of the low  $\beta$  insertions. The  $\beta$  functions are measured and corrected [12] and the orbits are subjected to a feedback control with threshold limits. There is a watch-dog monitoring the orbit deviations at the locations of the collimators and if the limits are violated, the beam is dumped. A similar system is employed at the location of the beam dump extraction kicker. The tolerances set on the  $\beta$  "beating" is around 20% and Figure 8 shows measurements made at beam energies between 1.5 and 3.5TeV.

Figure 8: Measurement of the  $\beta$  beating at different energies.

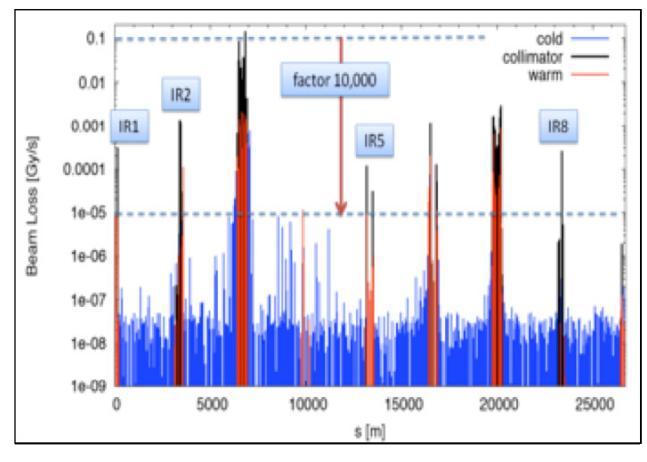
In order to measure the cleaning efficiency of the collimation system, "loss maps" are made by provoking beam losses around the circumference. When the collimators are well set up and the hierarchy of losses is correct, the vast majority of all losses should be localised at the collimator. Figure 9 shows one such plot where it can be seen that the ratio between the losses at the collimators and the worst cold location is a factor of 10,000. It has been found that the settings of the collimators remain constant [13] for periods of at least weeks.

Figure 9: Loss Maps for Collimation.

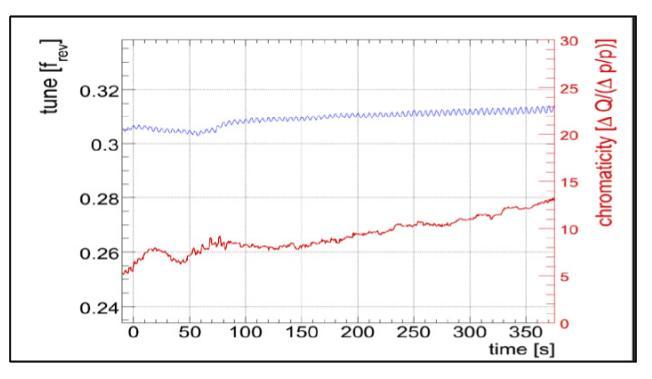
There are numerous examples of the high quality of the diagnostics and its implementation into the controls applications. Figure 10 shows one such example. In order to measure the chromaticity during the energy ramp, the beam momentum is modulated by varying the RF frequency and the transverse tunes are measured by a phase lock loop.

Figure 10: Tune and Chromaticity Measurements, (the upper blue plot shows the modulation of the tune and from the peak to peak of the modulation the chromaticity is calculated and shown in the lower red plot).

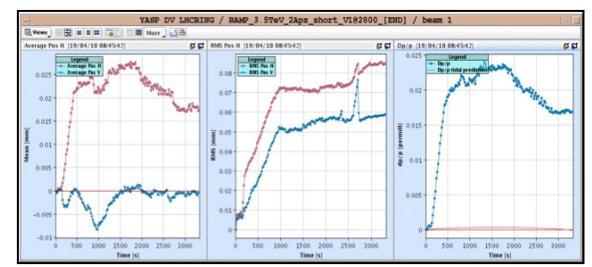
Another example is shown in Figure 11, which shows the operation of orbit feedback during the energy ramp. The three plots show the mean, rms orbit distortion and the momentum deviation. The maximum rms orbit change during the ramp is 0.08mm.

Figure 11: Orbit Feedback in Operation.

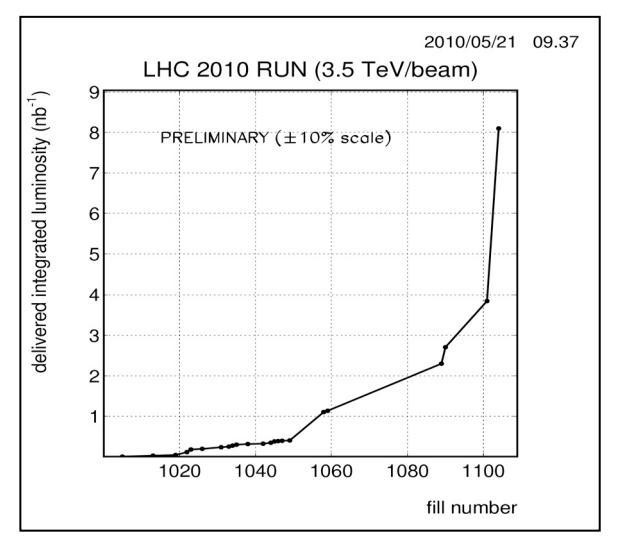
Figure 12: Integrated Luminosity delivered to the experiments during first 2 months of shared operation between commissioning and physics data taking.

As previously stated LHC has been operating in shared mode between beam commissioning and physics data taking during the months of April and May. The peak luminosity has been increased by almost 2 orders of magnitude during this period. However there are still another few orders of magnitude to be increased before the goal for the end of 2010 is reached  $(2x10^{32} \text{ cm}^{-2}\text{s}^{-1})$
